Susitna-Watana Hydroelectric Project Document

Title: Site-specific seismic hazard study plan Section 16.6, Study Completion Report. Attachment 3, Lineament mapping and analysis <i>Formal title:</i> Lineament mapping and analysis for the Susitna-Watana Dam site area		SuWa 289
Author(s) – Personal: Justin Pearce, Dean Ostenaa, Cooper Brossy, David Trench		
Author(s) – Corporate: Fugro Consultants, Inc.		
AEA-identified category, if specified: November 2015; Study Completion and 2014/2015 Implementation Reports		
AEA-identified series, if specified: NTP 11 Technical memorandum ; no. 8		
Series (ARLIS-assigned report number): Susitna-Watana Hydroelectric Project document number 289	Existing numbers on document: AEA11-022 TM-11-0008-032713	
Published by: [Anchorage : Alaska Energy Authority, 2015]	Date published: March 27, 2013	
Published for: MWH and Alaska Energy Authority	Date or date range of report:	
Volume and/or Part numbers: Study plan Section 16.6	Final or Draft status, as indicated: v0.0

NTP 11 Technical Memorandum No. 8 v0.0

Lineament Mapping and Analysis for the Susitna-Watana Dam Site

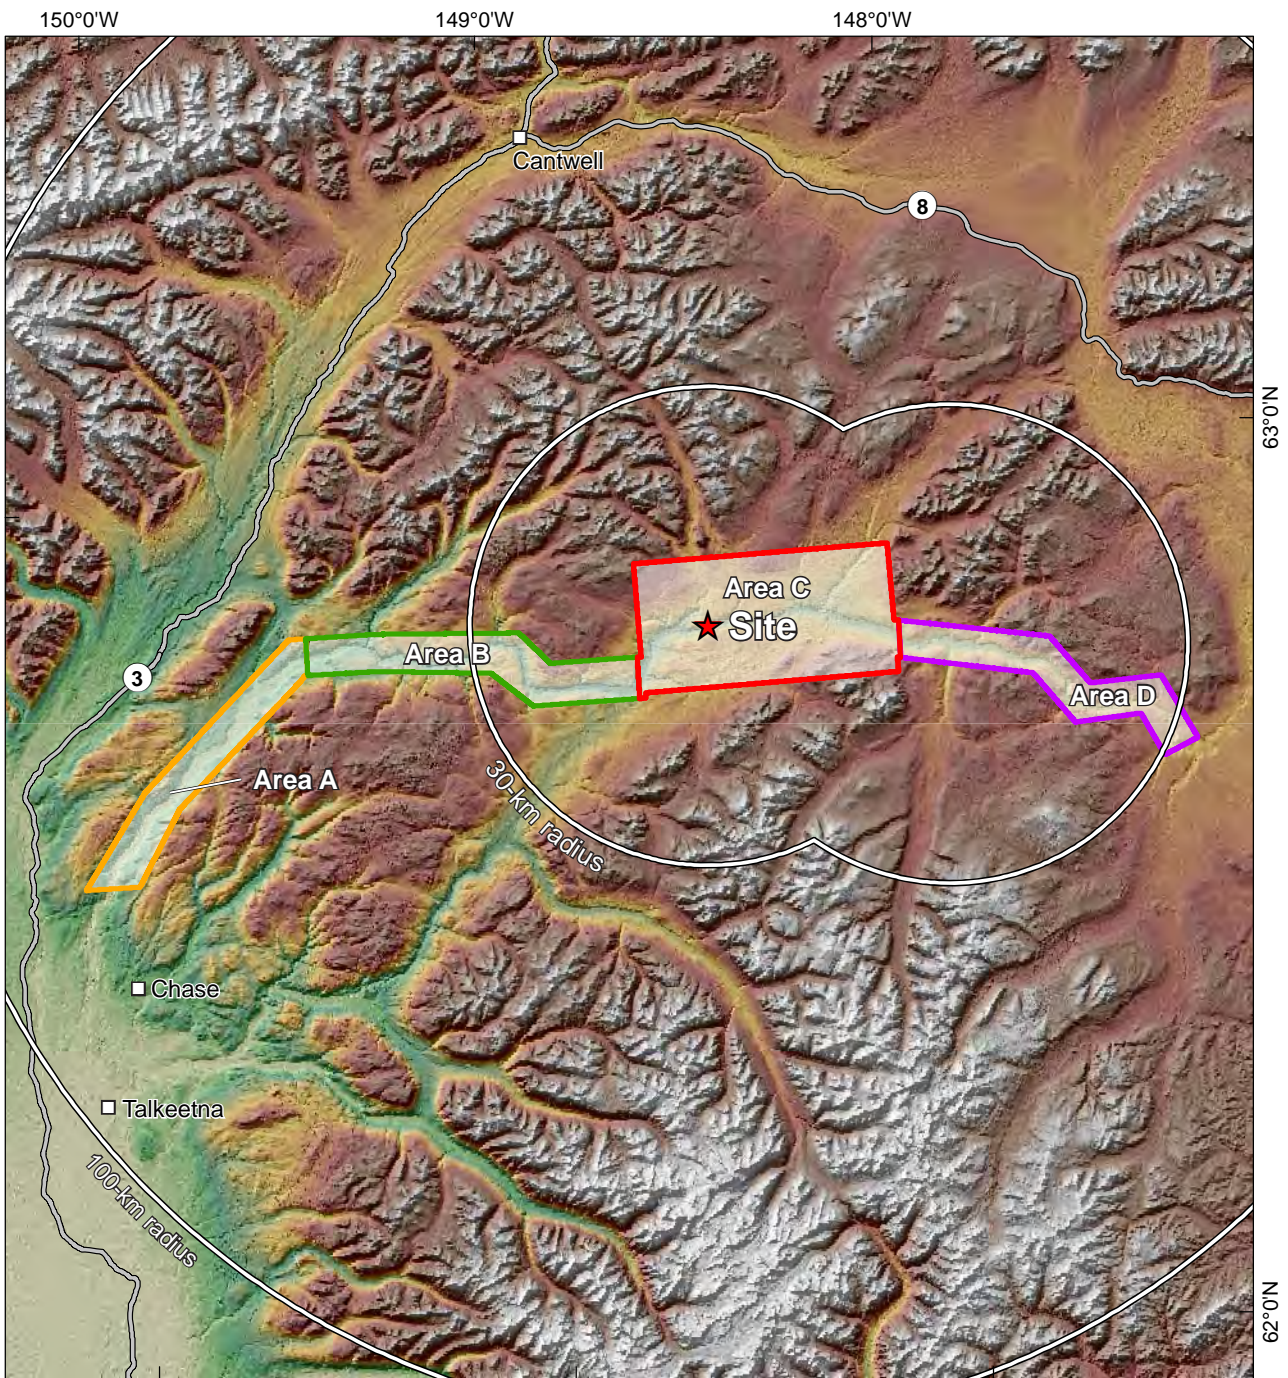
FIGURE 2-2

Base data from ASTER Global Digital Elevation Model

The objective of FCL's lineament mapping task was to use recently-acquired, detailed, topographic data (i.e., INSAR (Figure 2-1) and LiDAR (Figure 2-2) to re-examine the landscape for evidence of potential lineaments, faults, or geomorphic features suggestive of Quaternary faulting. These data form a basis for evaluating potential seismic sources previously not accounted for in the initial PSHA, and to assess the potential for fault rupture through the proposed dam footprint. This work included review of the previous WCC studies (WCC, 1980; WCC, 1982) as well as recent literature, and provides updated mapping and interpretations on the presence or absence of potentially fault-related lineament features. Recent, detailed, digital terrain models were constructed from the INSAR and LiDAR data acquired well after the WCC study. Limited field reconnaissance including low-altitude fly-overs were performed to inspect and verify features identified by the desktop-based lineament mapping. Detailed structural or geologic mapping of the local dam site vicinity and broader region was not conducted during this lineament mapping effort. Such mapping of the dam site, including synthesis of existing geotechnical, geological, and geophysical data, is beyond the scope of this lineament mapping effort but is planned in upcoming work phases.

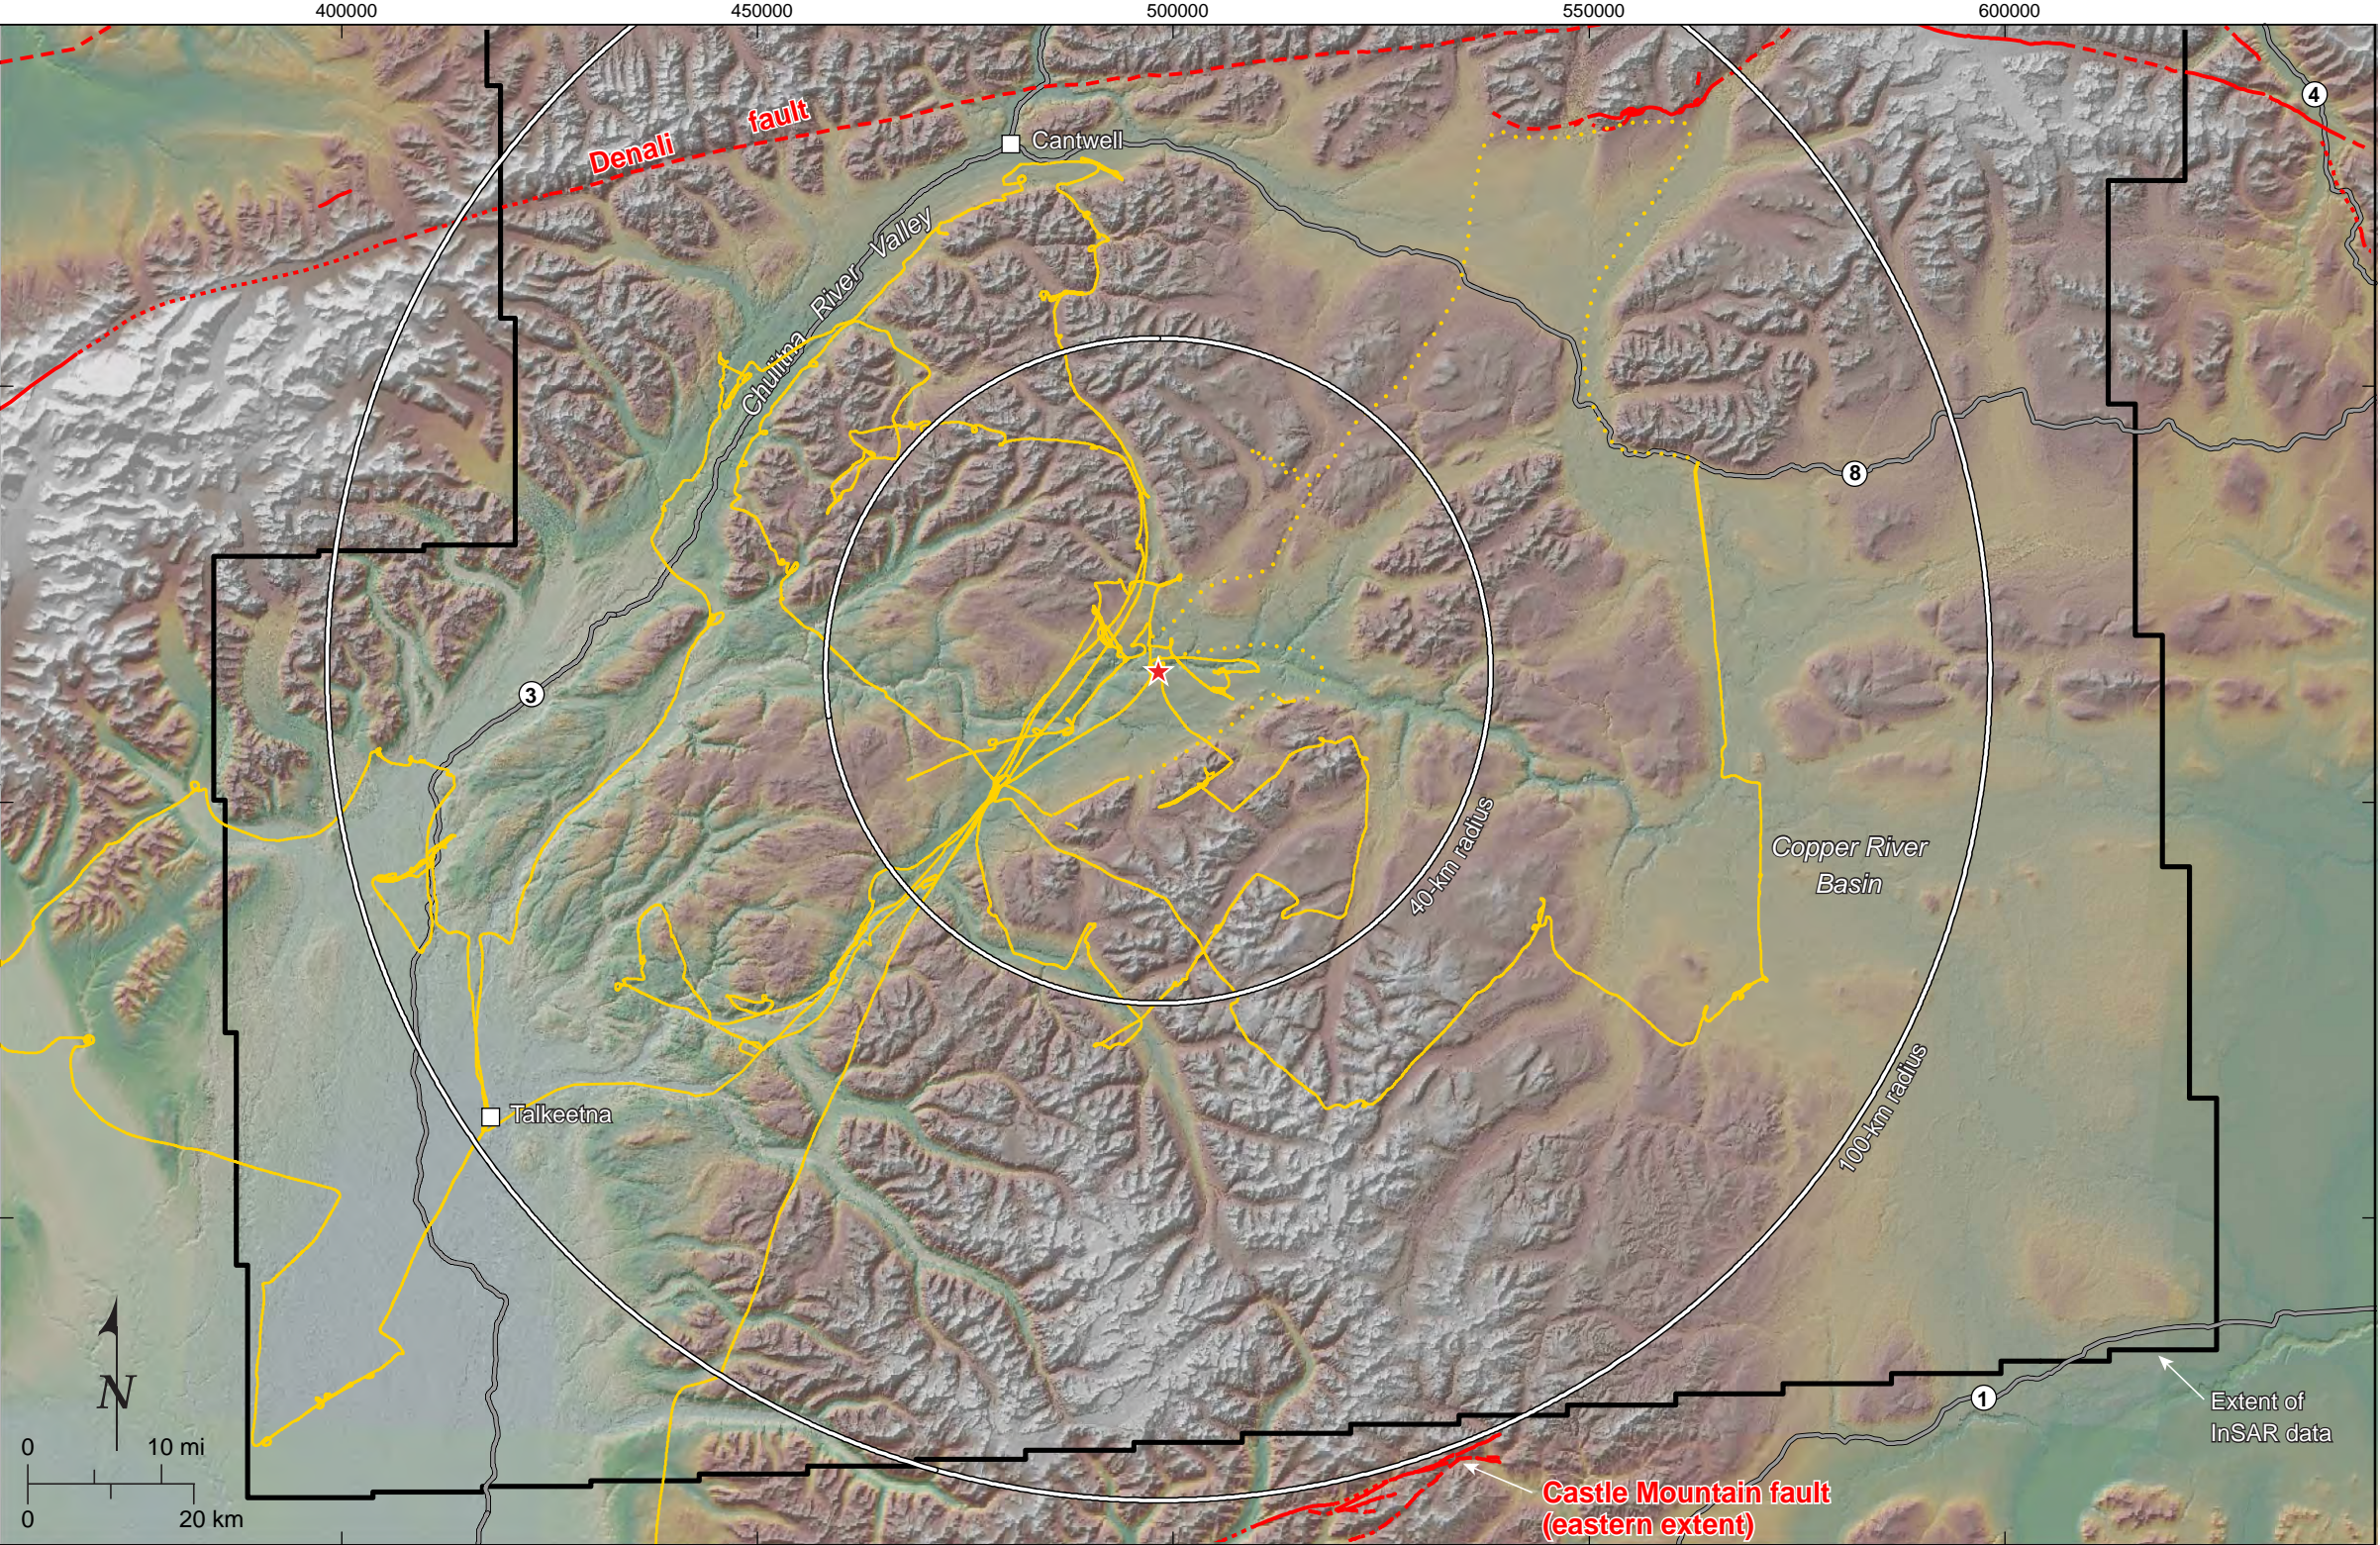
FIGURE
FIGURE 2-3

SUSITNA-WATANA HYDROELECTRIC PROJECT
SEPTEMBER 2012
FIELD RECONNAISSANCE GPS TRACKS

occurred during September 5 through 9, 2012, and involved low-altitude helicopter flyovers of the site area and much of the 100 km (~62 mi) site radius area targeted to visually review features that were identified during the lineament mapping (Figure 2-3). The objective of the reconnaissance was to confirm, refute, or develop degrees of confidence in the interpretation of lineament features as tectonic or non-tectonic in origin, with limited and brief on-ground observations. Selection of routes for the flyovers were dictated and restricted by weather conditions, which included periods of low clouds and rain during the reconnaissance period. The field reconnaissance was conducted by senior FCL geologists (D. Ostenaar, J. Pearce). The field reconnaissance observations were documented by notes, photographs, and GPS.

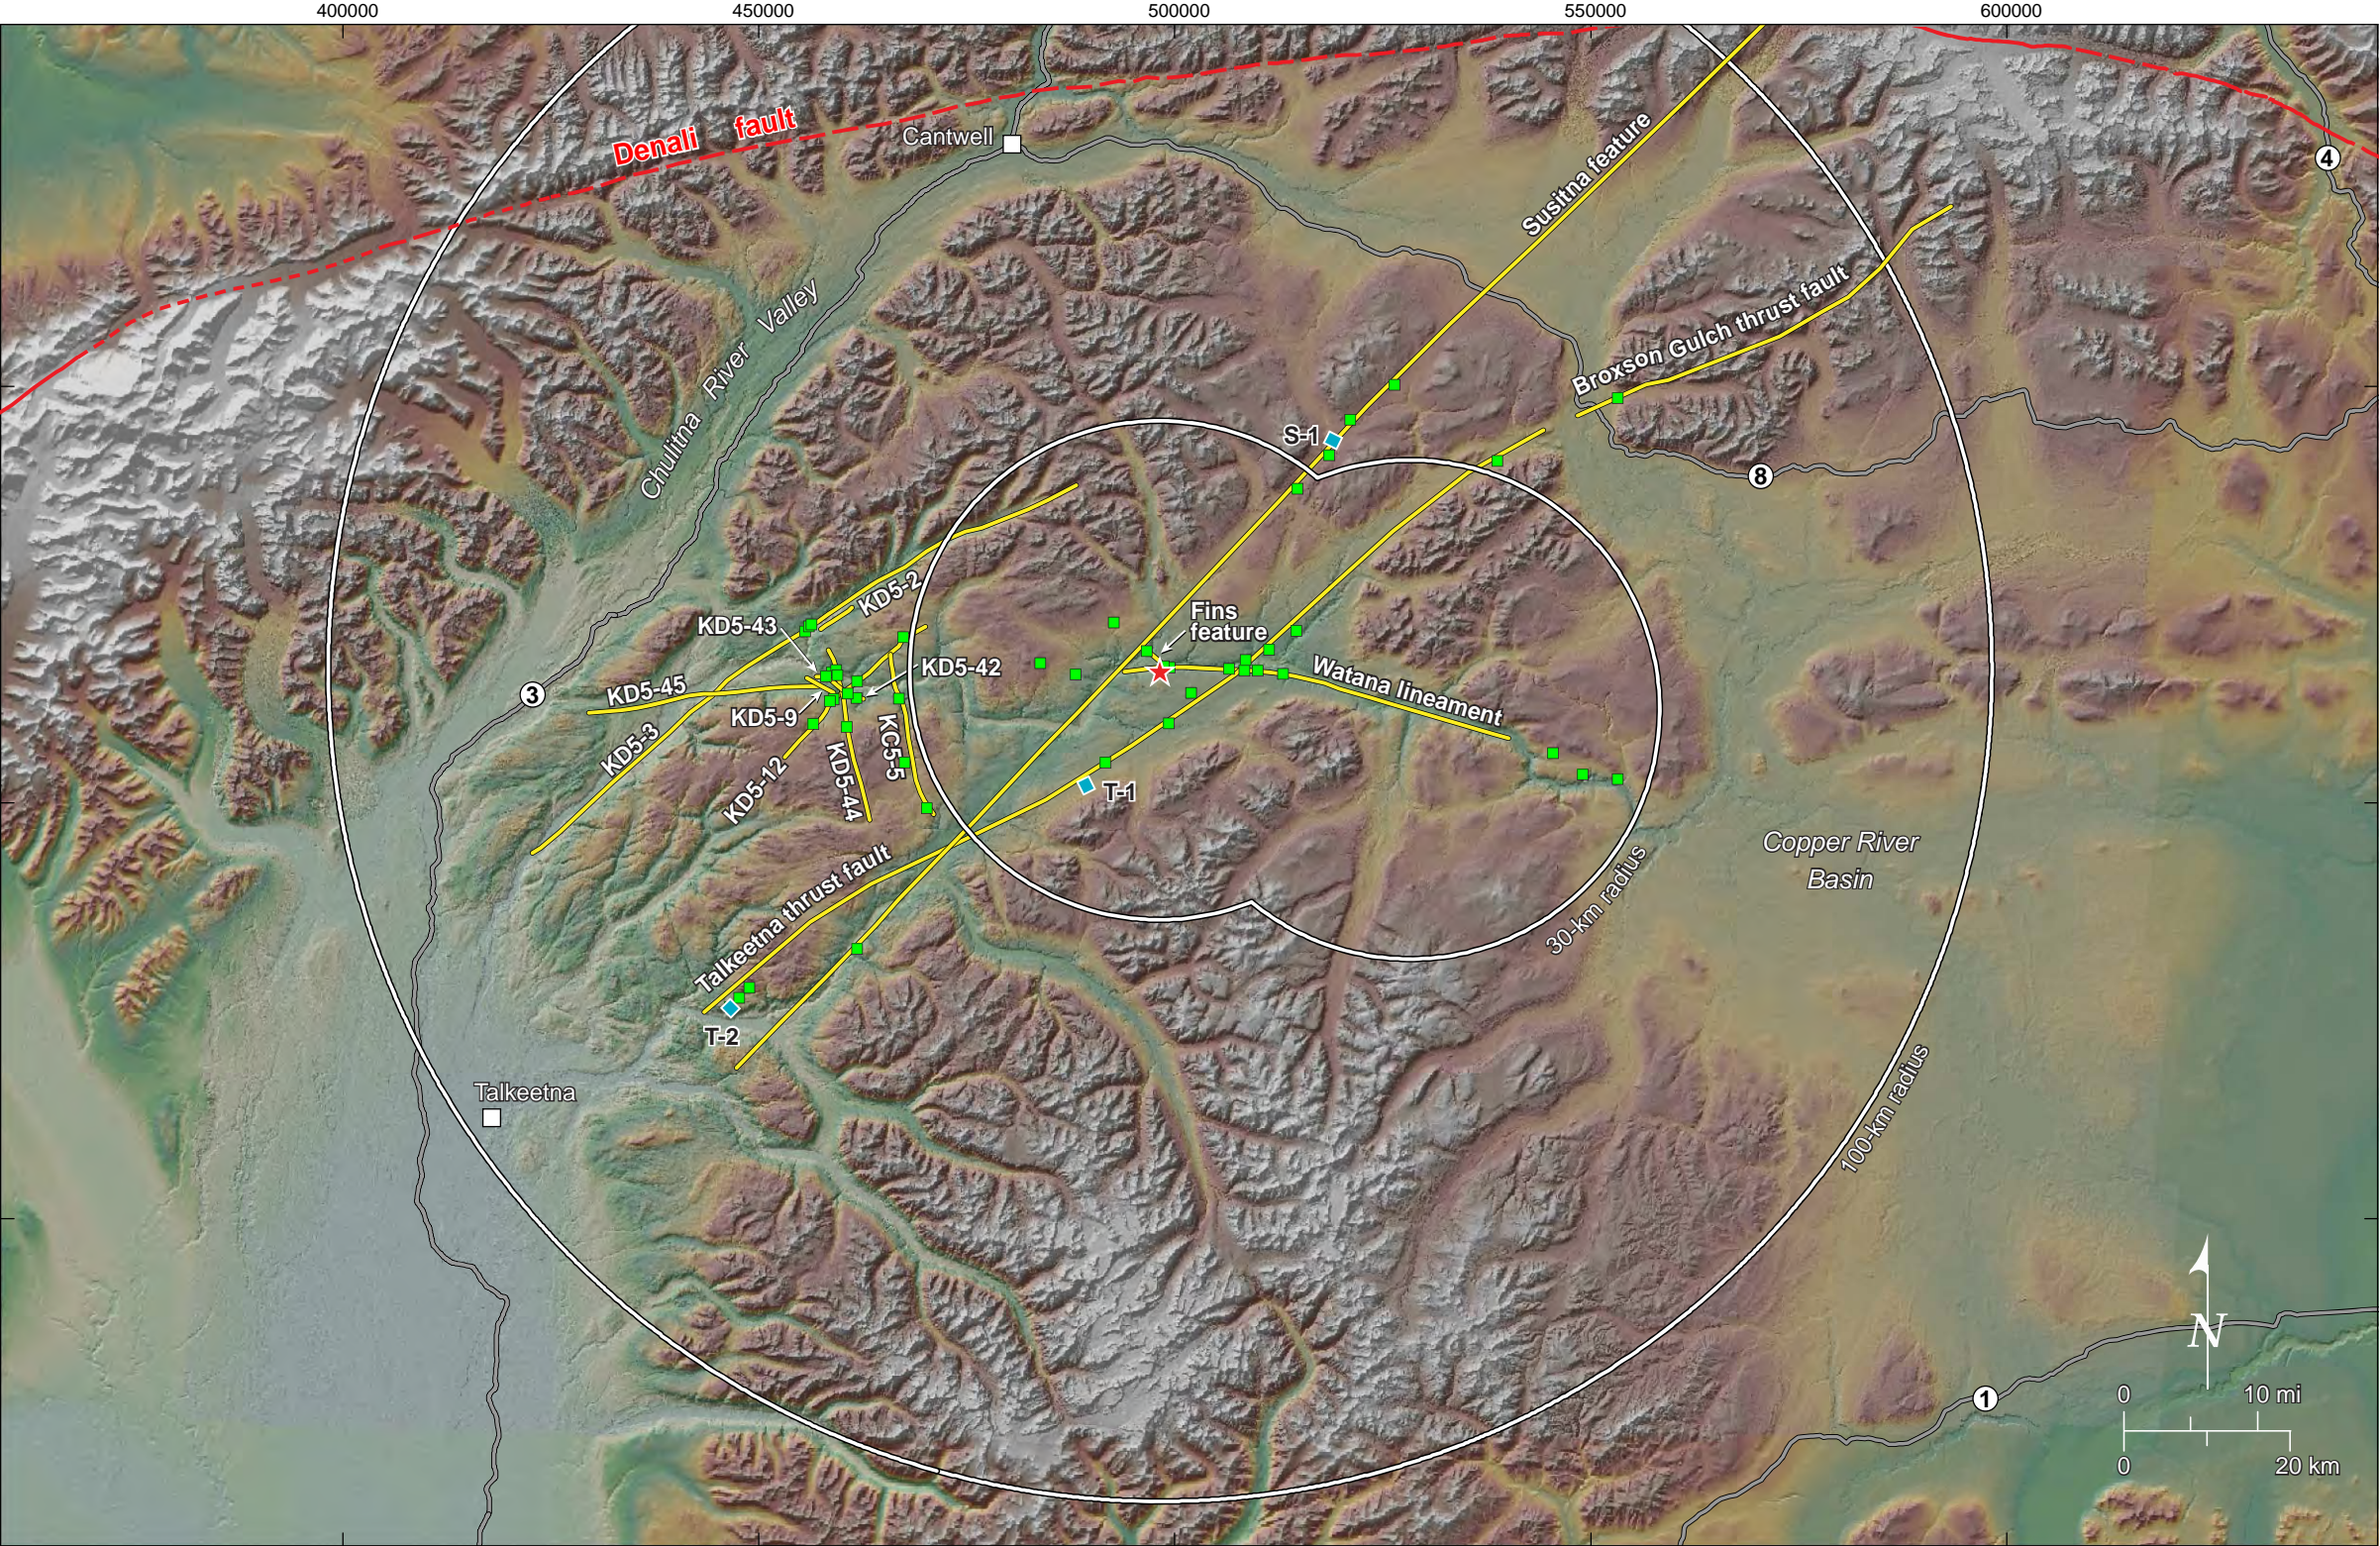
FIGURE
FIGURE 2-4

SUSITNA-WATANA HYDROELECTRIC PROJECT
SIGNIFICANT FEATURES
FROM WCC (1982)

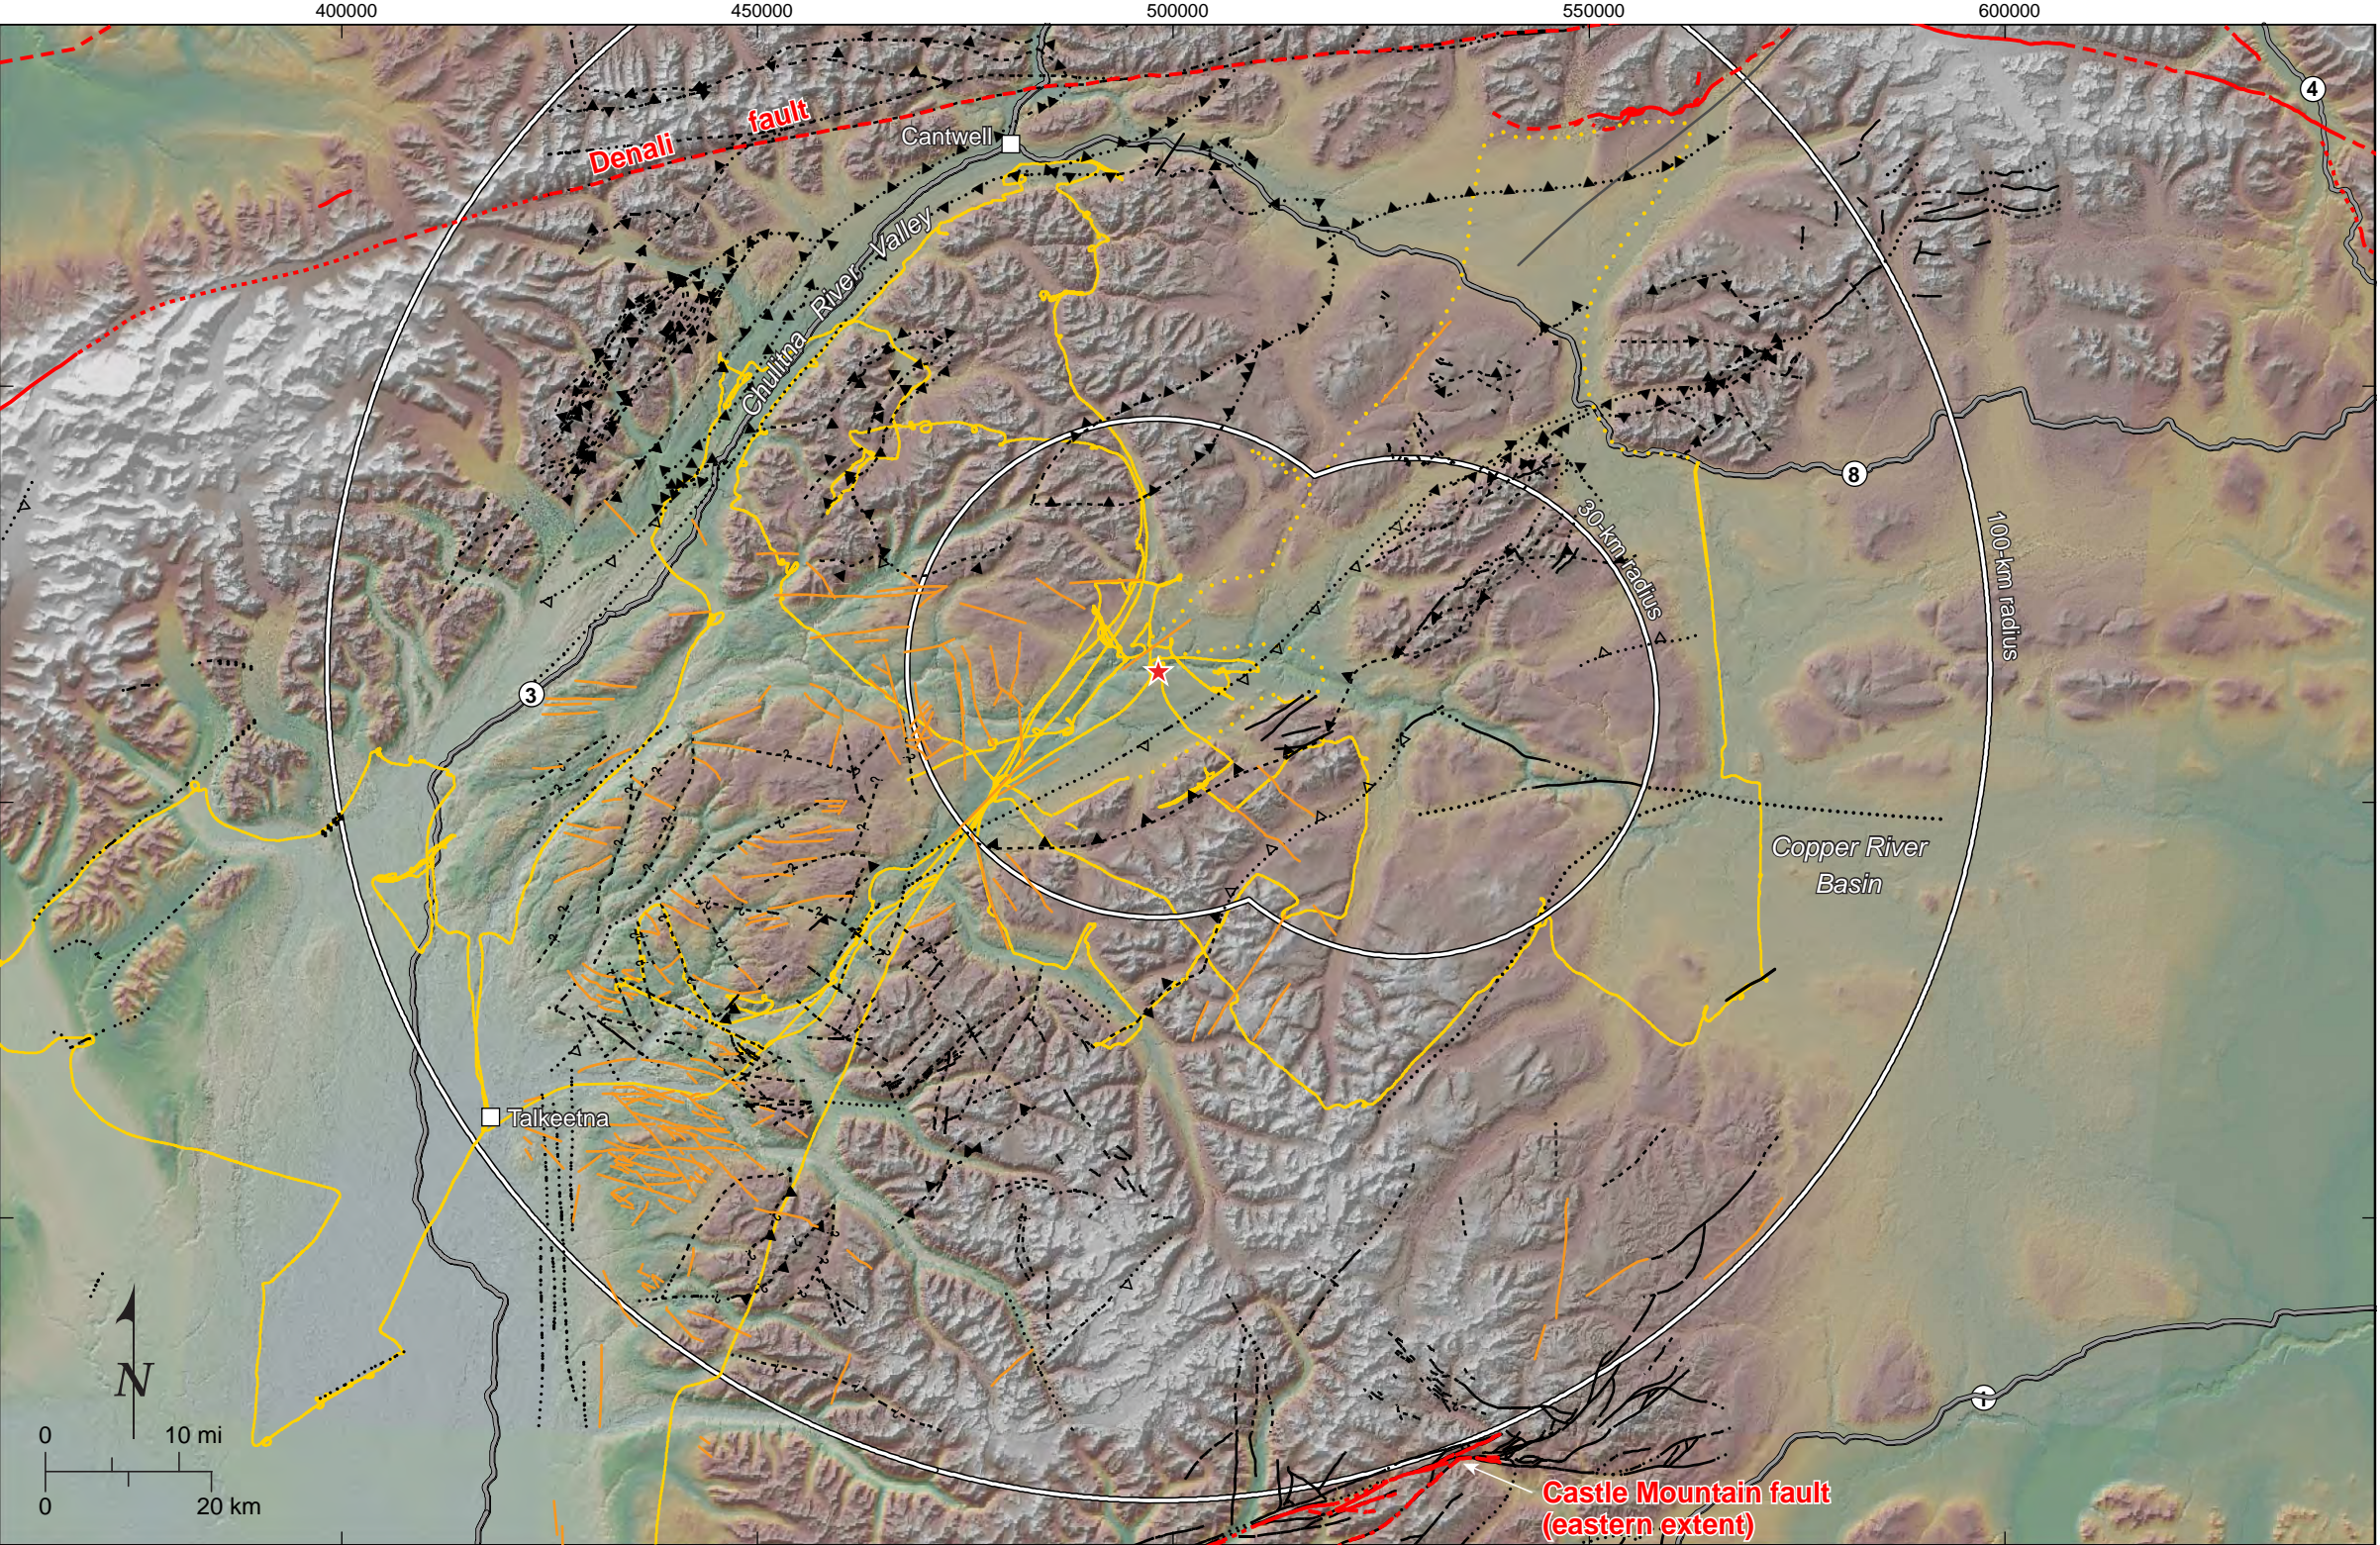
FIGURE
FIGURE 2-6

SUSITNA-WATANA HYDROELECTRIC PROJECT
FAULTS AND LINEAMENTS COMPILED
FROM PUBLISHED SOURCES

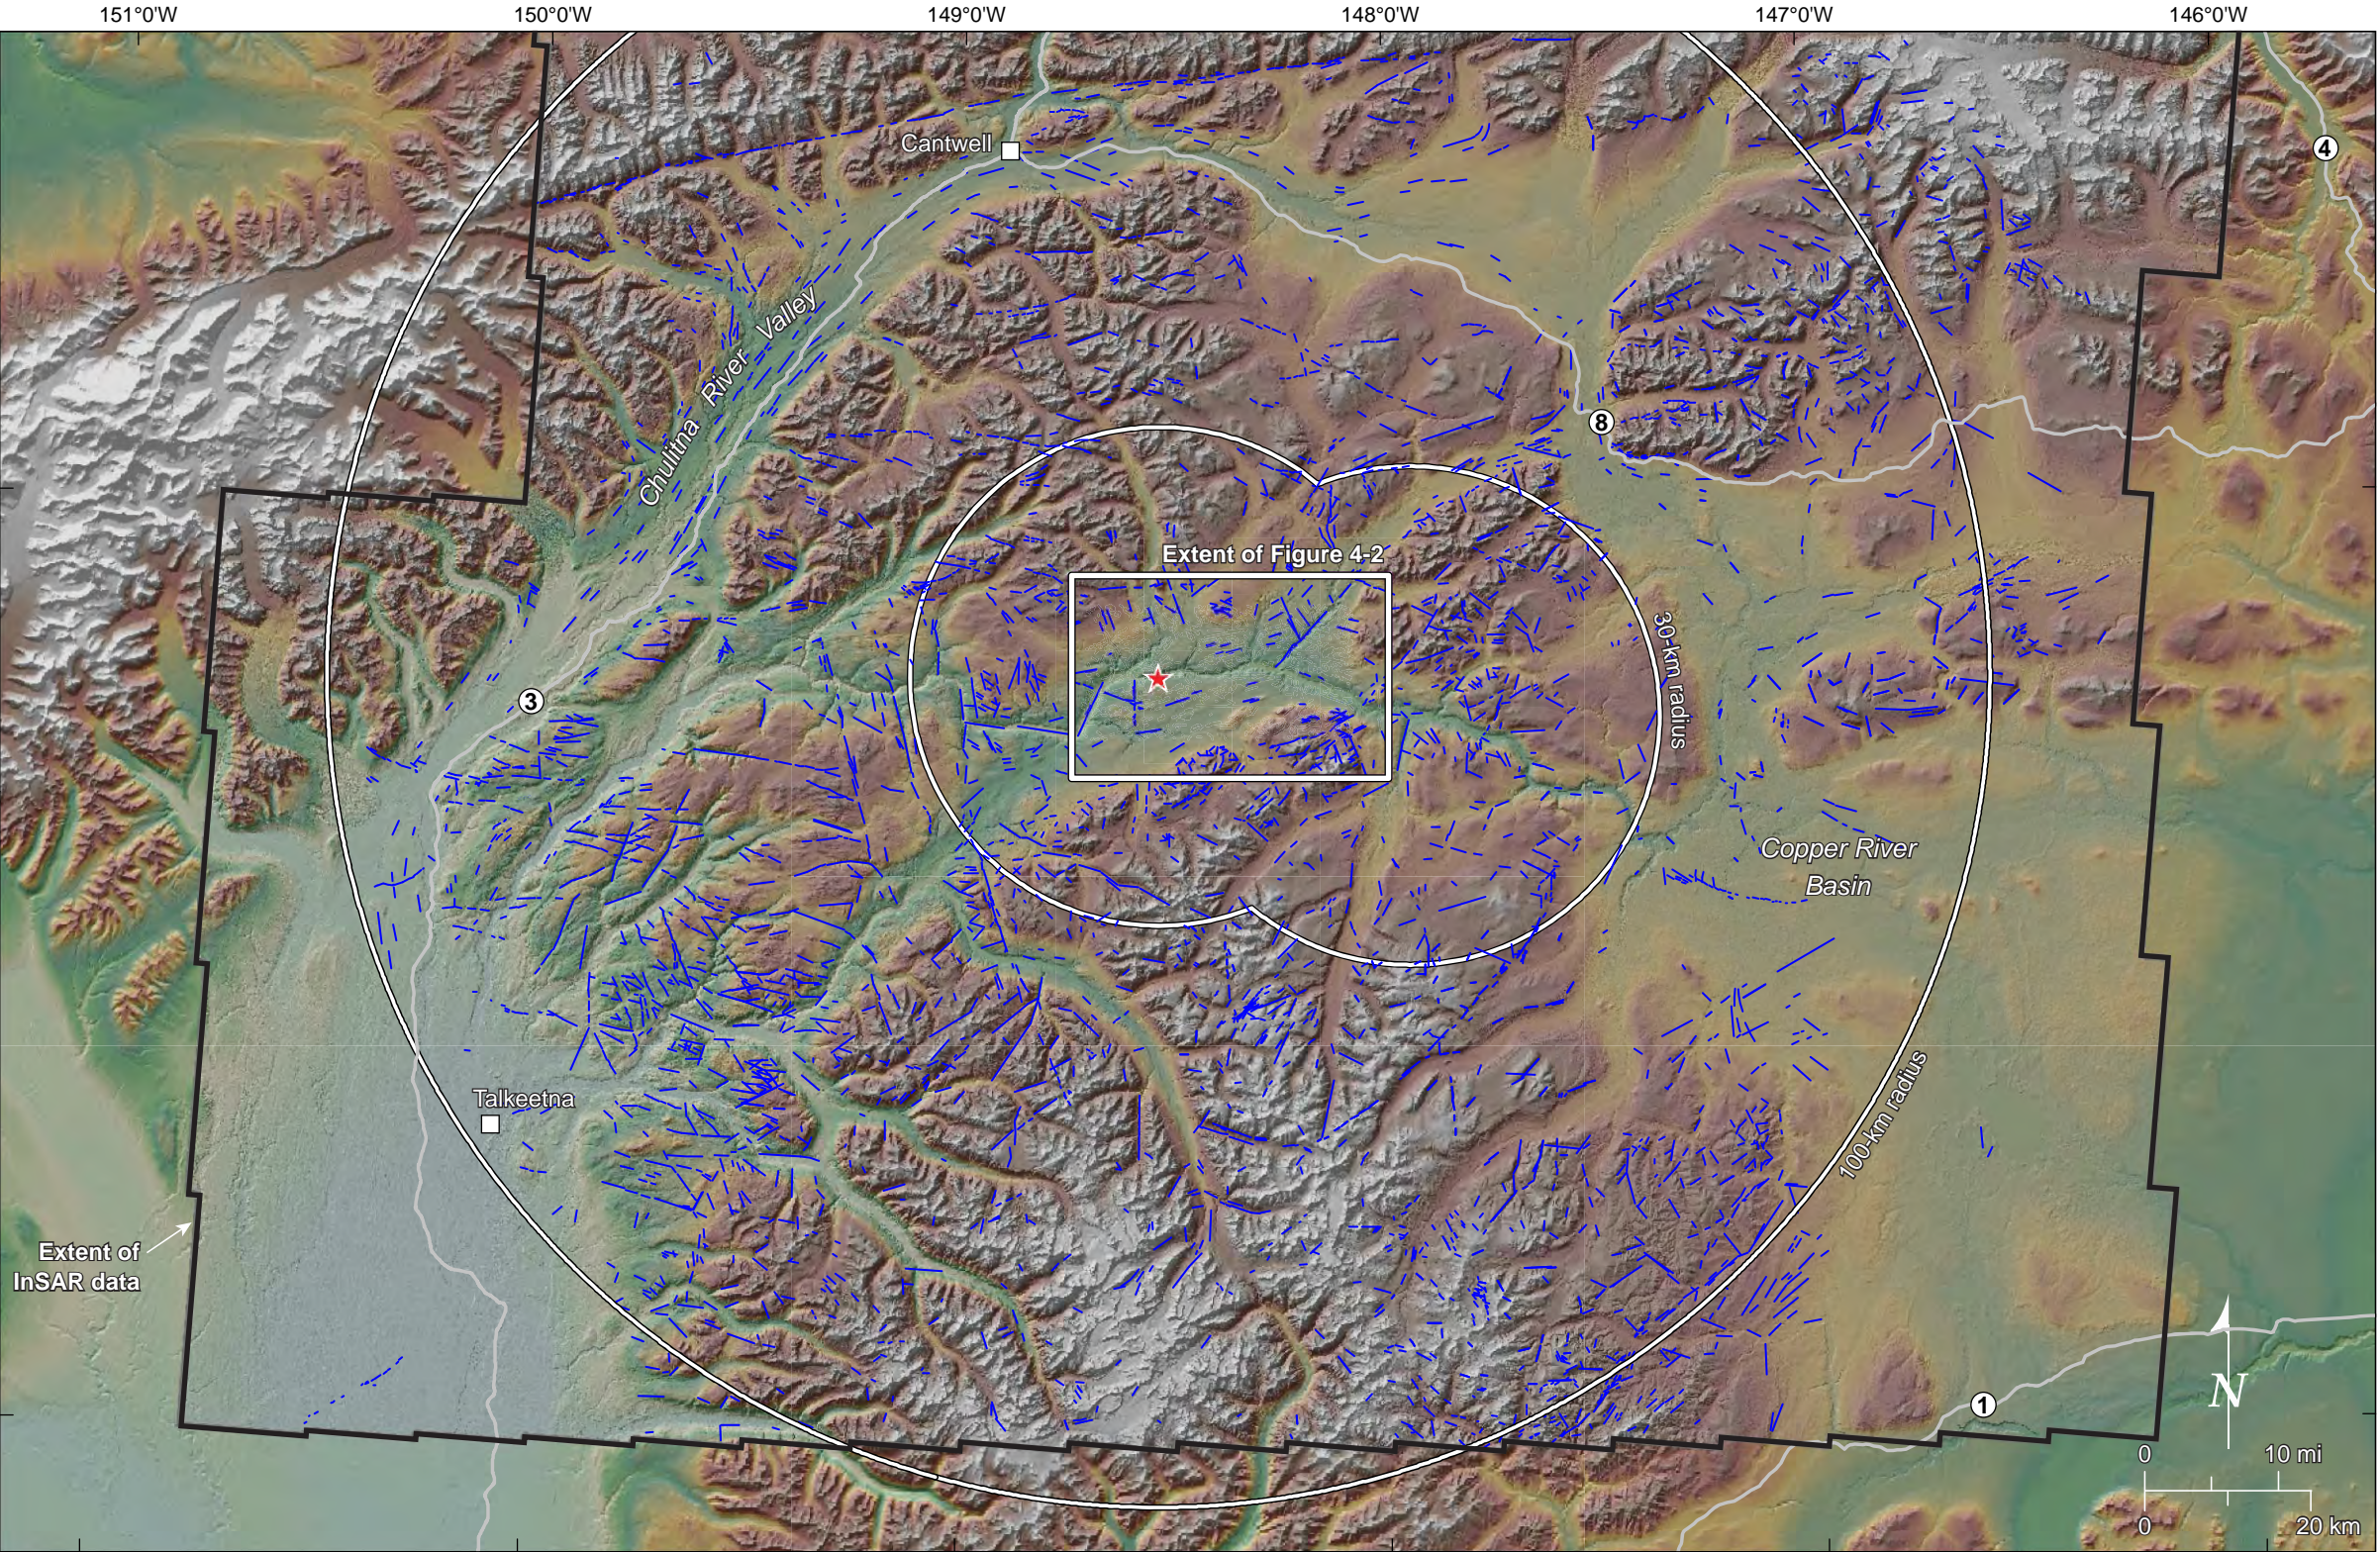
- Explanation**
- Lineament mapped by Fugro Consultants, Inc. (this study)
 - Proposed Watana site

Note: See Figure 4-2 for detailed lineament mapping on LiDAR.

As noted in Section 3, lineament length is, in part, a function of mapping and data scale. Mapping at more-detailed scale, with higher resolution imagery, will typically lead to identification of shorter features, which must be aggregated into groups for broader evaluation. Mapping by this study included identification of new, shorter features at more-detailed scales along previously mapped WCC lineaments, but recognized relatively little or no expression of these aligned, smaller scale features in the landscape (based on the INSAR data) which might be considered suggestive of potentially high rates of late Quaternary slip (Figure 4-1; Figure 4-2; Plate 1).
