## **Figures**

SUSITNA-WATANA HYDROELECTRIC PROJECT  
EXAMPLE OF  
LINEAMENT GROUP  
MAP DATA

SUSITNA-WATANA HYDROELECTRIC PROJECT

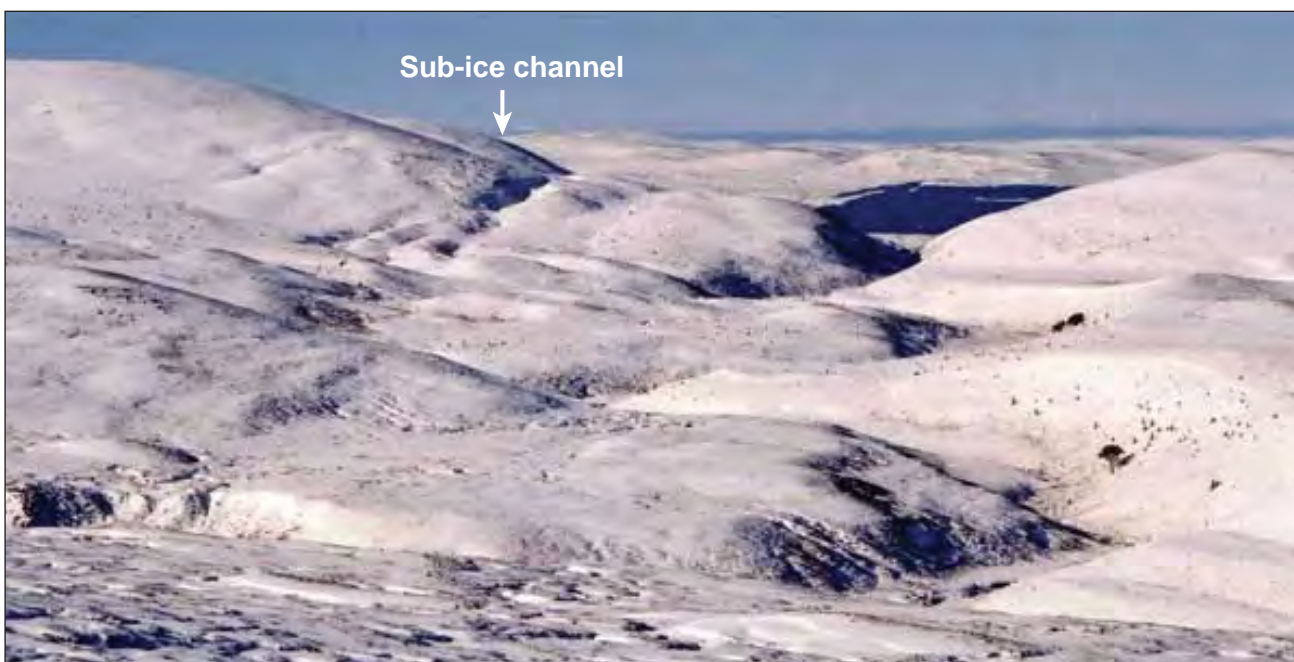
FIGURE  
3-10

These sub-ice channels are cut through interfluves, seen as notches on the skyline.

SUSITNA-WATANA HYDROELECTRIC PROJECT  
SUB-ICE CHANNELS CUT THROUGH  
INTERFLUVES, SCOTLAND AND  
EXAMPLE SUB-ICE CHANNEL MORPHOLOGY

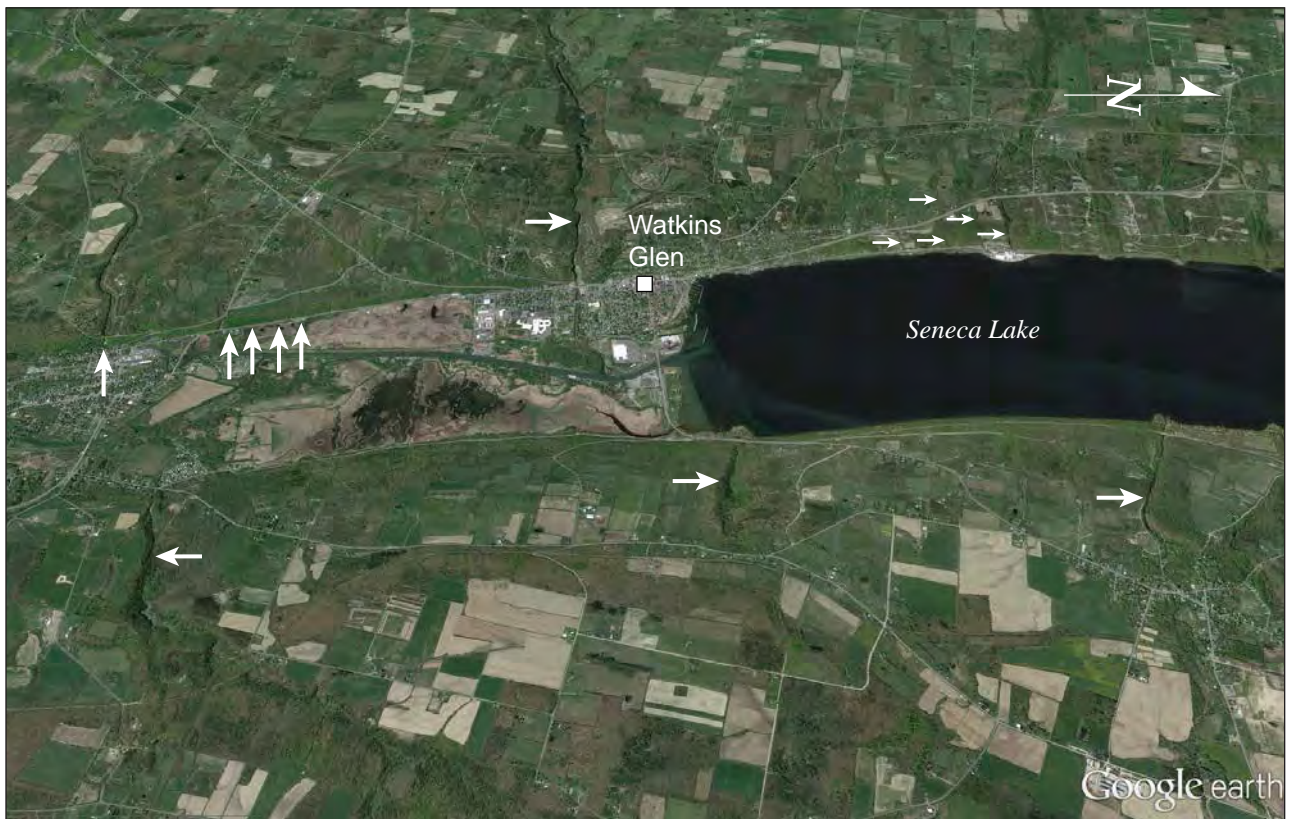
White arrows denote locations of linear to sub-linear incised creeks that enter at high angles to Seneca Valley and Lake.

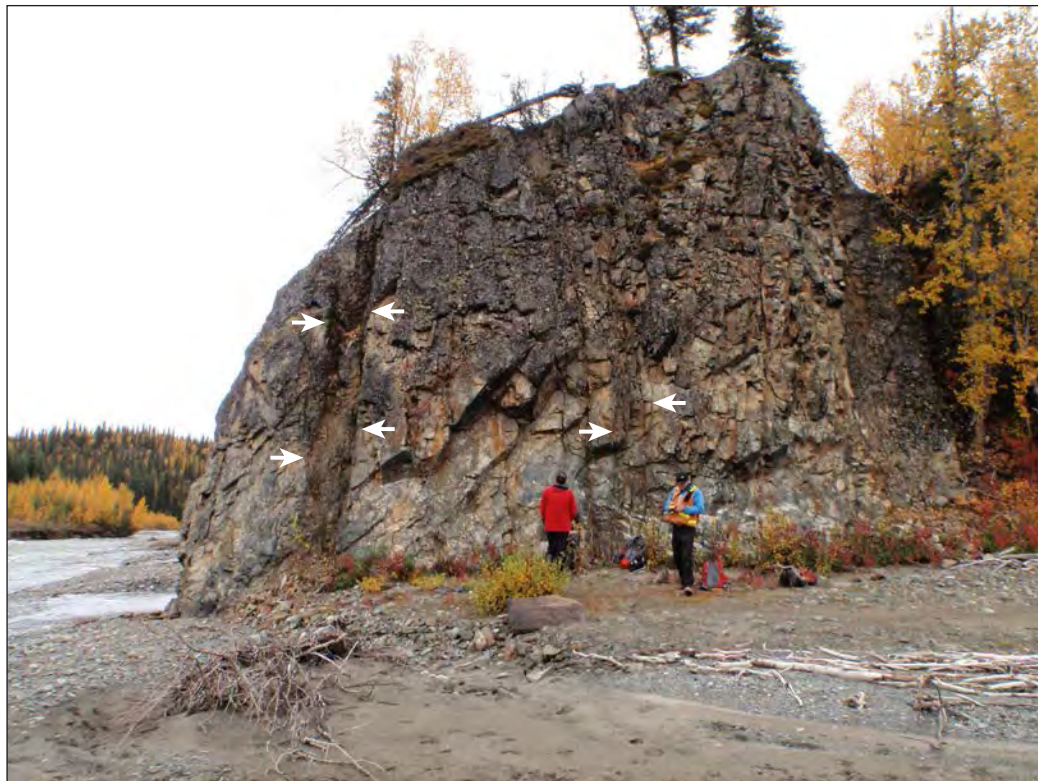
Vertical faults exposed in Triassic rocks, at the mouth of Watana Creek.

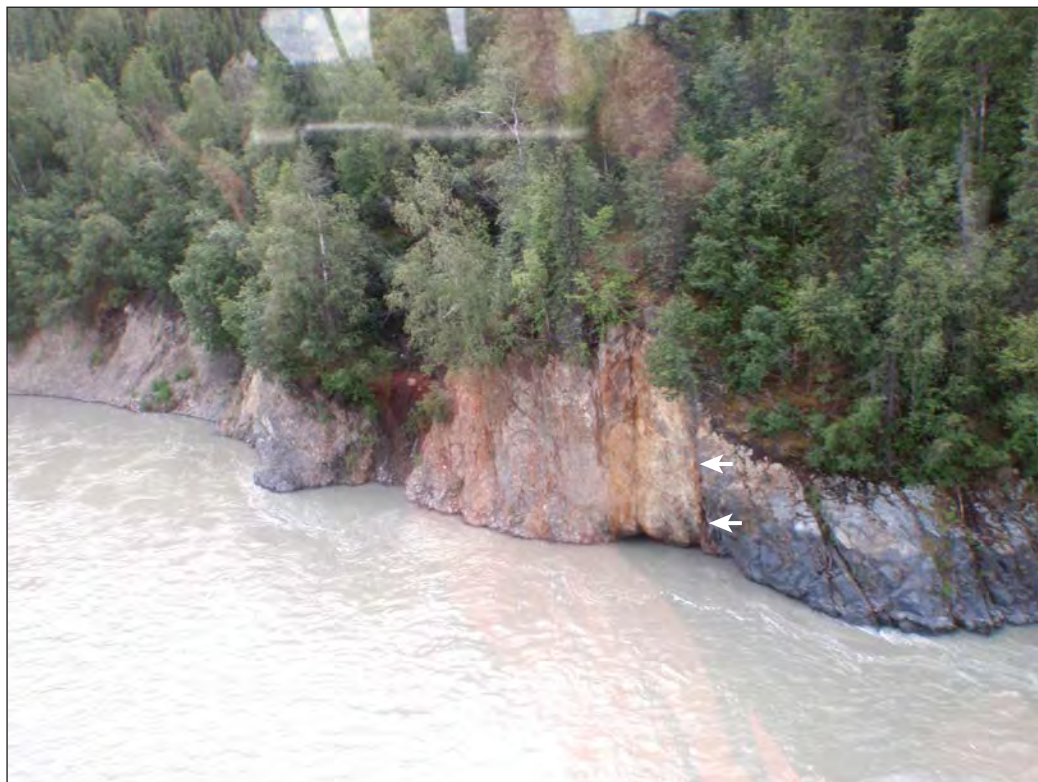
Vertical faults exposed in Triassic rocks, across from the mouth of Watana Creek.

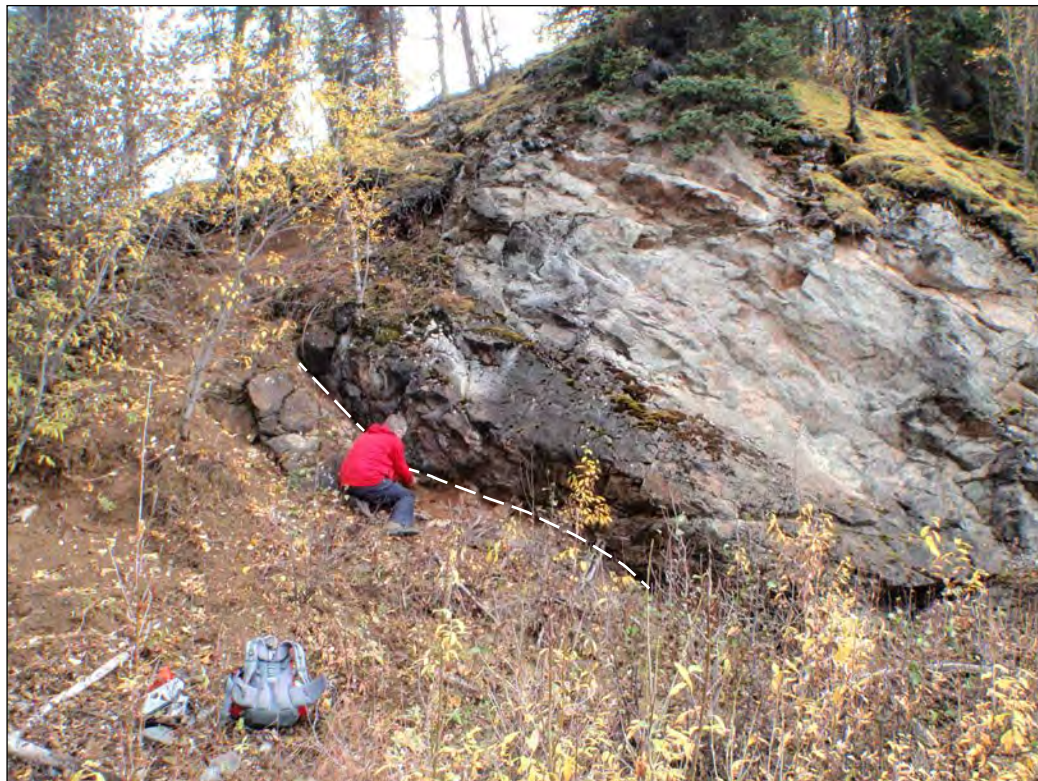
Triassic shear (140, 45 SW) outcrop.

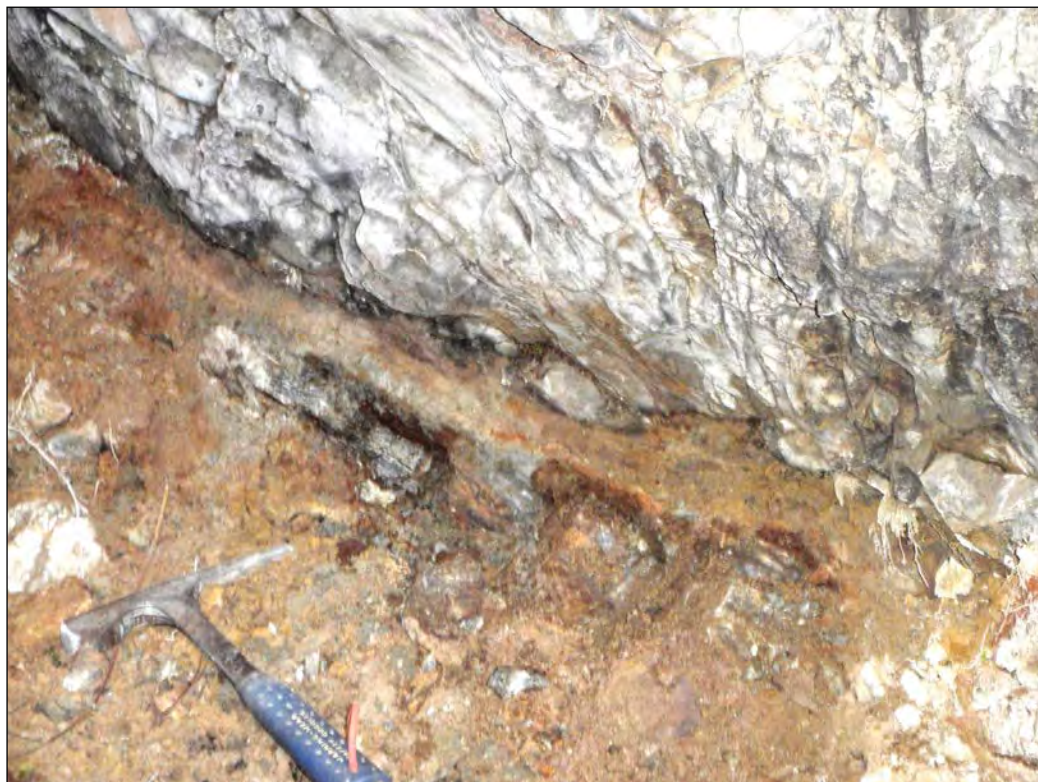
Close up of a shear feature.

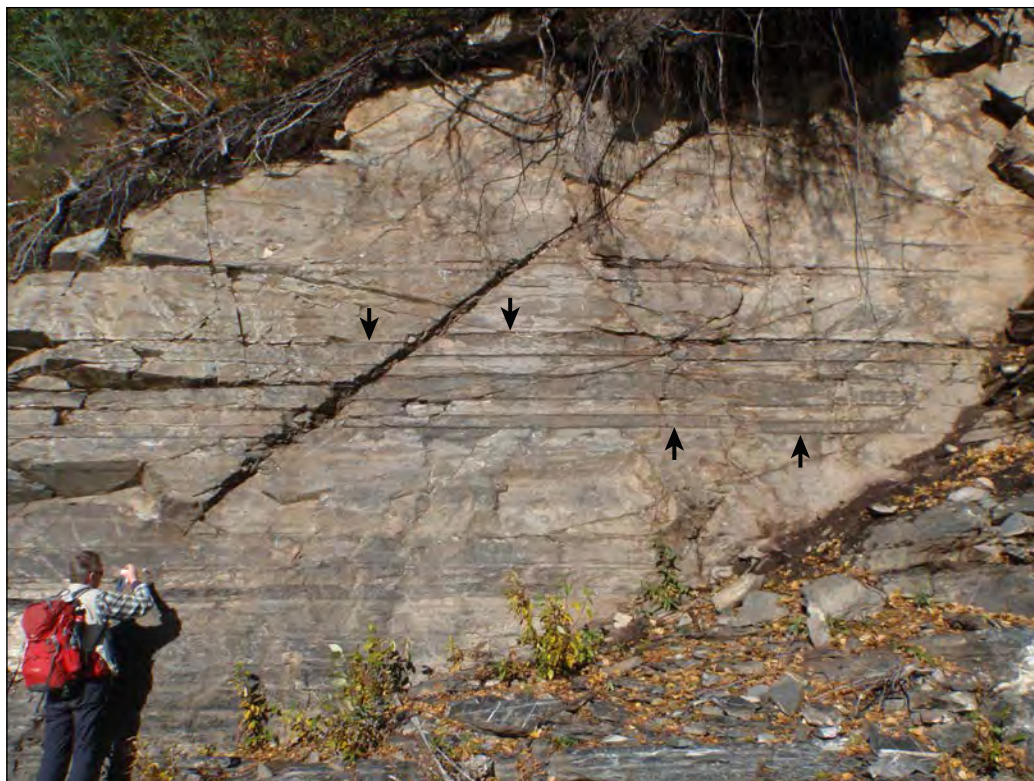
Fault S1 outcrop.

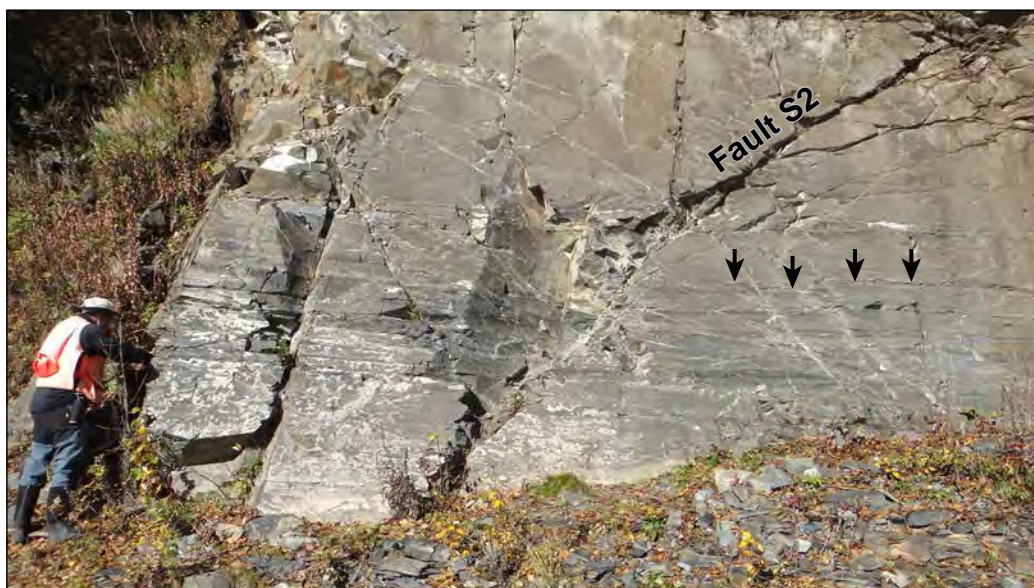
Fault S2 outcrop.

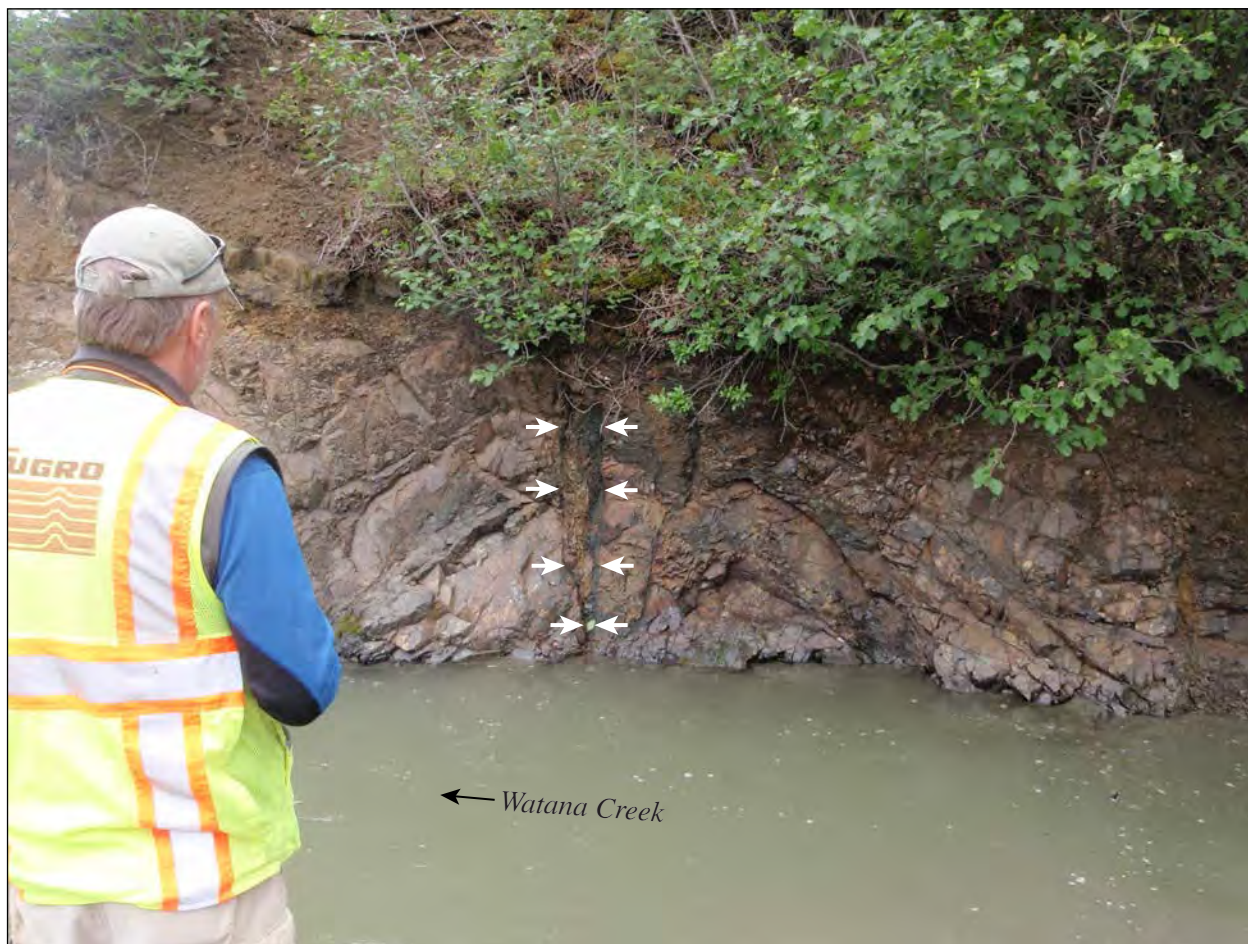
FIGURE  
5-9

View looking south at vertical fault in Triassic rocks; visually estimated apparent strike is northeast.

SUSITNA-WATANA HYDROELECTRIC PROJECT  
FAULT EXPOSED IN TRIASSIC  
ROCK, LOWER WATANA CREEK
