**Susitna-Watana Hydroelectric Project  
(FERC No. 14241)**

**Geomorphology Study  
Study Plan Section 6.5**

**2014-2015 Study Implementation Report**

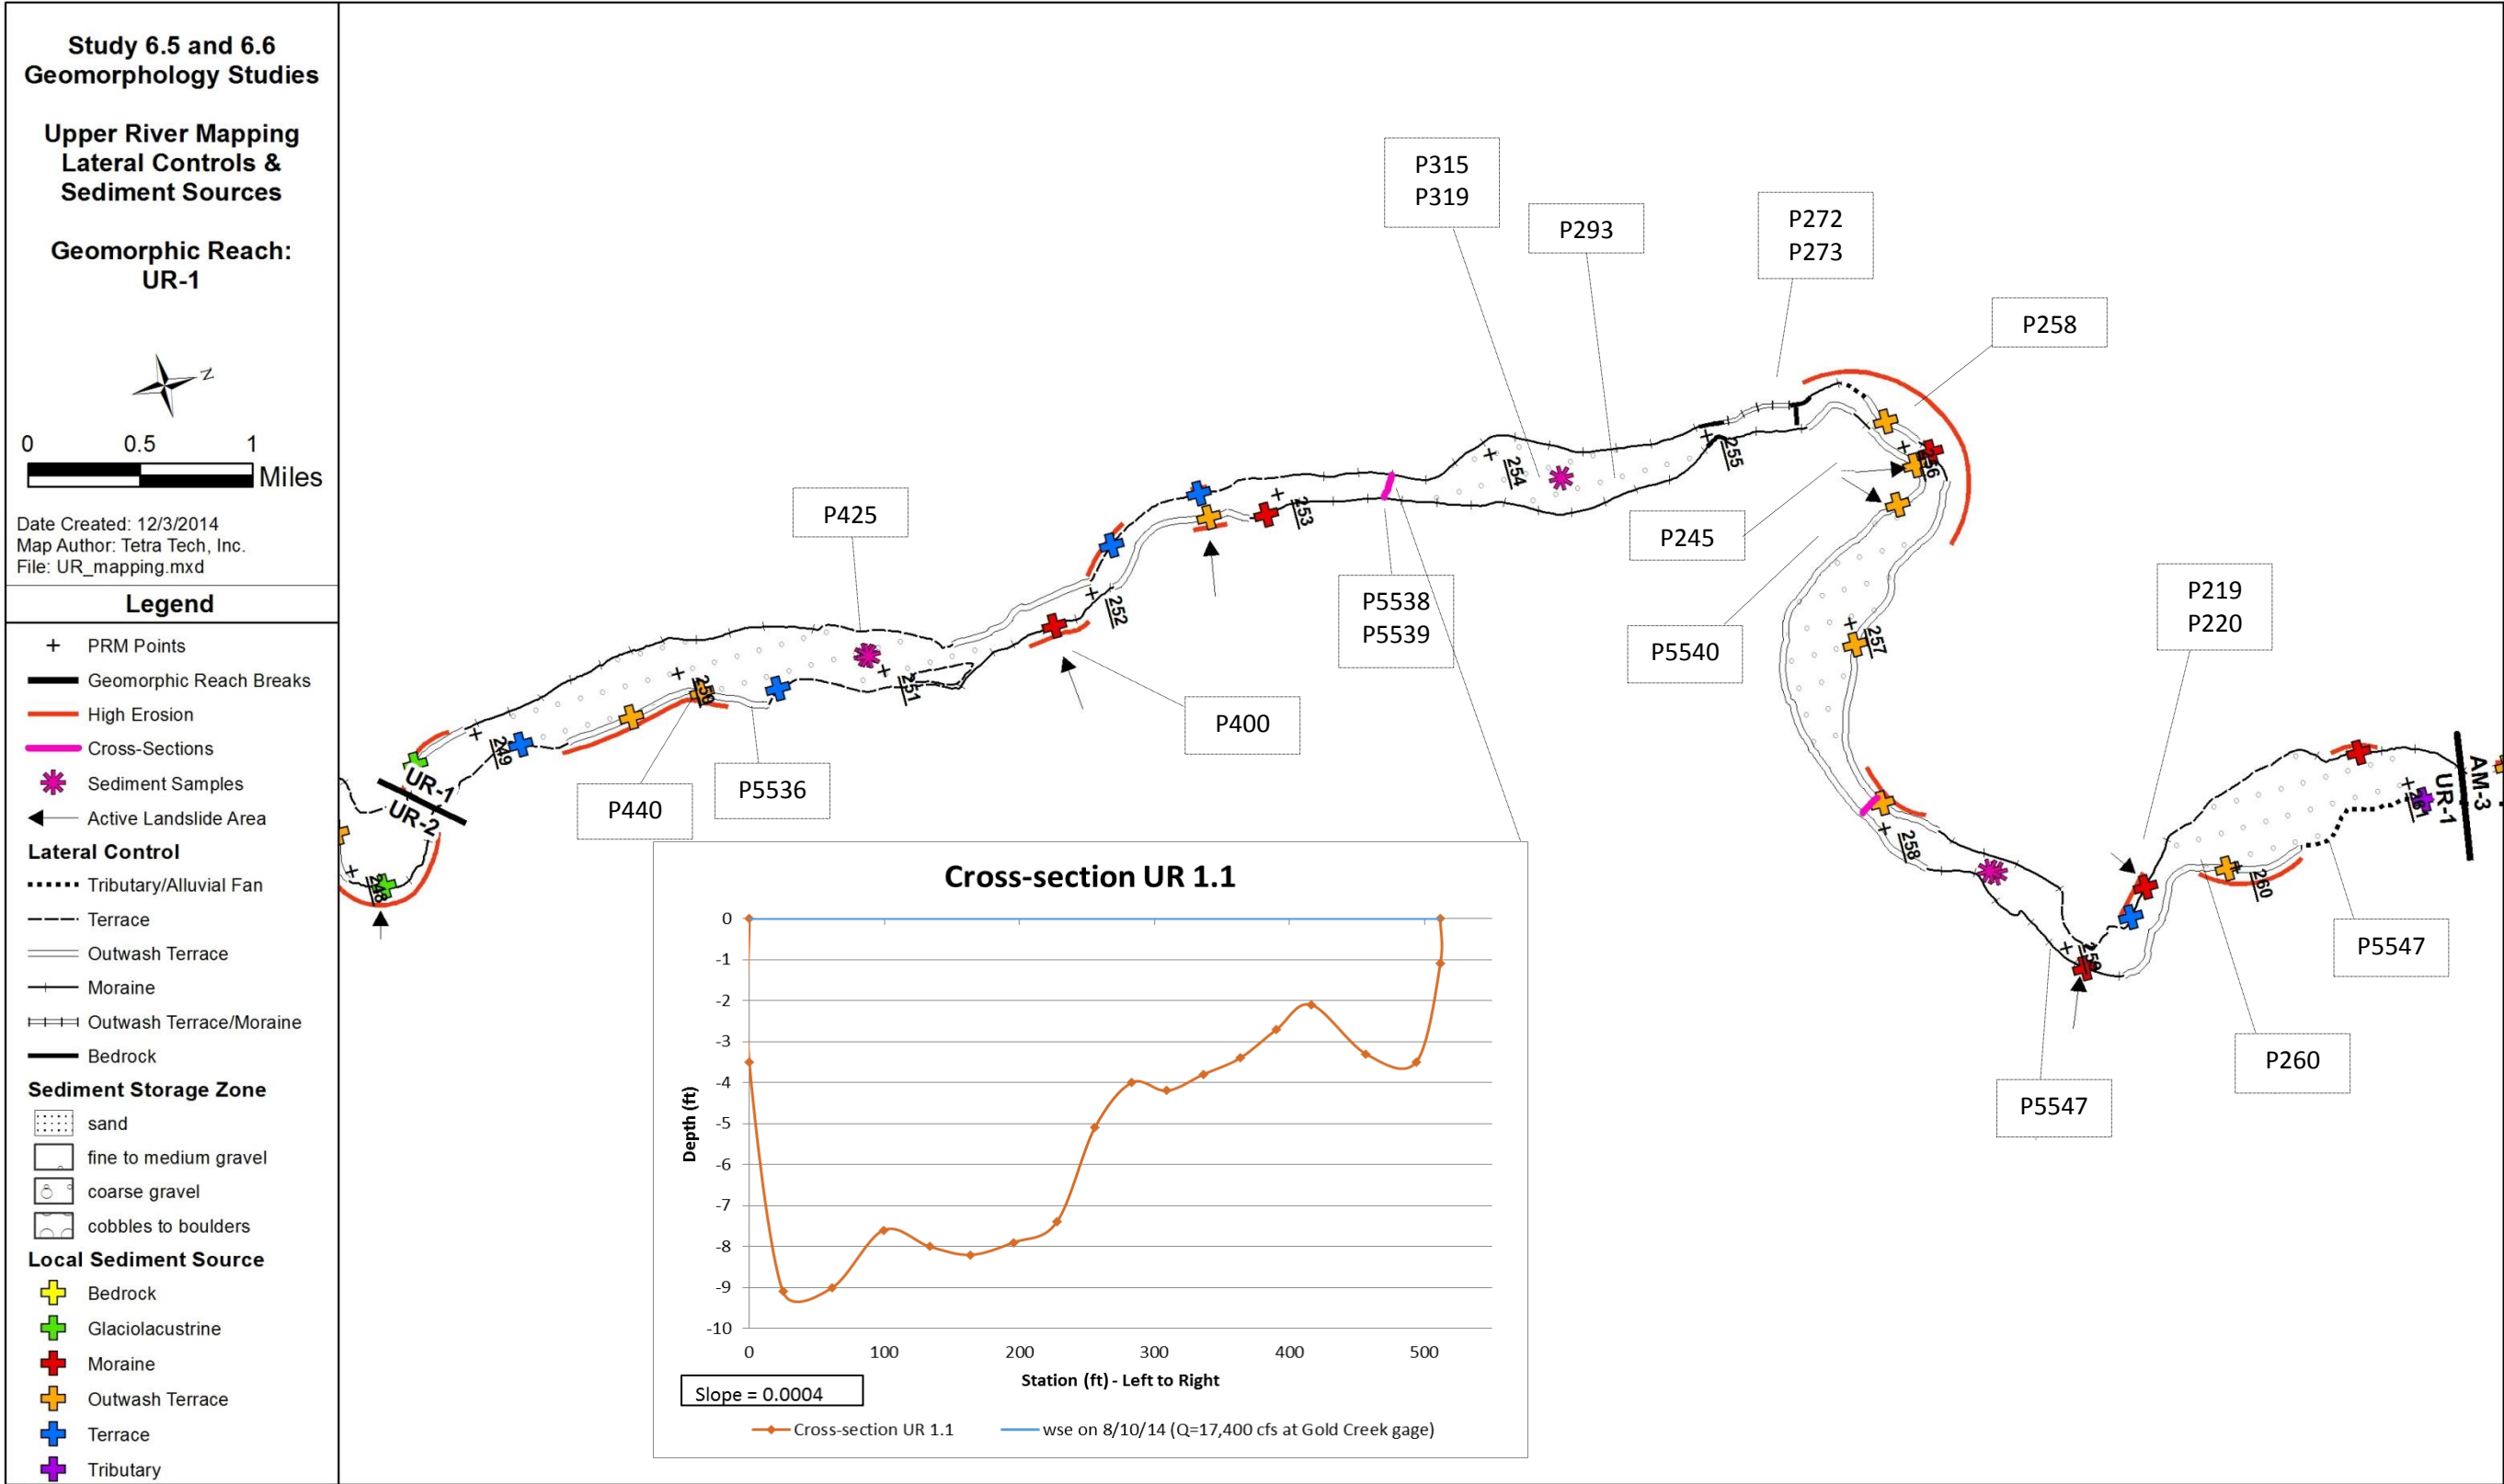
Figure 5.1-4: Upper River Lateral Control and Sediment Source Mapping with illustrative photo numbers noted (See Appendix A for photos) for geomorphic reach UR-1.

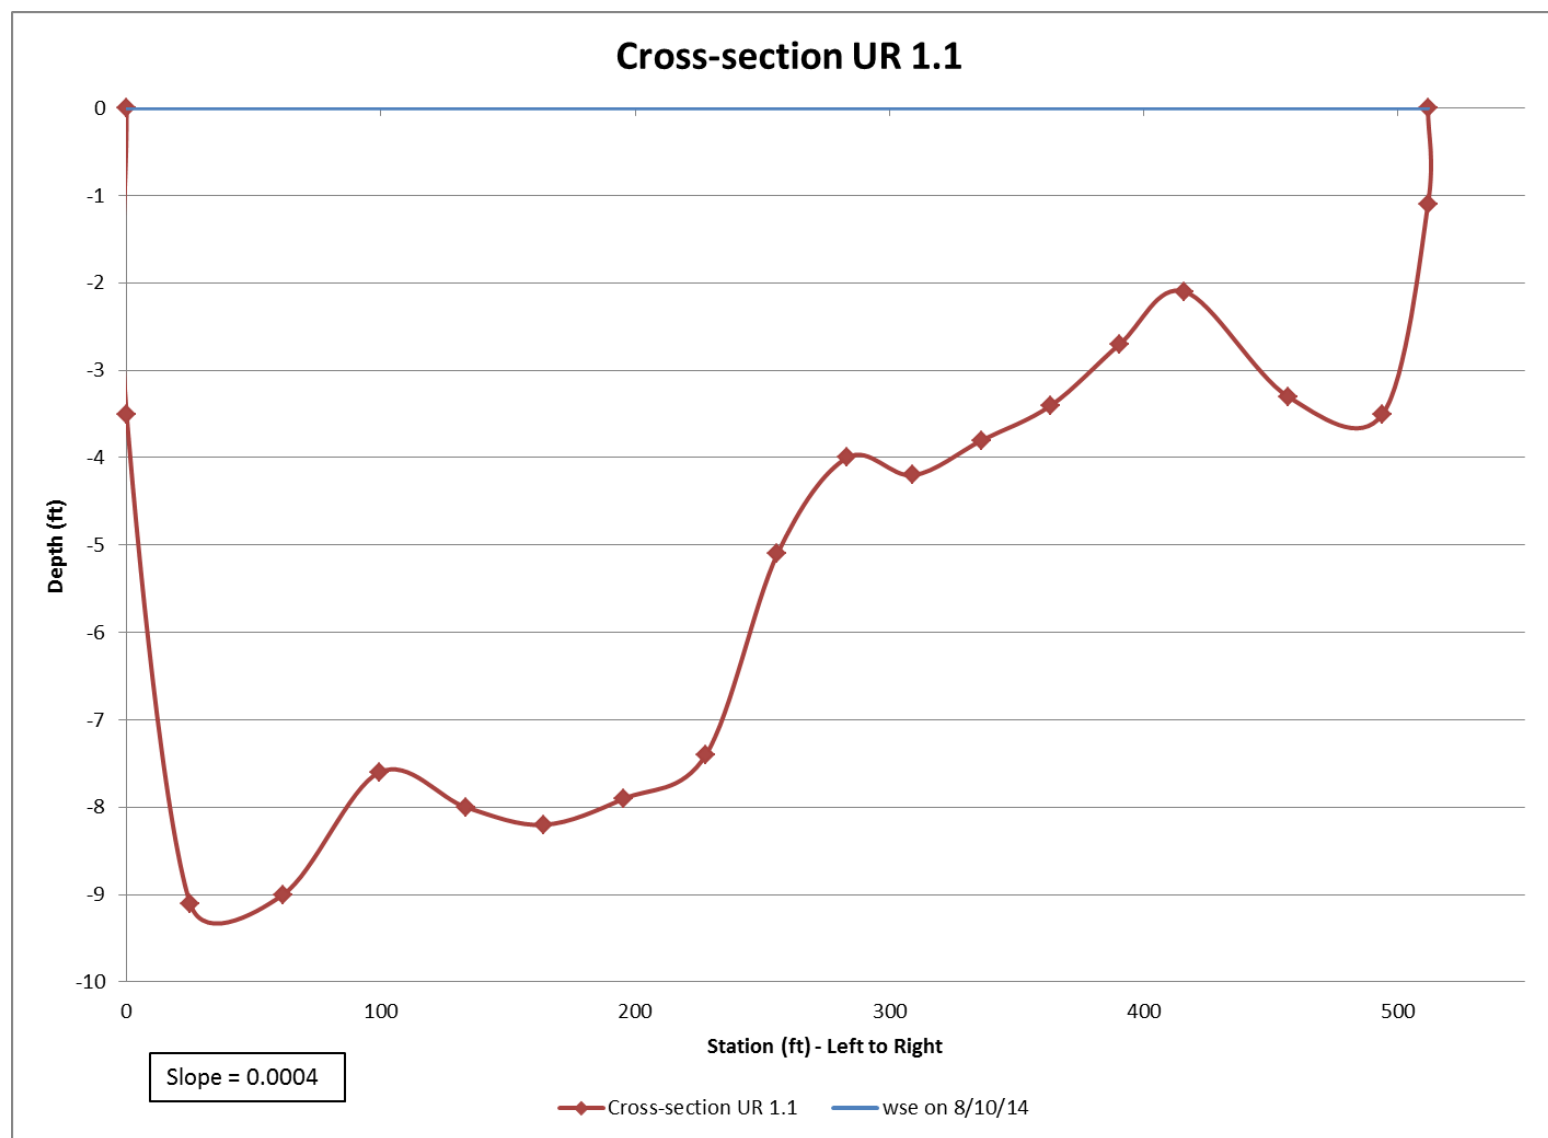
Figure 5.1-10: Cross-section UR 1.1 at PRM 257.9 (Q = - 17,400 cfs at Gold Creek gage).

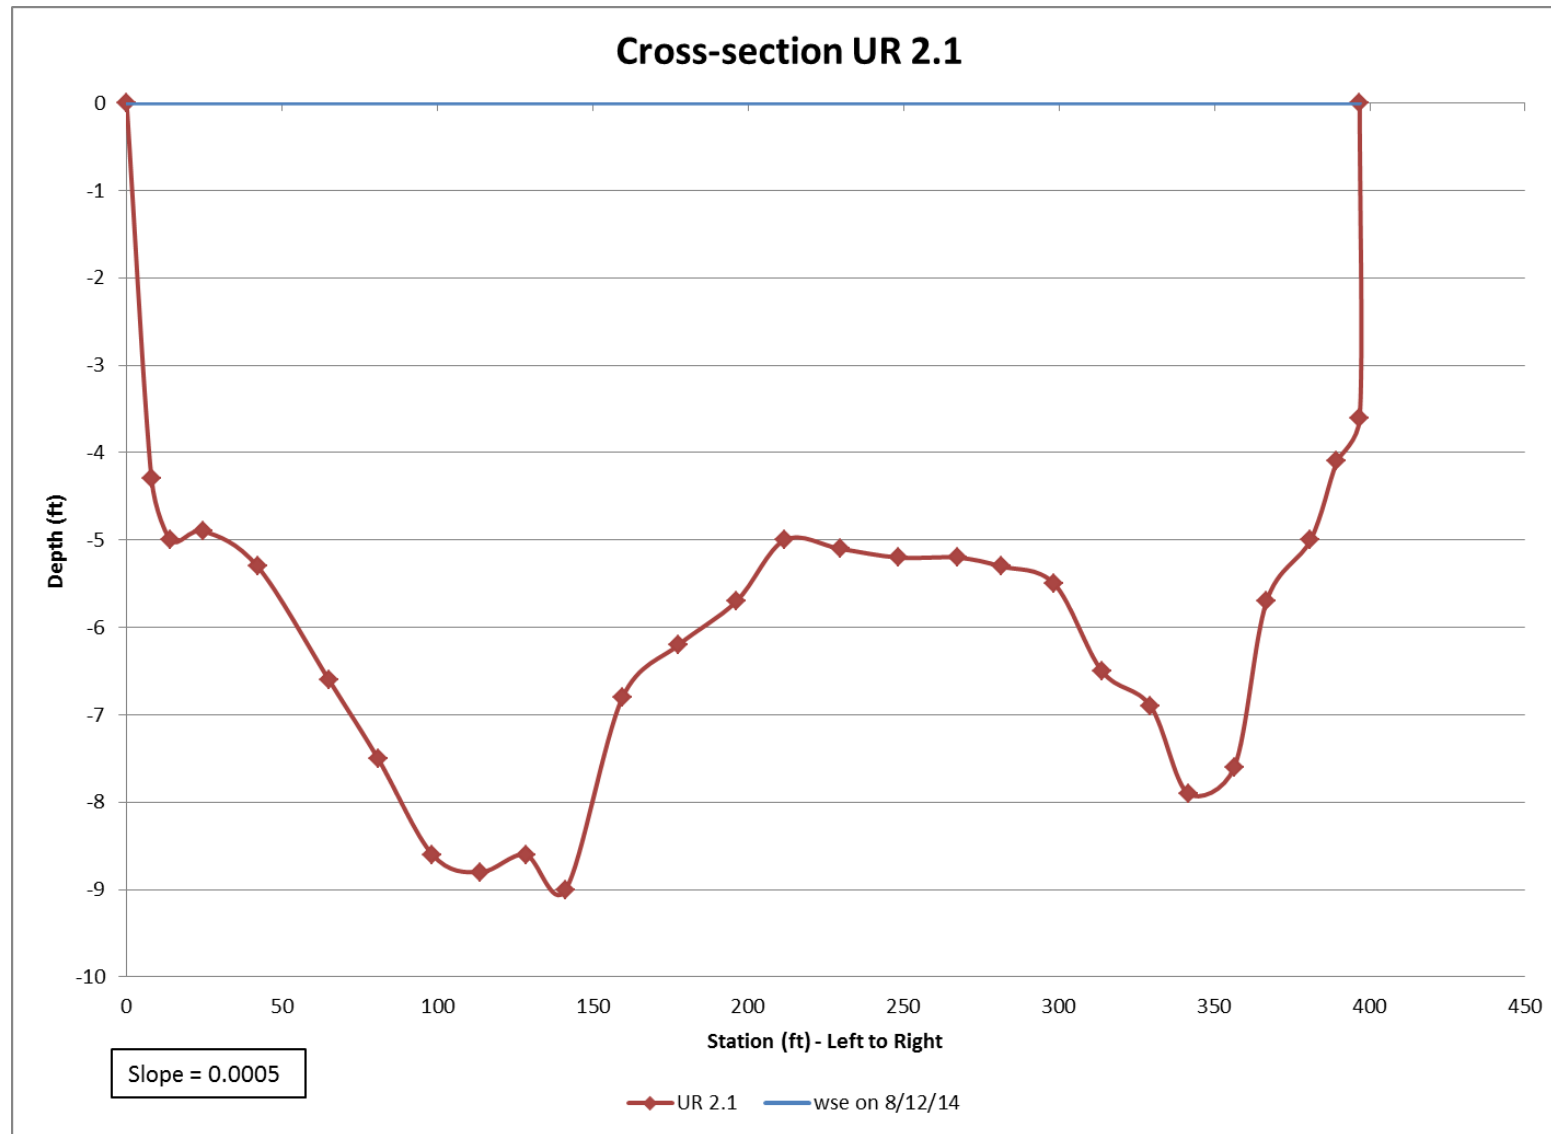
Figure 5.1-12: Cross-section UR 2.1 at PRM 245.4 (Q = 17,000 cfs at Gold Creek gage).

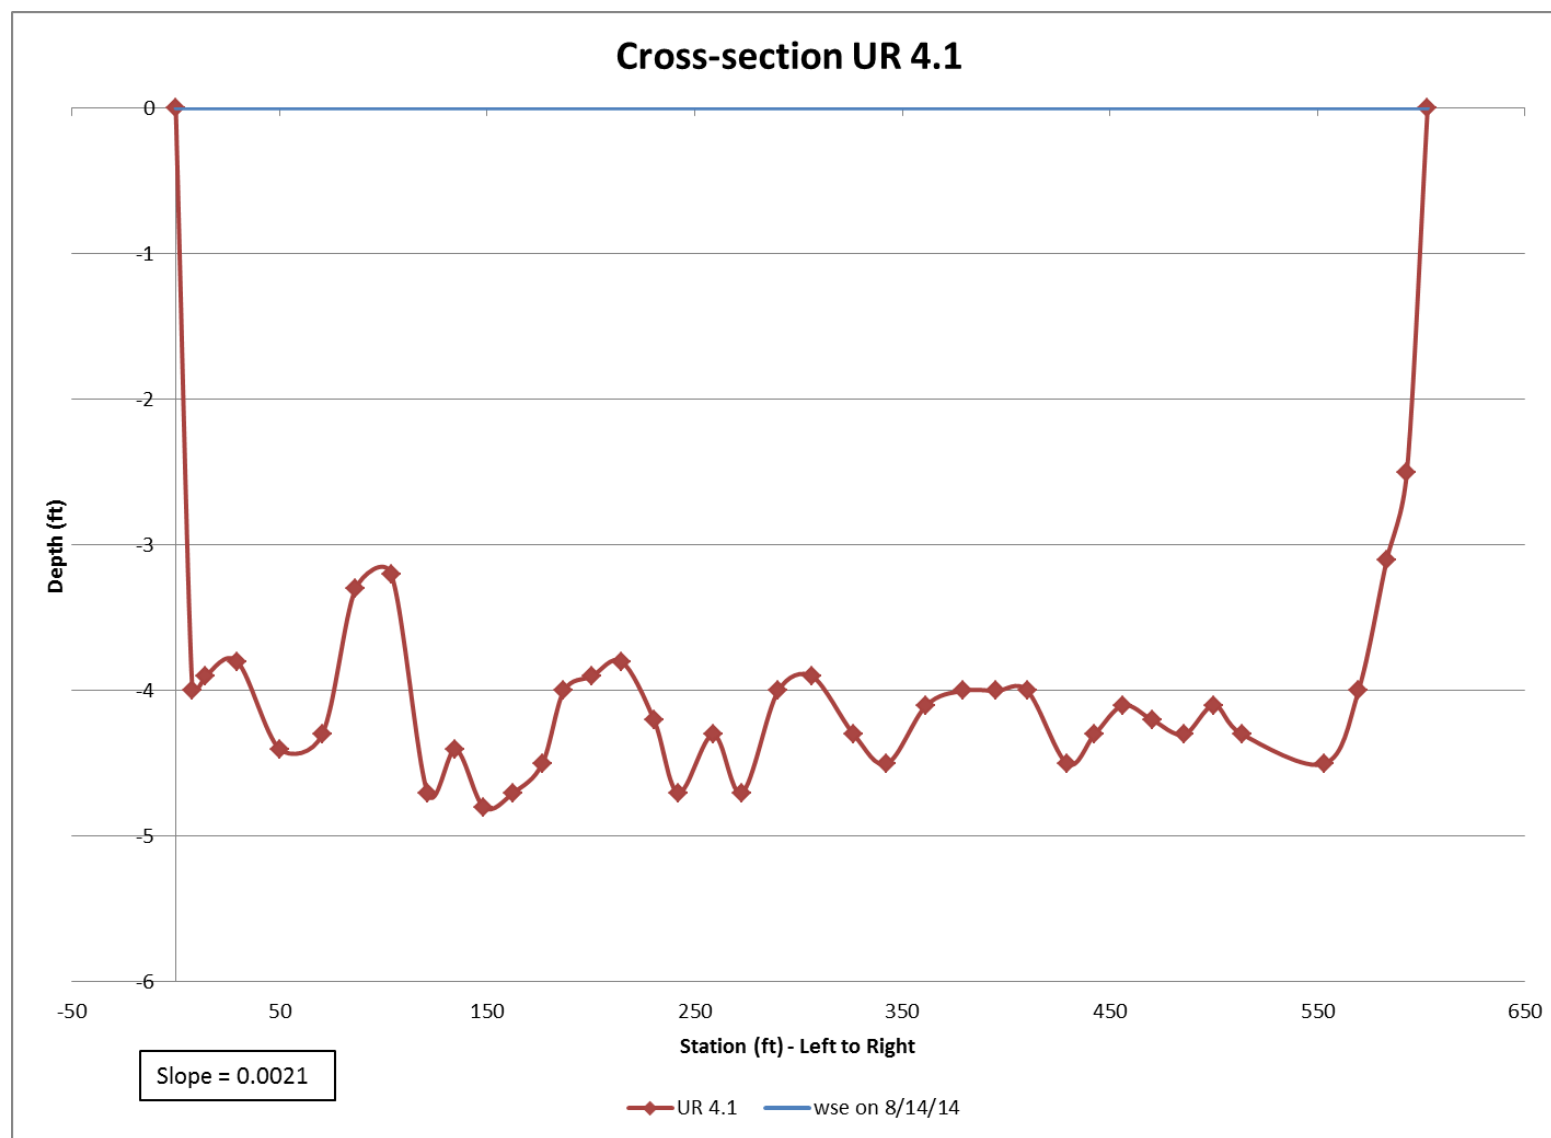
Figure 5.1-13: Cross-section UR 4.1 at PRM 220.7 (Q = 16,800 cfs at Gold Creek gage).

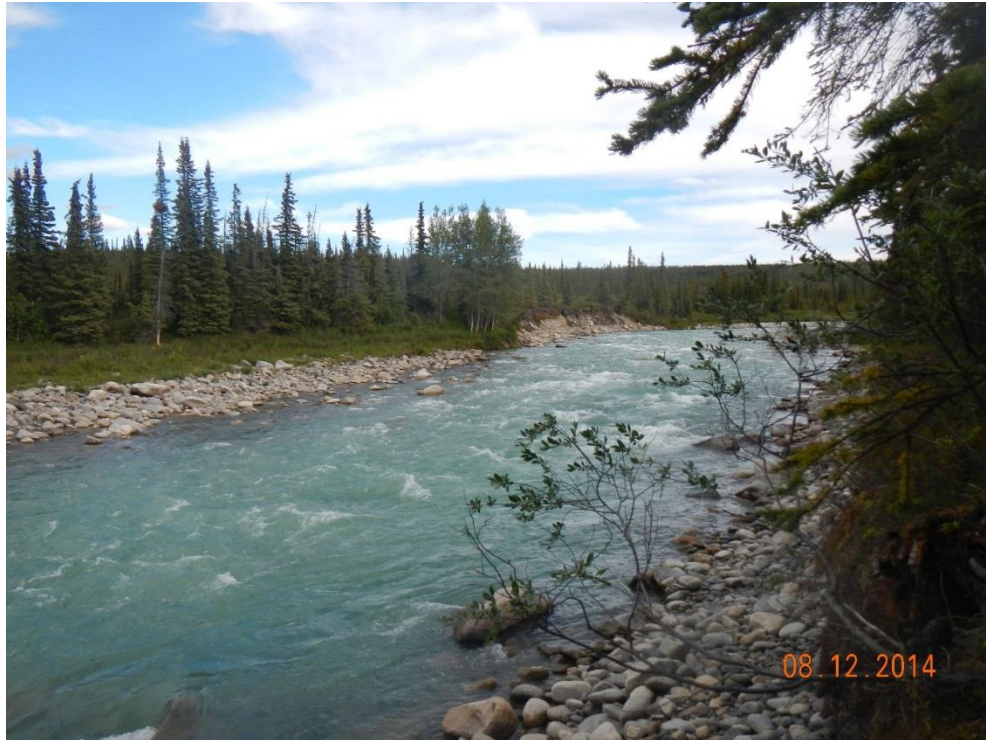
**Figure 5.8-1: View upstream Oshetna River from confluence with Susitna River. Clear water evident.**

Starting from upstream and proceeding downstream, some observations concerning the selected tributaries are summarized in the following paragraphs. The mouth of the Oshetna River is at an elevation above 2,050 feet. While the flow in the creek was relatively clear (Figure 5.8-1), the channel splits in the upstream direction with larger gravel bars and a more active planform, indicating potential for substantial gravel yield. Safe landing sites and access were noted near the mouth of the Oshetna River (Figure 5.8-2).

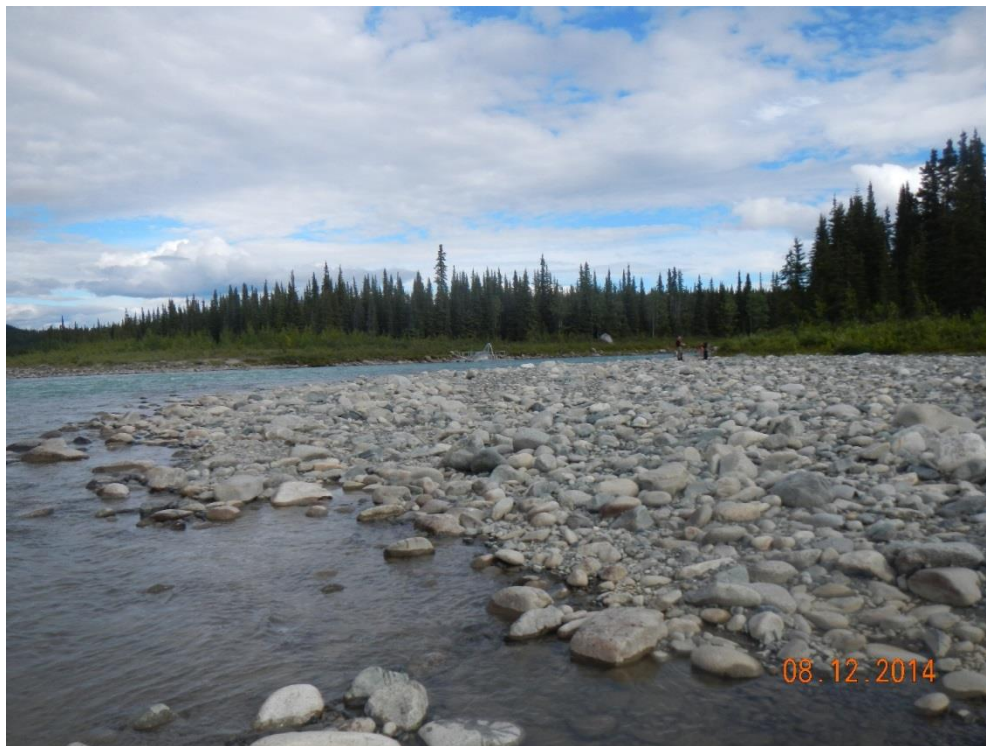
**Figure 5.8-2. View upstream of Oshetna River fan at confluence with Susitna River. Helicopter access present upstream and downstream of Oshetna River confluence on Susitna River left.**

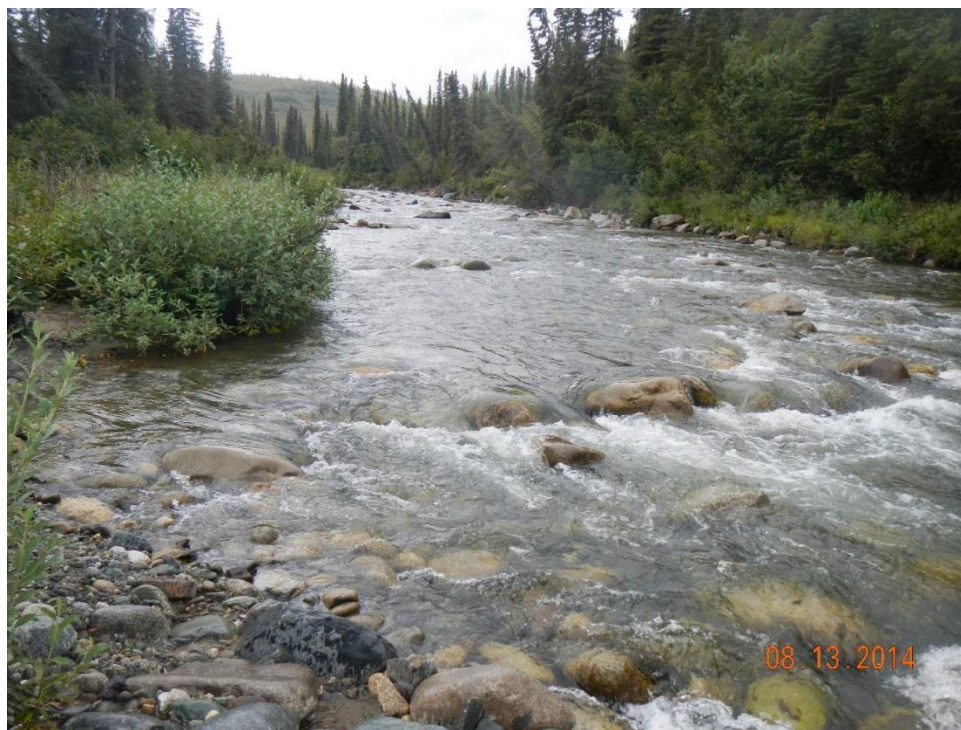
**Figure 5.8-3. View upstream Goose Creek from confluence with Susitna River. Plane-bed channel evident.**

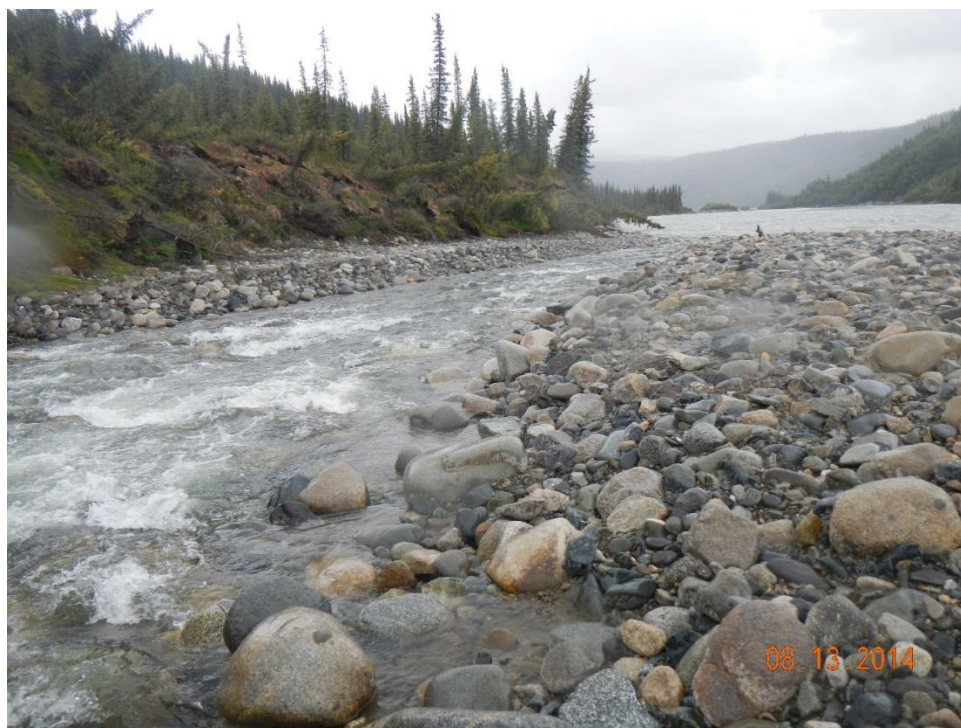
**Figure 5.8-4. View downstream Goose Creek to confluence with Susitna River. Armored channel evident with large sediment deposition and fan at Goose Creek mouth. Slumping left bank along Goose Creek. Safe landing zone present on Goose Creek fan.**

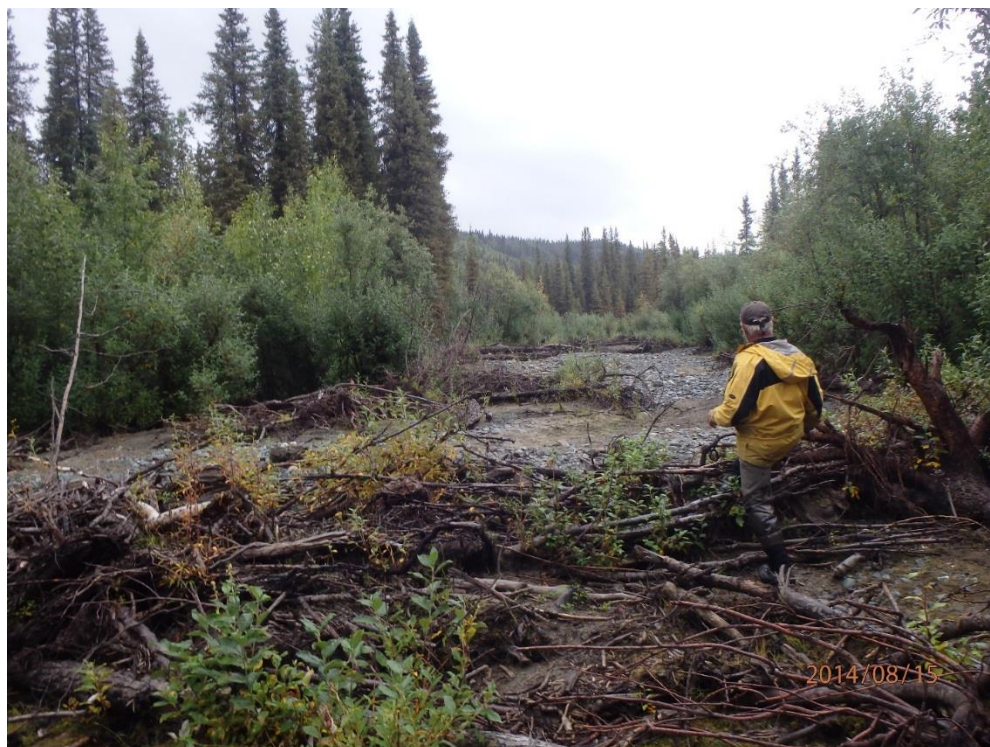
**Figure 5.8-5. View upstream Jay creek above Jay Creek confluence with Susitna River. Log jams present in channel. Channel filled-in with sand, gravel, boulder, and large wood deposits.**

Jay Creek transports large woody debris and gravel as it flows through a narrow valley (elevated sediment yield may be driven by landslides and colluvial input from the hillslopes) (Figure 5.8-5). Safe landing sites were noted on the fan at the mouth of Jay Creek (Figure 5.8-6), upstream of elevation 1,850 feet and at an elevation of 2,050 feet.

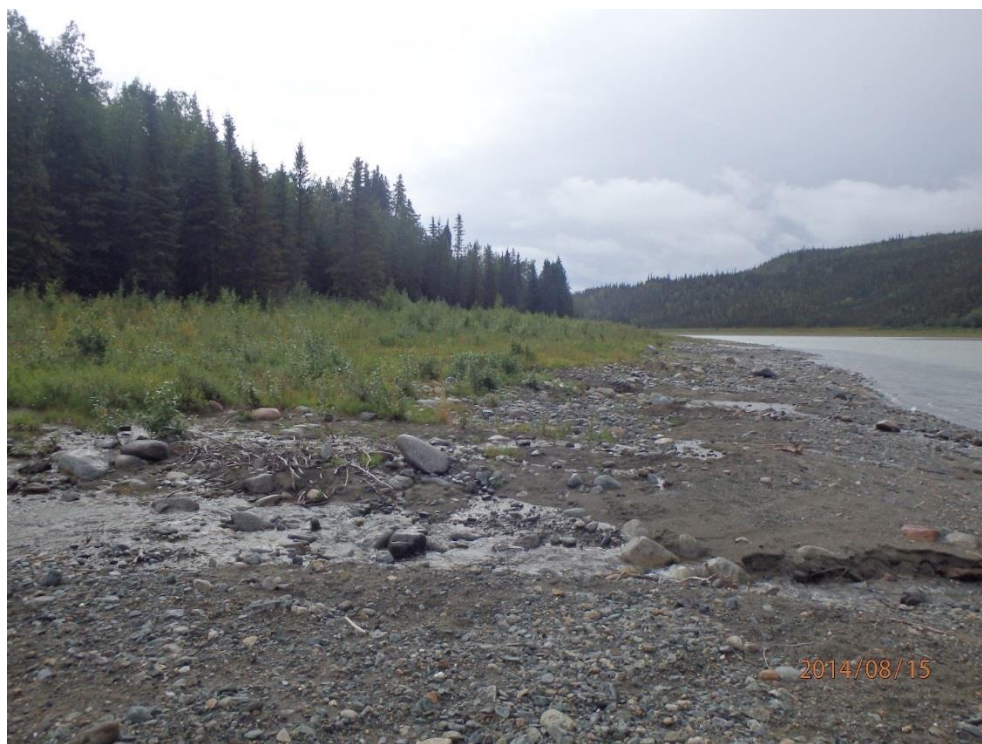
**Figure 5.8-6. Upstream Jay Creek fan, looking upstream Susitna River (right bank) along sheet flow from Jay creek. Safe landing zones present upstream and downstream Jay Creek fan on Susitna River right bank.**

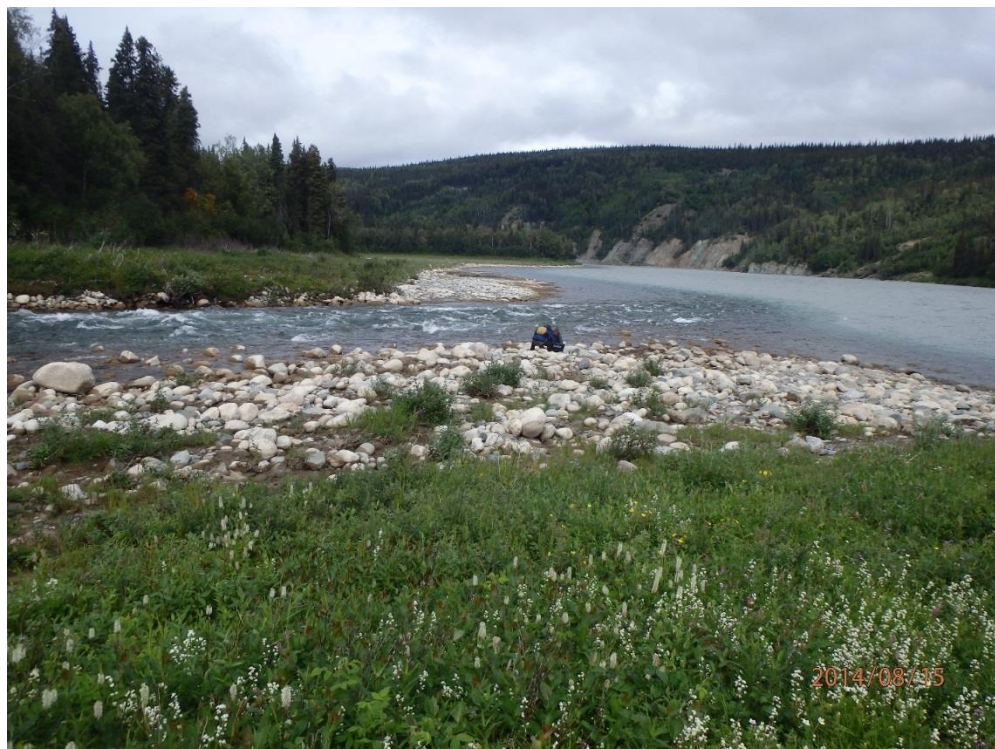
**Figure 5.8-7. View downstream Susitna River left bank to Kosina River fan. Plane-bed, boulder-cobble channel evident. Safe landing zones present upstream and downstream Kosina River confluence along Kosina fan.**

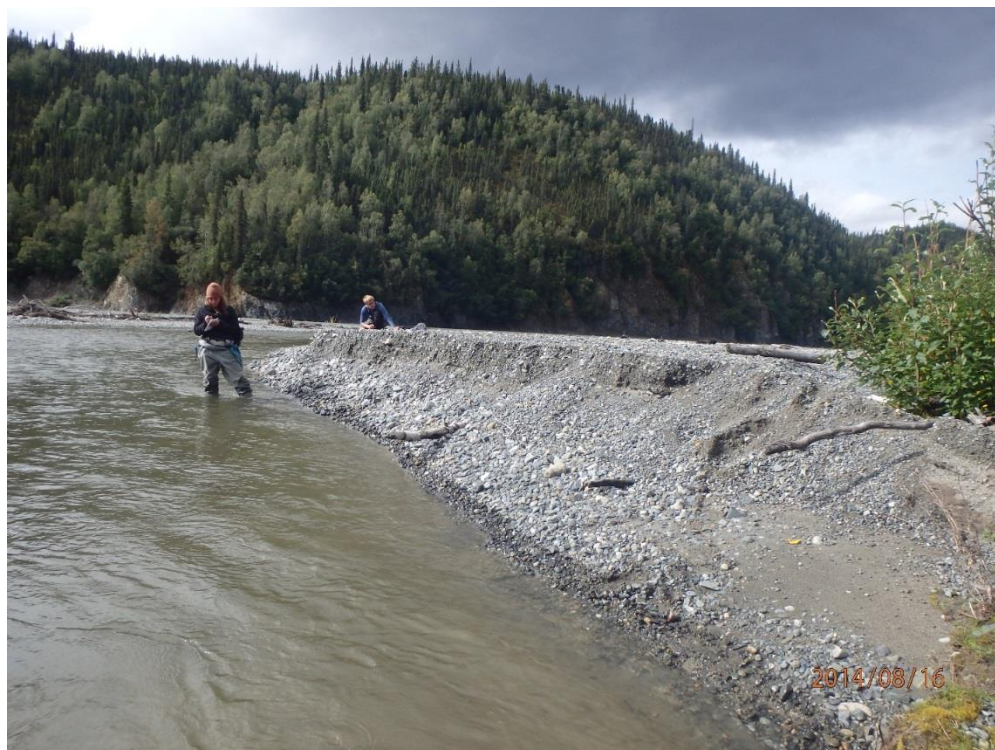
**Figure 5.8-8. View downstream Watana Creek towards confluence with Susitna River. Gravel deposits present along Watana Creek right bank.**

Large gravel bars, ample large woody debris, and evidence of an active channel transporting sediment and reworking deposits were observed in Watana Creek (Figure 5.8-8). Along Watana Creek, many safe landing sites were noted at the confluence with the Susitna River (Figure 5.8-9) near elevations of 1,850 feet and 2,050 feet.

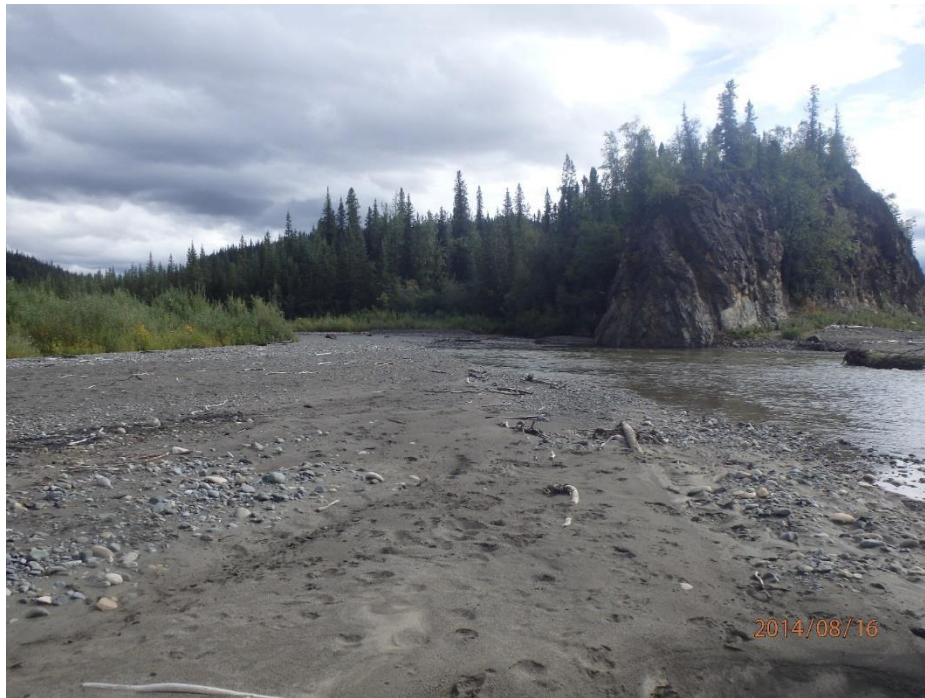
**Figure 5.8-9. View upstream to Watana Creek (Susitna River right bank). Safe landing zones present along Watana Creek fan and floodplain.**

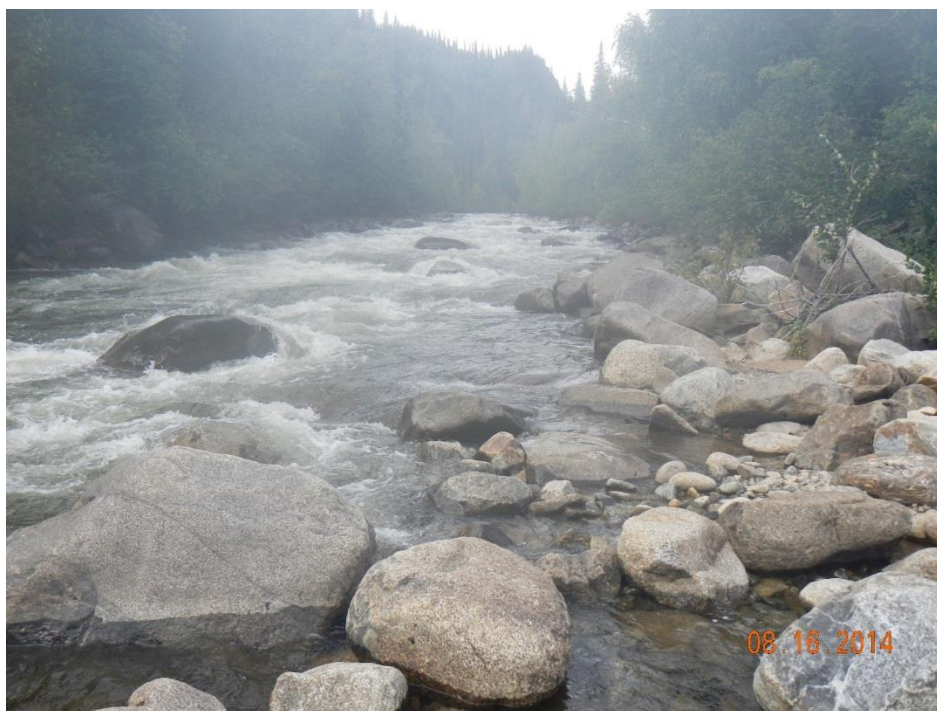
**Figure 5.8-10. View upstream Deadman Creek. Steep, confined, boulder-dominated channel evident.**

A steep confined channel was observed in Deadman Creek near the confluence with the Susitna River (Figure 5.8-10), and the creek opens into an unconfined meadow in the upstream direction. Safe access was identified at the confluence with the Susitna river (Figure 5.8-11), and within the reservoir fluctuation zone along Deadman Creek either (1) in the creek channel if flows are low enough, or (2) on the left bank terrace.

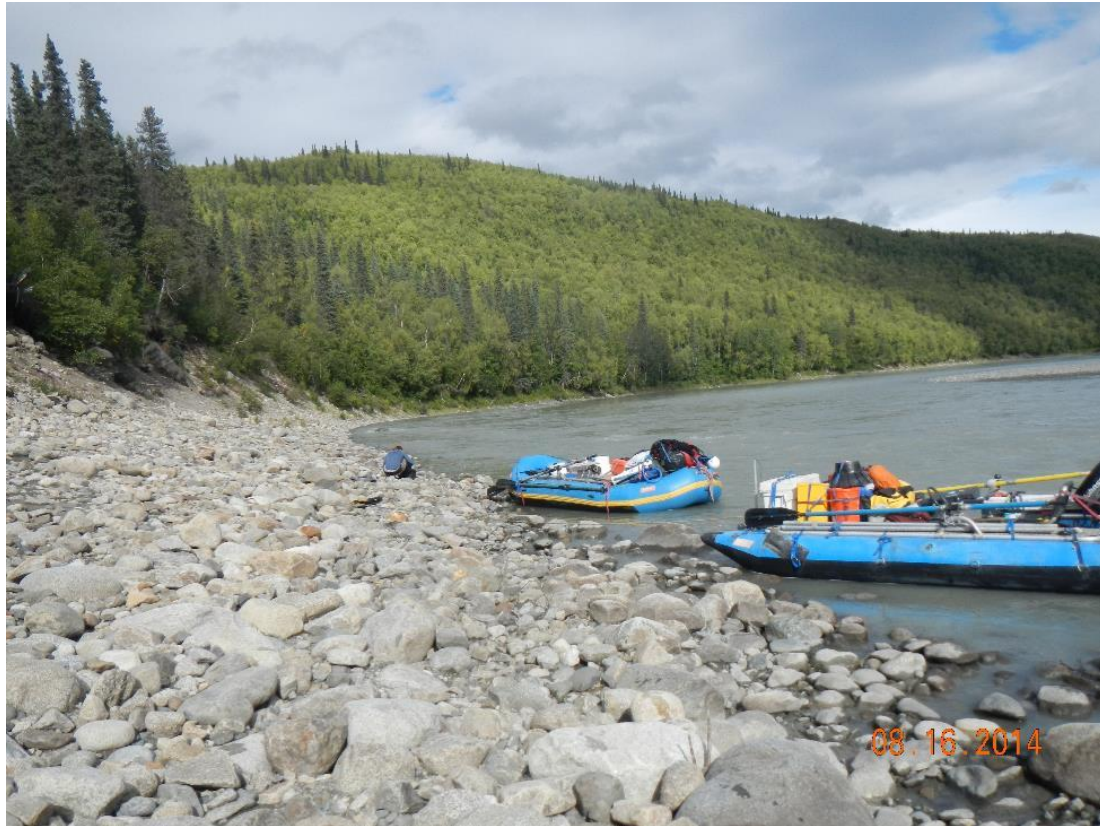
**Figure 5.8-11. View upstream Susitna River right bank upstream of Deadman Creek fan. Safe landing zones present upstream and downstream of Deadman Creek confluence with Susitna River.**
