**Susitna-Watana Hydroelectric Project  
(FERC No. 14241)**

**Fish Passage Barriers in the Middle and Upper  
Susitna River and Susitna Tributaries  
Study Plan Section 9.12**

**2014 Study Implementation Report**

R2 Resource Consultants, Inc. and ABR, Inc.

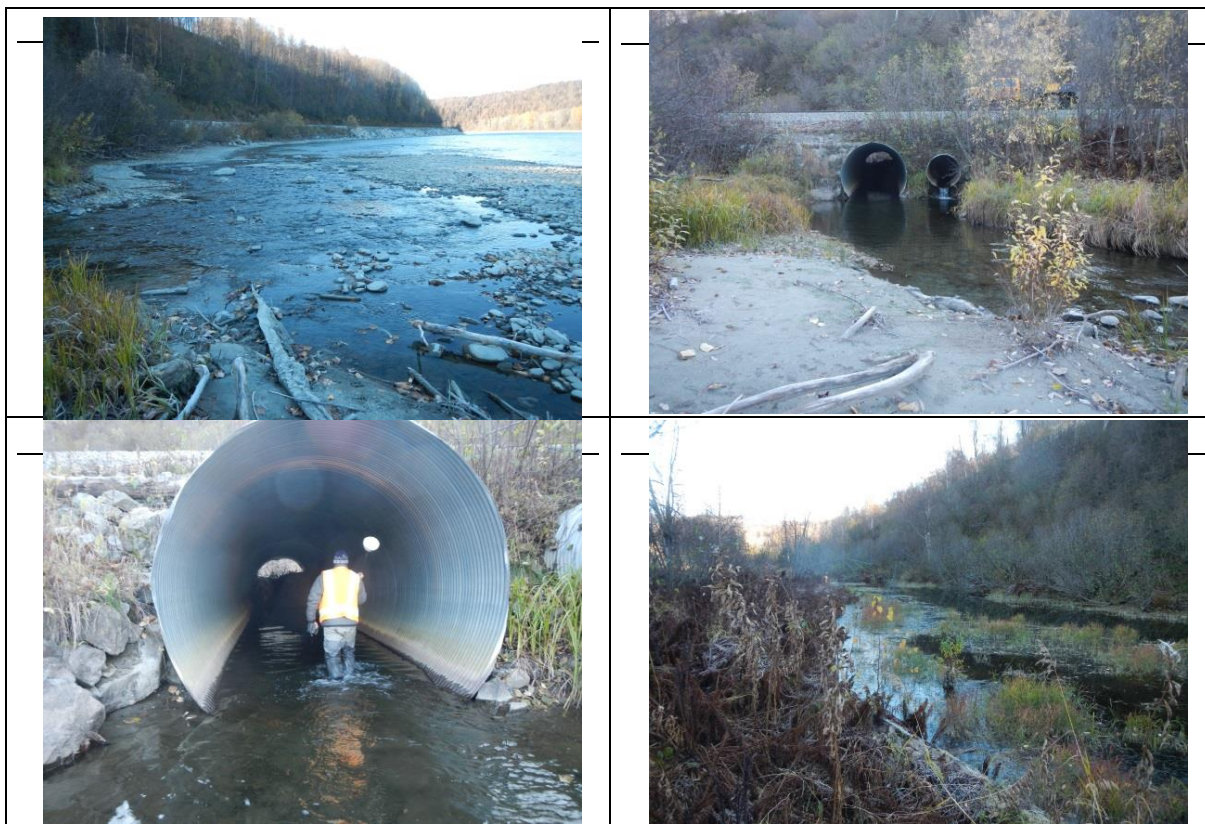
Figure 5.4-1. Photos of Lower McKenzie Creek/Slough, September 30, 2014. Clockwise from upper left: bottom of creek mouth; upstream view to culvert; culvert and beaver dam; and beaver dam above culvert and upstream of Alaska Railroad tracks.

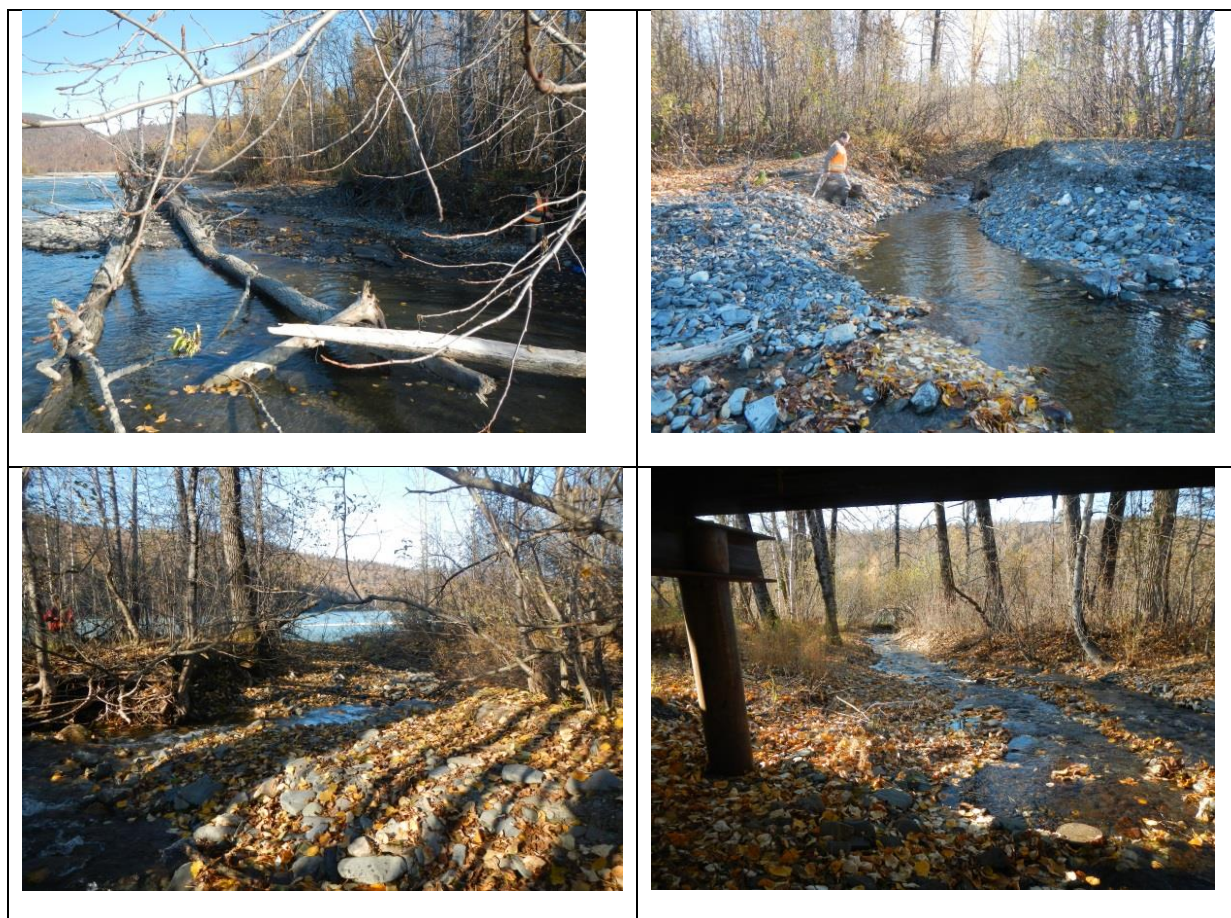
Figure 5.4-3. Photos of McKenzie Creek, September 30, 2014. Clockwise from upper left: bottom of creek mouth and debris apron from mainstem Susitna River; bottom of creek mouth; looking downstream to creek mouth; and looking downstream from Alaska Railroad bridge.

McKenzie Creek entered the Susitna River on river left at PRM 120.2. The stream channel was surveyed for a distance of 348.8 ft on September 30, 2015 from downstream of the railroad culvert to the mouth. This section of creek was contained within a defined channel as it meandered through a mixed cottonwood and birch stand (Figure 5.4-3). Downstream of the hardwood stand, flow spread out across a small boulder apron just before reaching the Susitna River (Figure 5.4-4). During low Susitna River flow conditions (mean daily flow at Gold Creek USGS gage was 10,609 cfs), the creek mouth was separated from the mainstem flow by a gravel bar. Thalweg substrate was dominated by cobbles and gravel with water depths between 0.3 and 1.0 ft and water velocities averaging 1.4 feet per second (fps) with a maximum of 2.8 fps (Table 5.4-2).

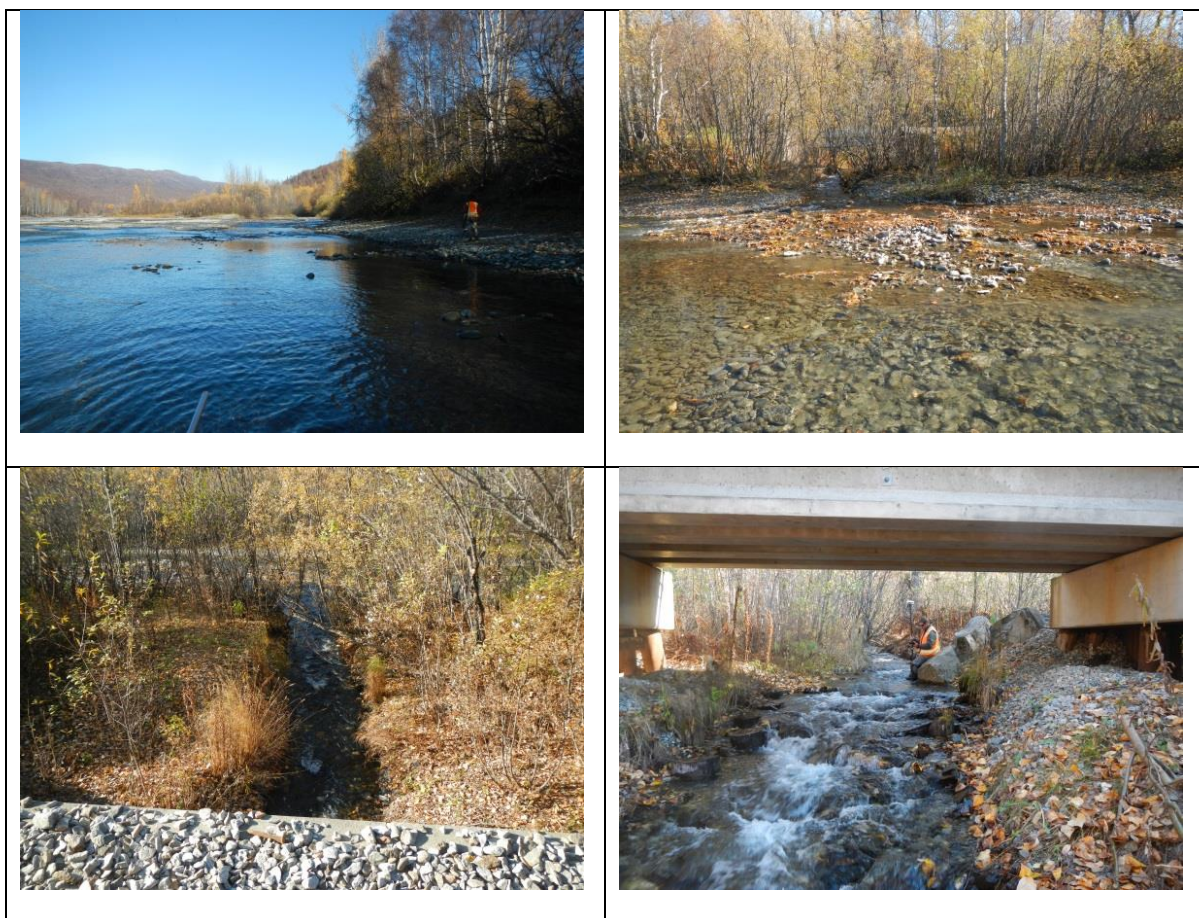
Figure 5.4-5. Photos of Little Portage Creek, September 30, 2014. Clockwise from upper left: looking upstream to creek mouth from mainstem Susitna River; creek mouth and debris apron; and looking upstream under Alaska Railroad bridge, looking downstream to creek mouth from Alaska Railroad bridge.

Little Portage Creek was surveyed over a distance of 745.6 ft on September 30, 2014. The stream flowed through a moderate gradient channel and dispersed across a delta before reaching a shallow side channel riffle adjacent to the left bank of the Susitna River. While this riffle was comprised solely of creek flow during the low flow survey conditions it likely becomes submerged by mainstem flows at higher Susitna River flows (Figure 5.4-5, Figure 5.4-6). Substrates were dominated by cobble and gravel and stream depth ranged from 0.25 to 1.10 ft (Table 5.4-3). Water velocity was generally low with an average of 0.8 fps and range of 0.4 to 1.9 fps.

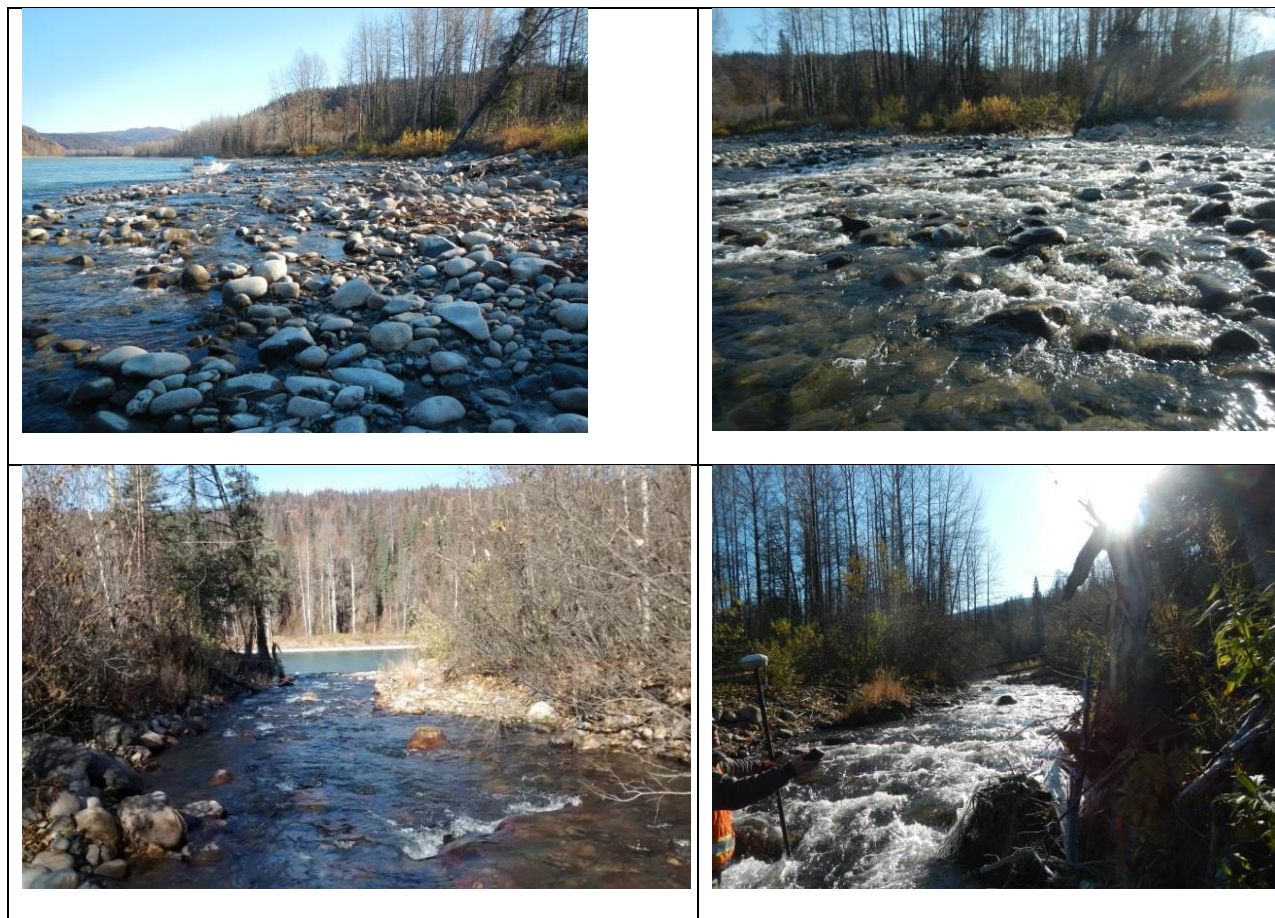
Figure 5.4-7. Photos of Jack Long Creek, October 1, 2014. Clockwise from upper left: looking upstream from Susitna River to creek mouth; flow over debris apron; flow above creek mouth; downstream view to creek mouth from top survey station.

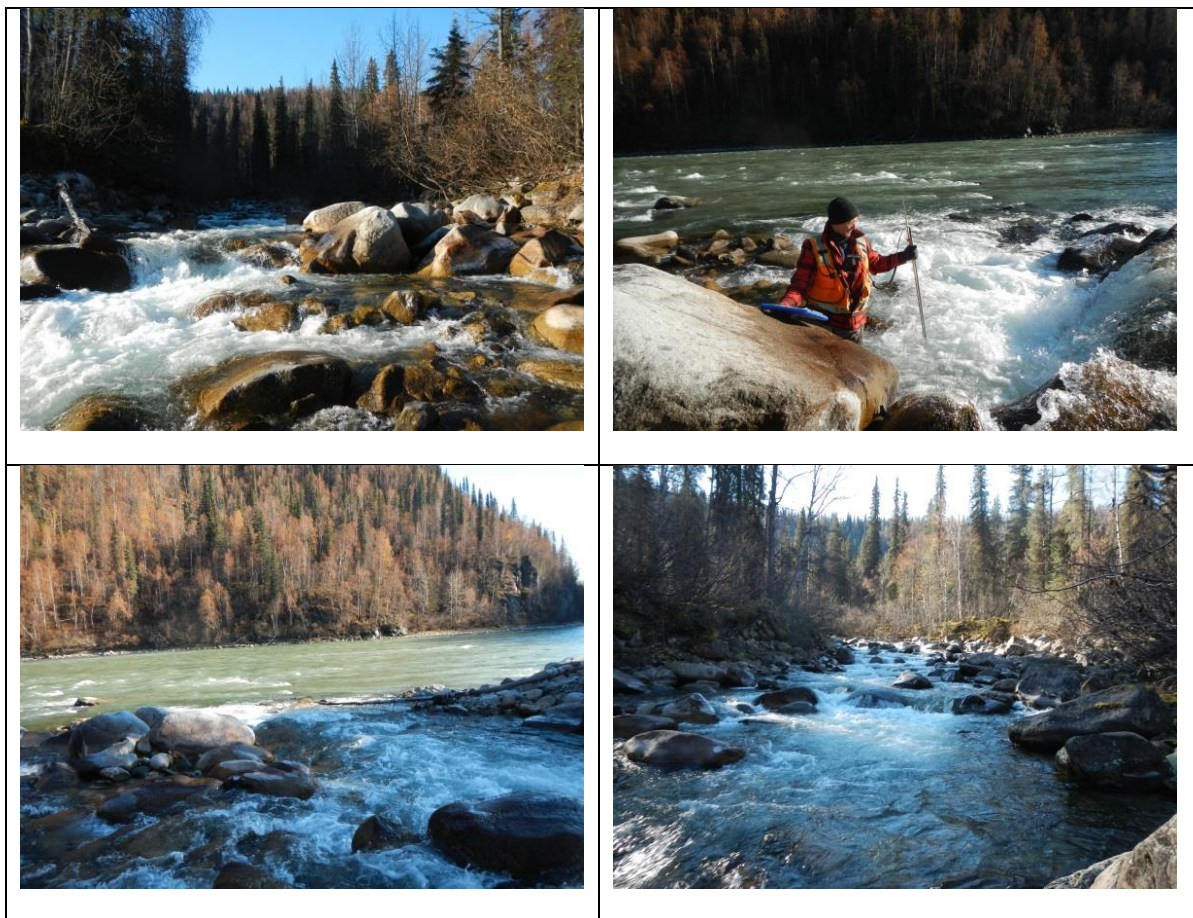
Figure 5.4-9. Photos of Cheechako Creek, October 2, 2014. Clockwise from upper left: bottom of creek mouth; multiple channels through creek mouth; riffle upstream of tributary apron; and looking downstream from top of survey.

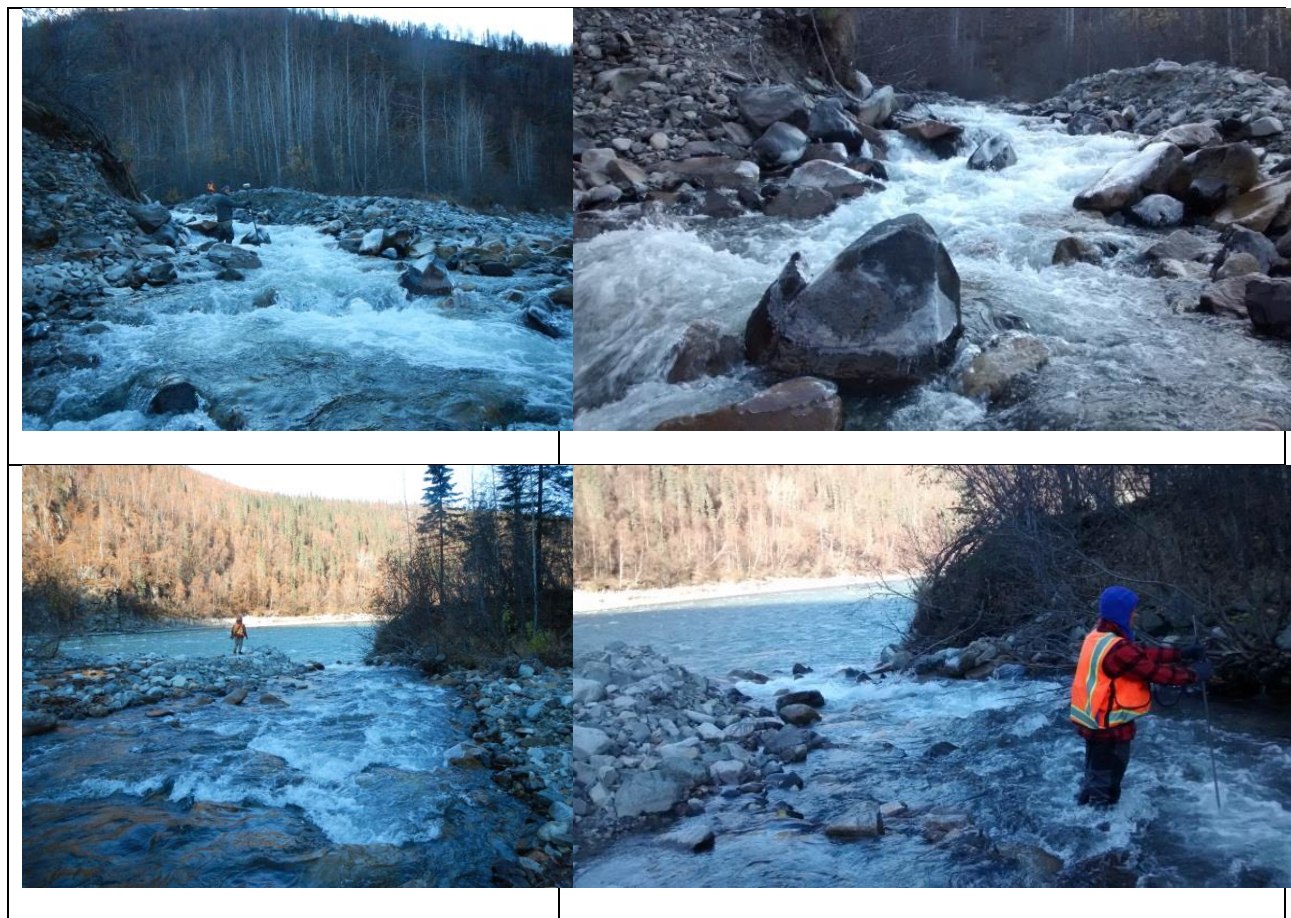
Figure 5.4-11. Photos of Chinook Creek, October 2, 2014. Clockwise from upper left: bottom of creek mouth from mainstem Susitna River; upstream view from creek mouth; downstream view of creek mouth; downstream view from top survey station.

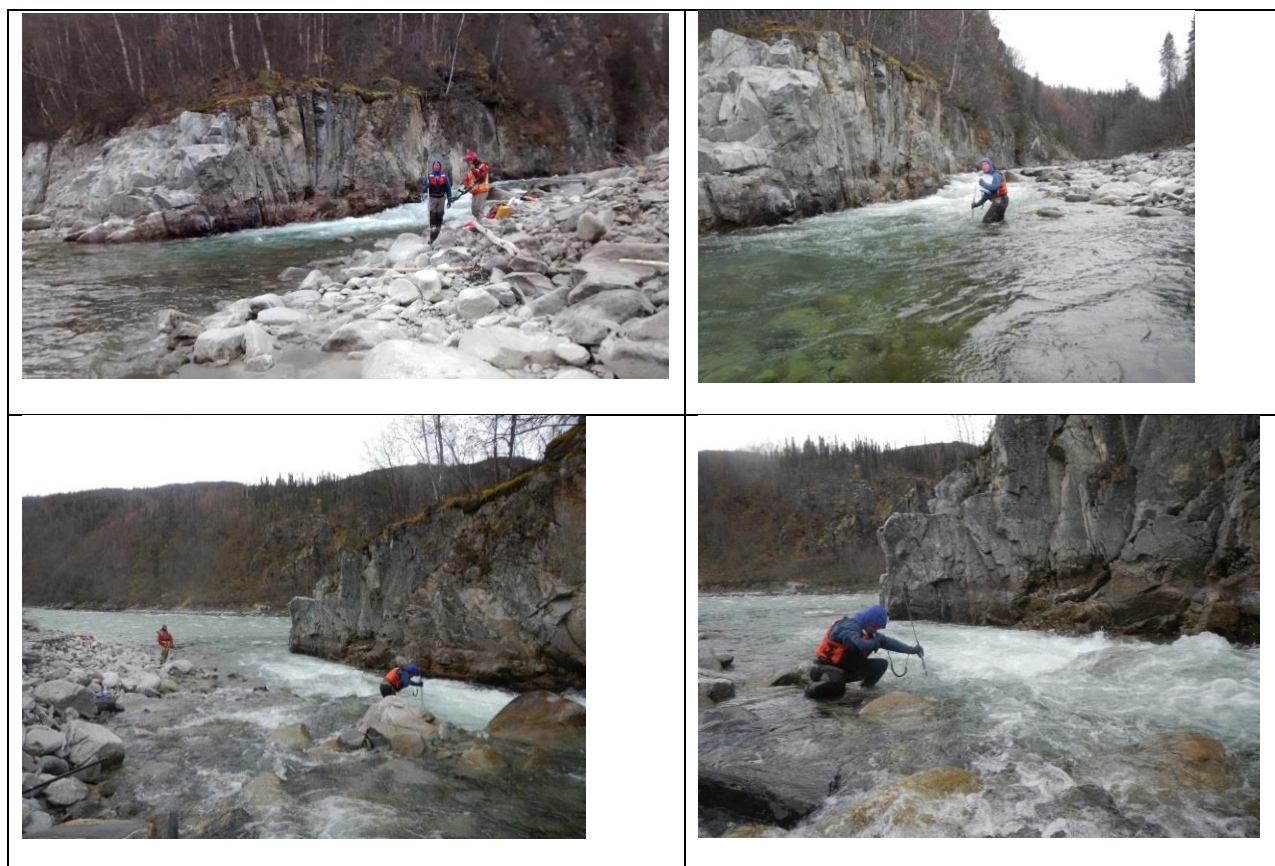
Figure 5.4-13. Photos of Devil Creek, October 3, 2014. Clockwise from upper left: bottom of creek mouth from mainstem Susitna River; upstream view from creek mouth; downstream view of creek mouth; downstream view from top survey station.

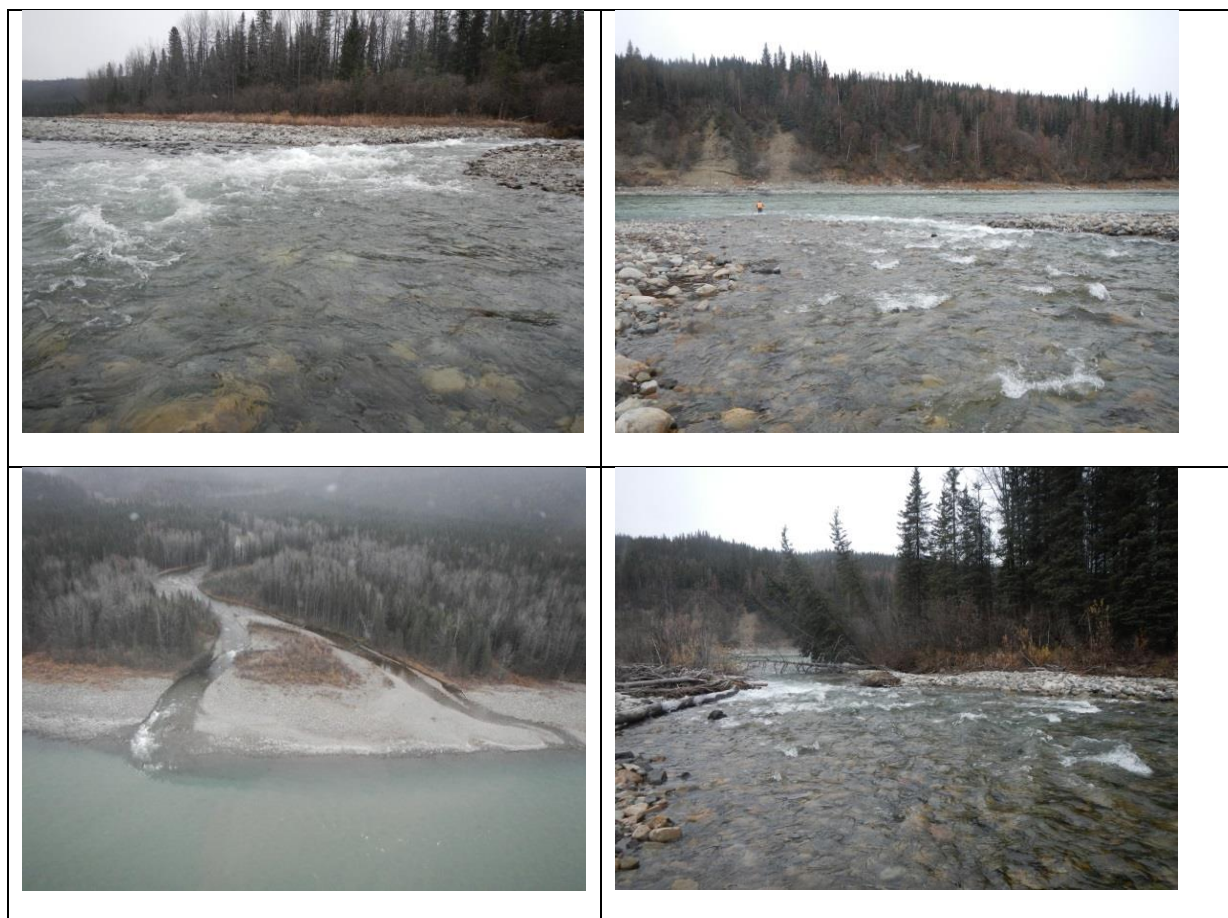
Figure 5.4-15. Photos of Fog Creek, October 3, 2014. Clockwise from upper left: bottom of creek mouth from mainstem Susitna River; view of creek mouth from middle of transect; downstream view from top survey station; aerial view of main surveyed channel and a secondary channel.
