# Erosion and Sedimentation in the Kenai River, Alaska

GEOLOGICAL SURVEY PROFESSIONAL PAPER 1235

By KEVIN M. SCOTT

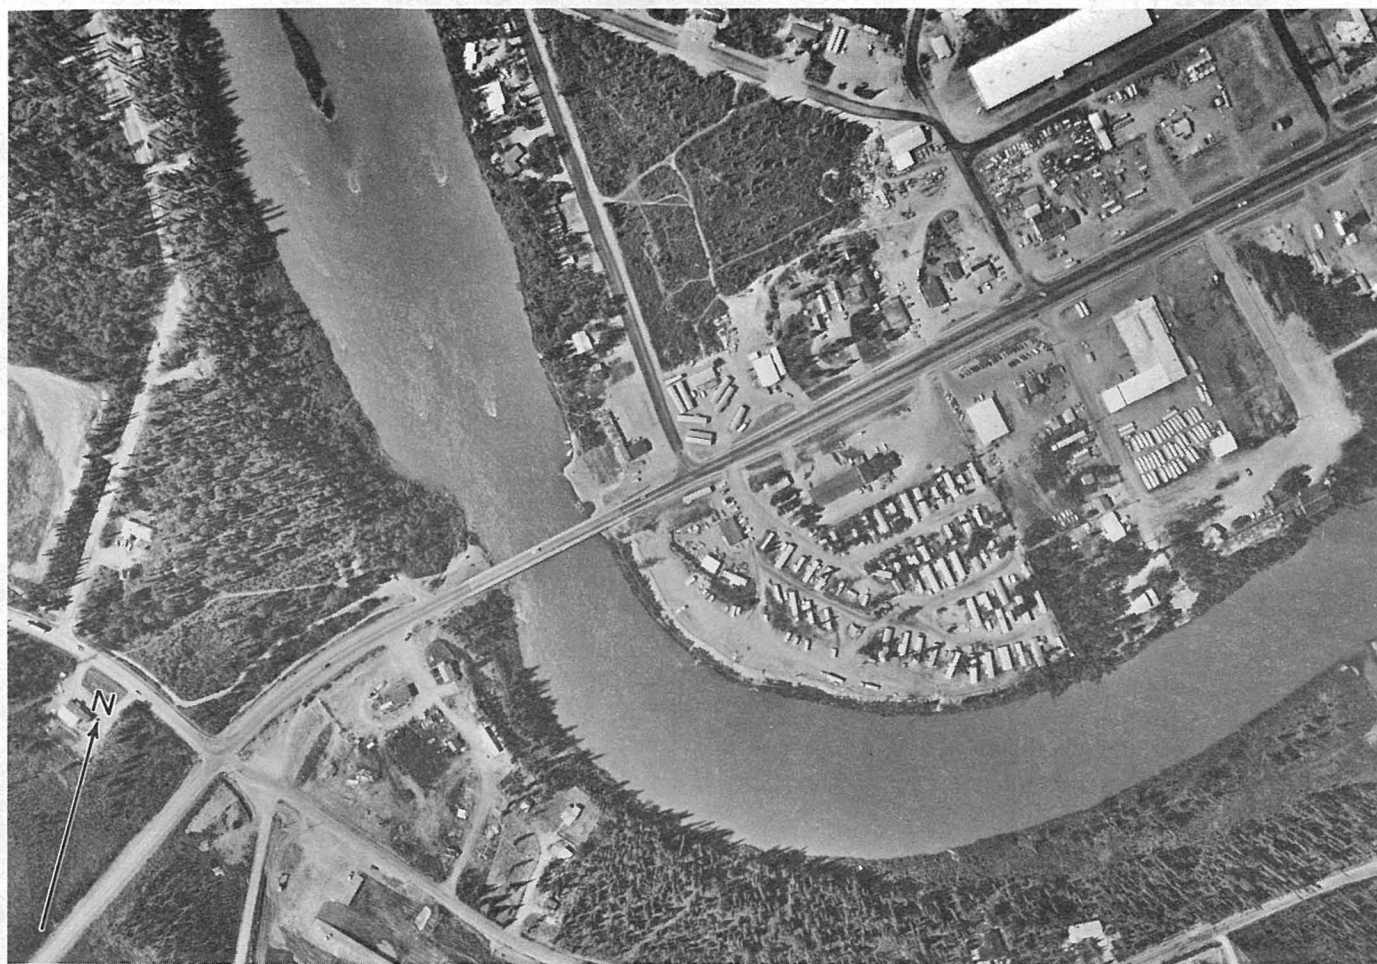
FIGURE 4.—Kenai River at the Soldotna bridge. The river is entrenched 30 to 40 ft below the Soldotna terrace, upon which part of the town of Soldotna is visible here. Wakes in the river are caused by large boulders, the presence of which is characteristic of the entrenched section of the stream. Direction of flow is toward upper left. Reach visible in photograph extends from approximately river miles 21.5 to 20.7. Scale, 1:4,800, or 1 in. = 400 ft. Photograph credit: U.S. Army Corps of Engineers.

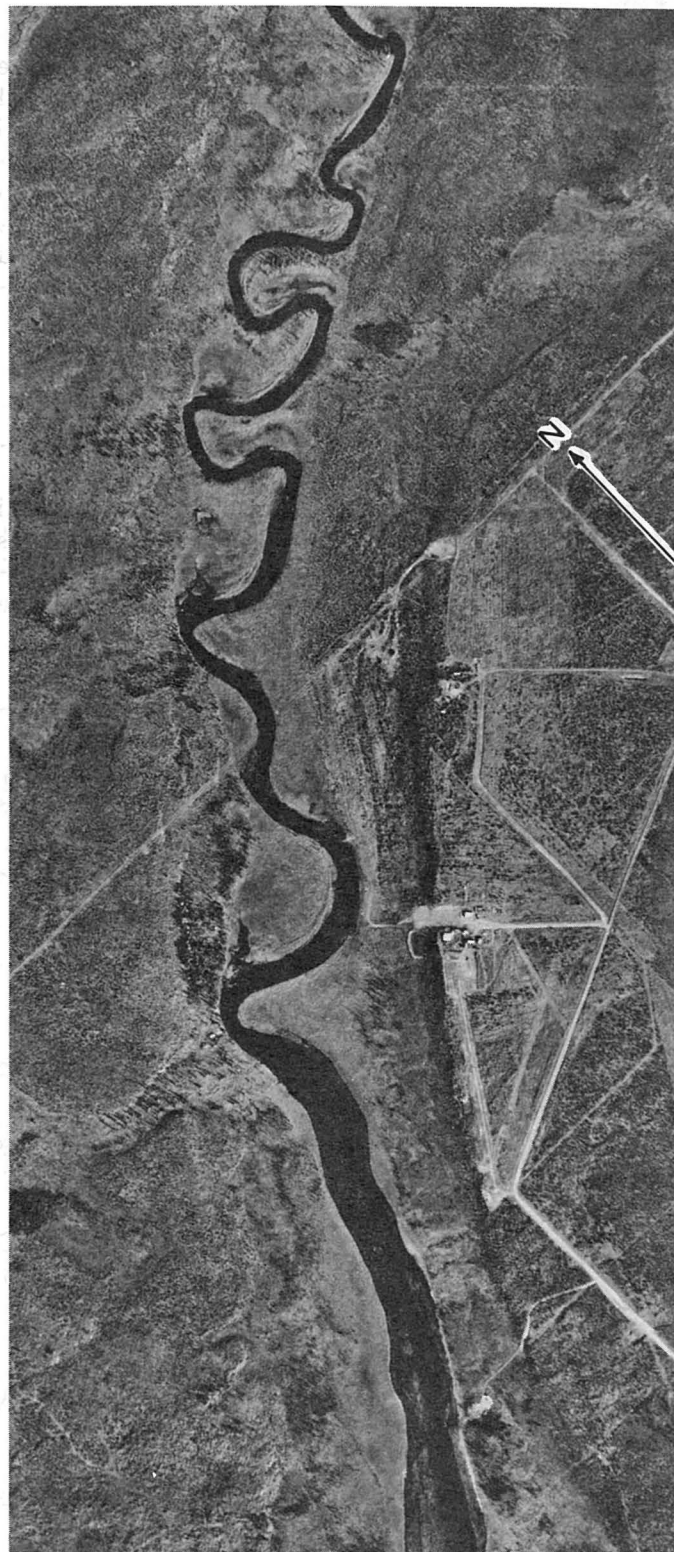
FIGURE 7.—Moose River channel between 1.3 and 2.6 mi upstream from its junction with the Kenai River—a striking example of confined meanders occurring within a large sinuous paleochannel. Flow is toward bottom of photograph. Downstream change in pattern of present channel from meandering to straight is in response to entrenchment of the Kenai River. Scale, 1:12,000, or 1 in. = 1,000 ft. Photograph credit: U.S. Army Corps of Engineers.

Figure 7 illustrates the channel of the Moose River a short distance upstream from its junction with the Kenai River. The underfit condition is pronounced. The present channel is approximately 80 ft wide where it meanders within a paleochannel 600 to 700 ft wide. The Moose River paleochannel appears to be a natural upstream extension of the lower part of the Kenai River, from both the similarity in pattern and the trends of the two channels at their junction.

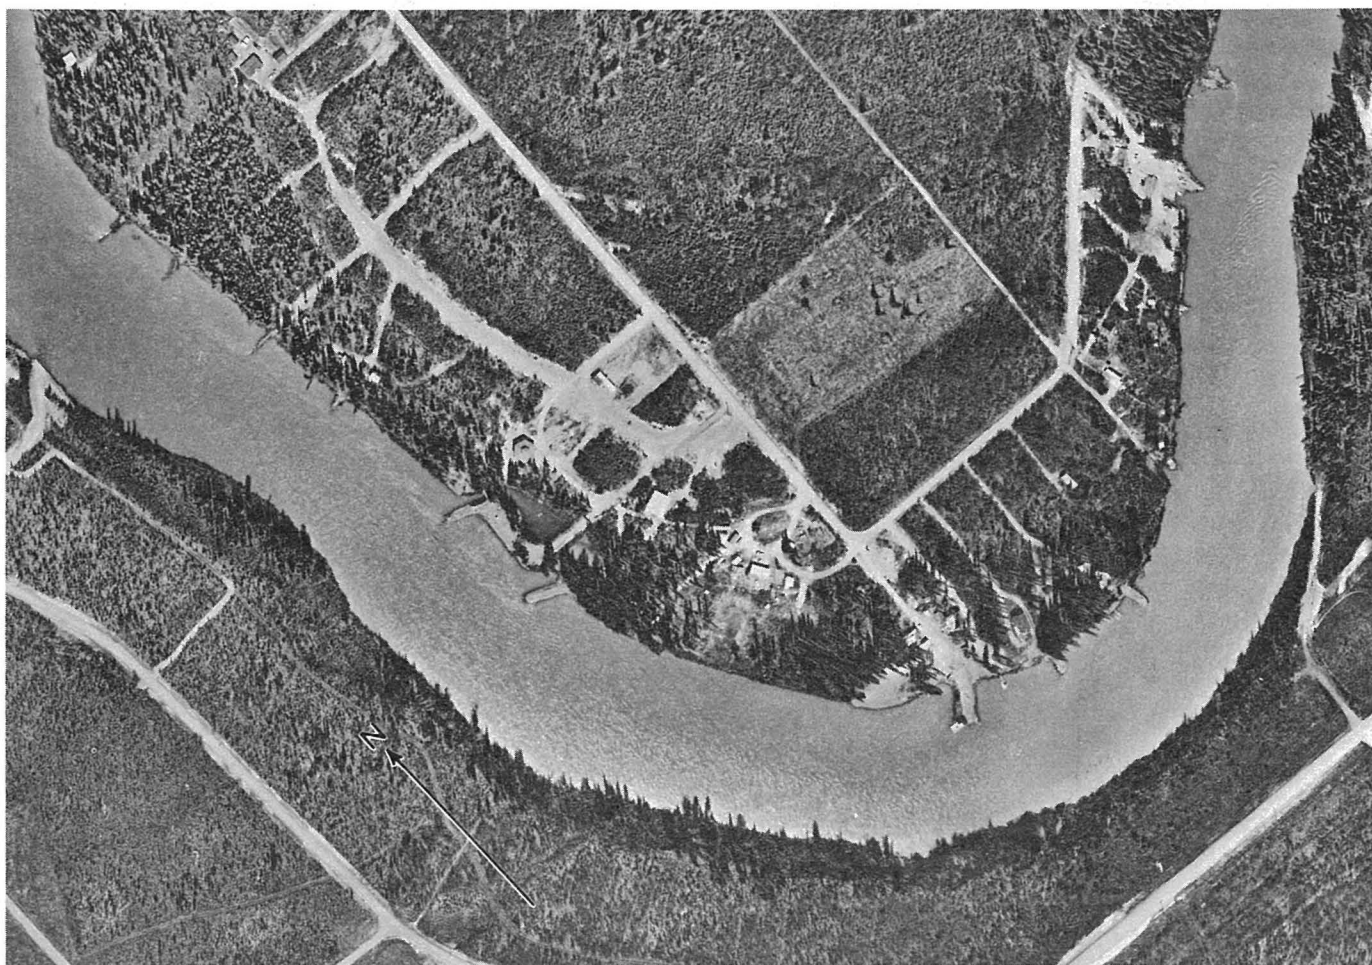
FIGURE 18.—Kenai River between approximate river miles 38.2 and 37.0. Flow is from right to left. Scale, 1:4,800, or 1 in. = 400 ft. Date: July 11, 1977. Photograph credit: U.S. Army Corps of Engineers.

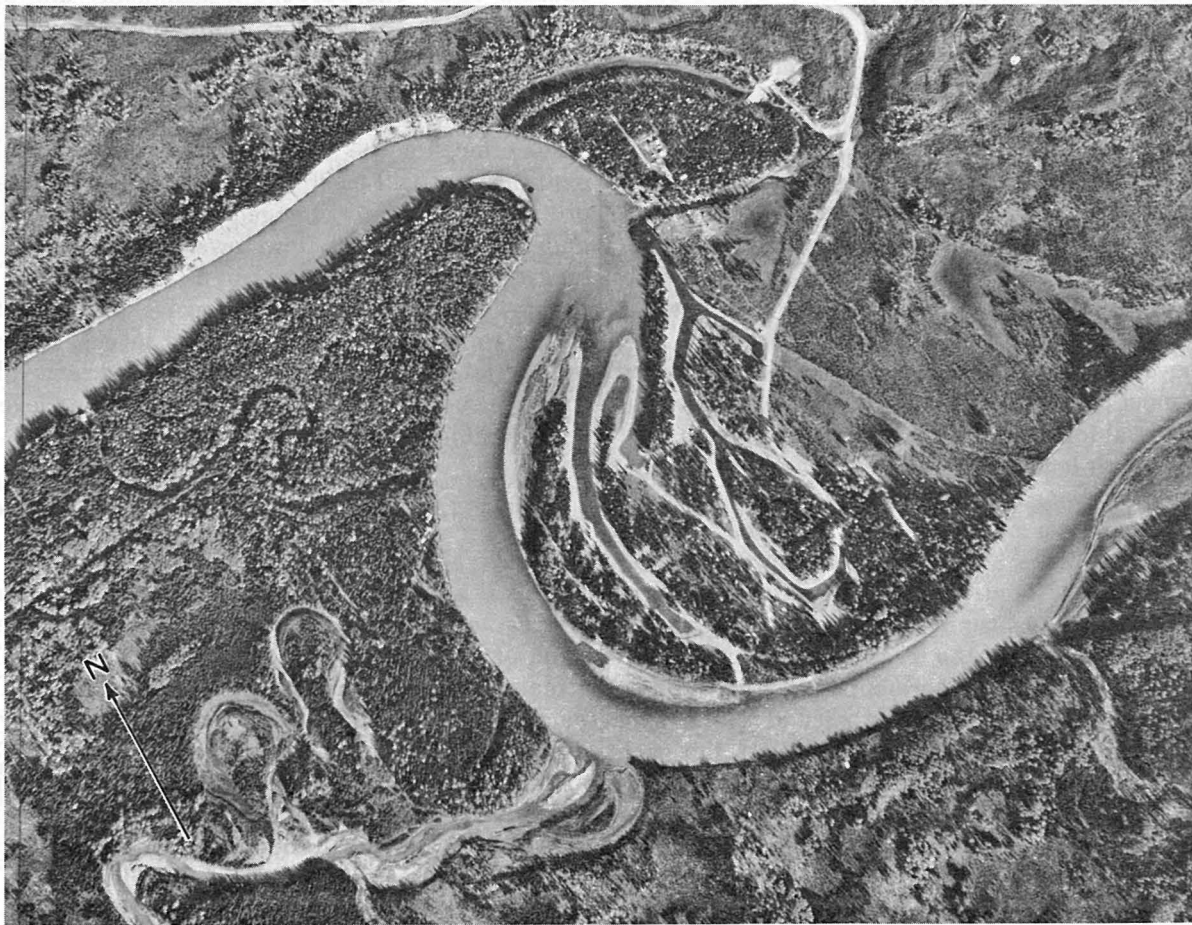
FIGURE 19.—Kenai River between approximate river miles 44.8 and 42.9. Interior of meander loop has been developed with canals. Note natural channels across neck of meander; one channel has been partly excavated to form a canal. The Killey River enters from bottom of photograph. Flow direction is from right to left. Scale, 1:12,000, or 1 in. = 1,000 ft. Date: September 24, 1972. Photograph credit: U.S. Army Corps of Engineers.
