Subtask 7.10
Phase 1 Final Draft Report Vol. 1
Aquatic Habitat & Instream Flow Project
ADF & G / Su Hydro 1981

SUSITNA HYDROELECTRIC PROJECT

Phase 1 Final Draft Report Vol. 1

Aquatic Habitat & Instream Flow Project

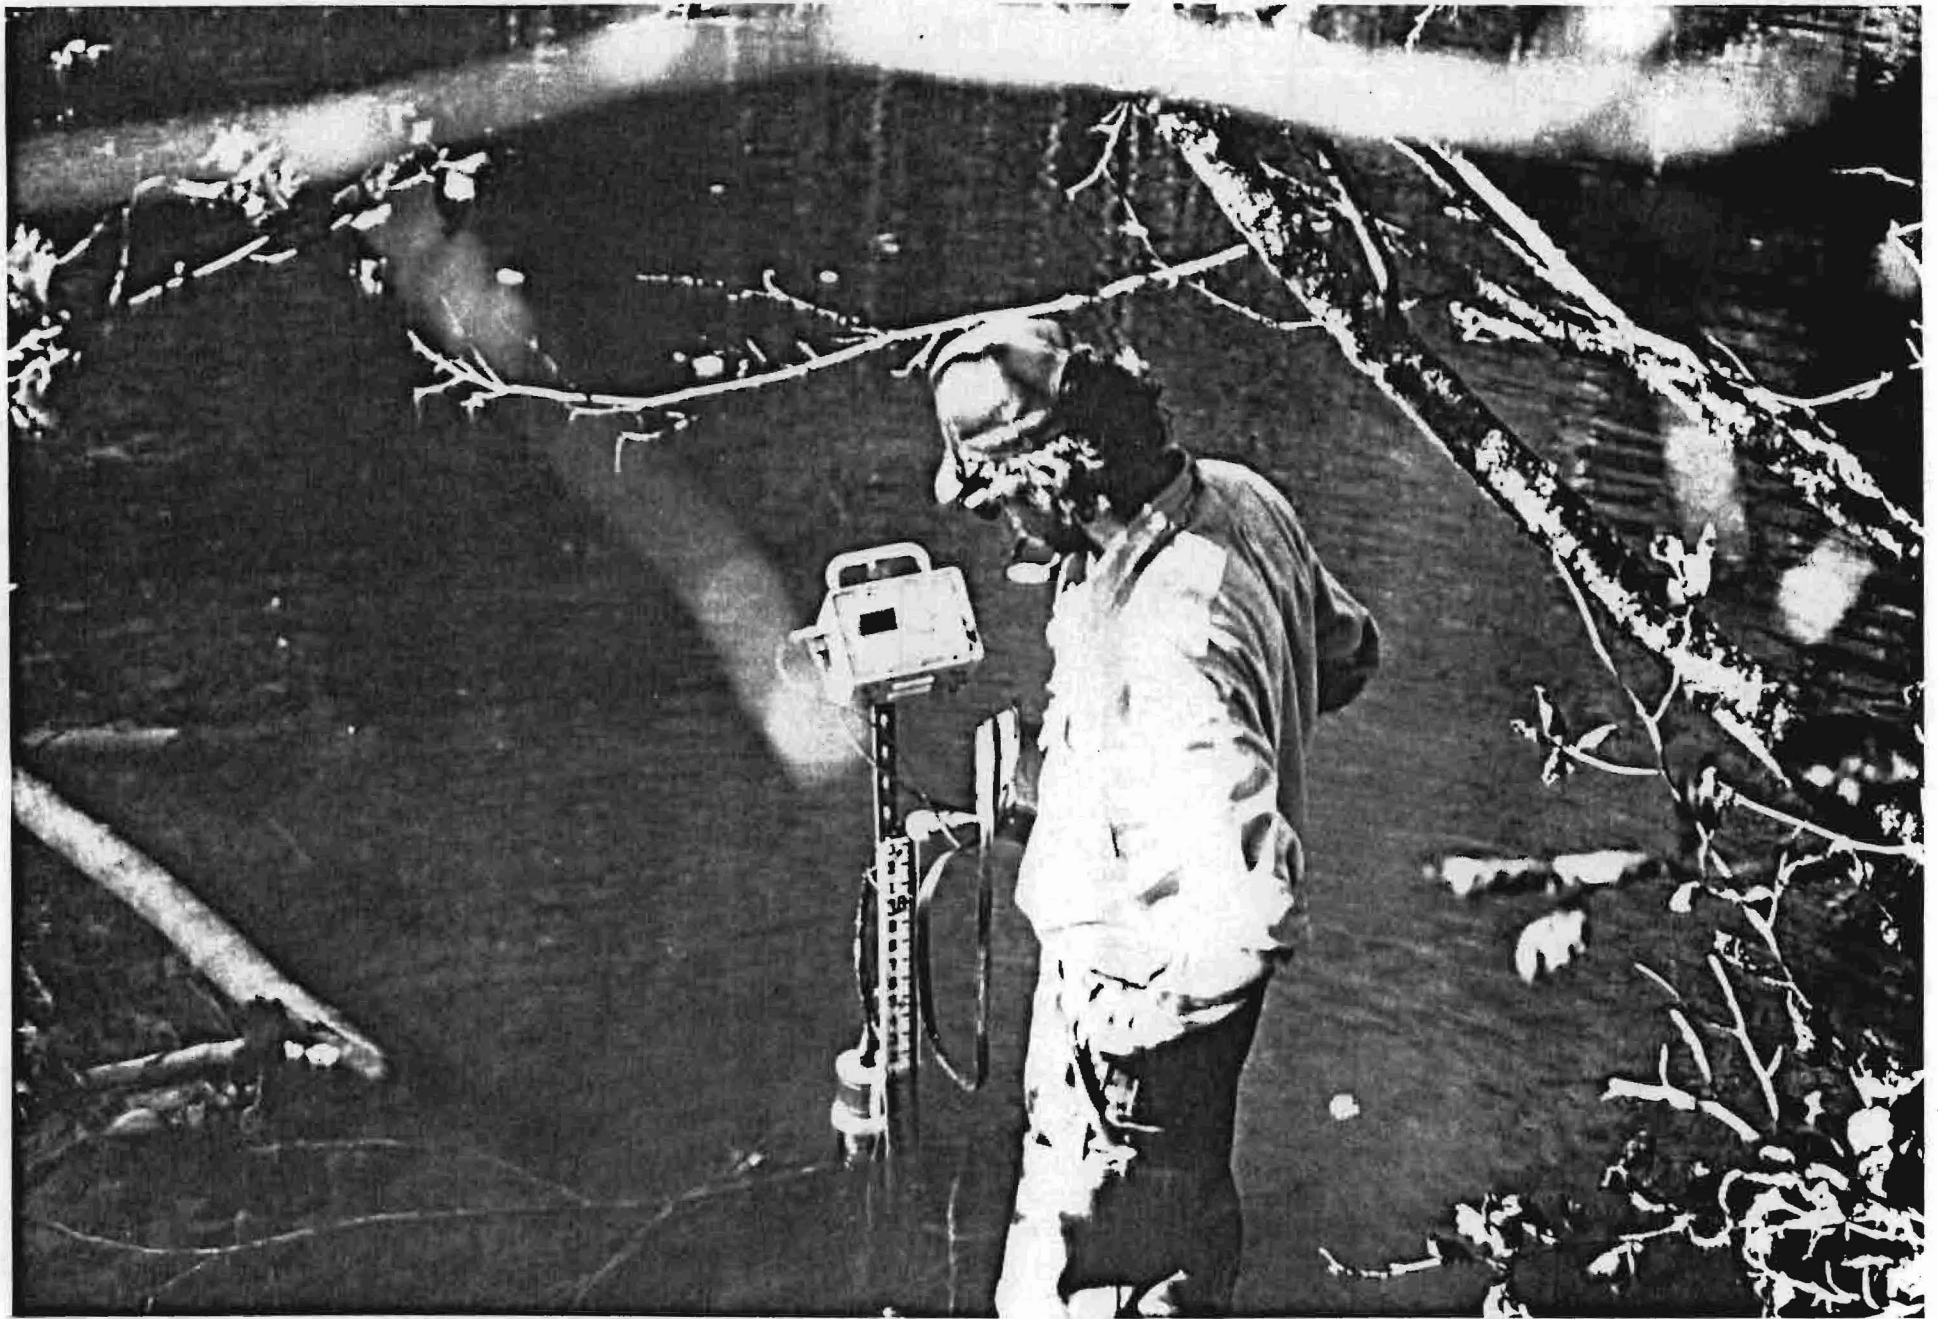
Plate 2. Hydrolab being used to determine water quality parameters at Cache Creek.

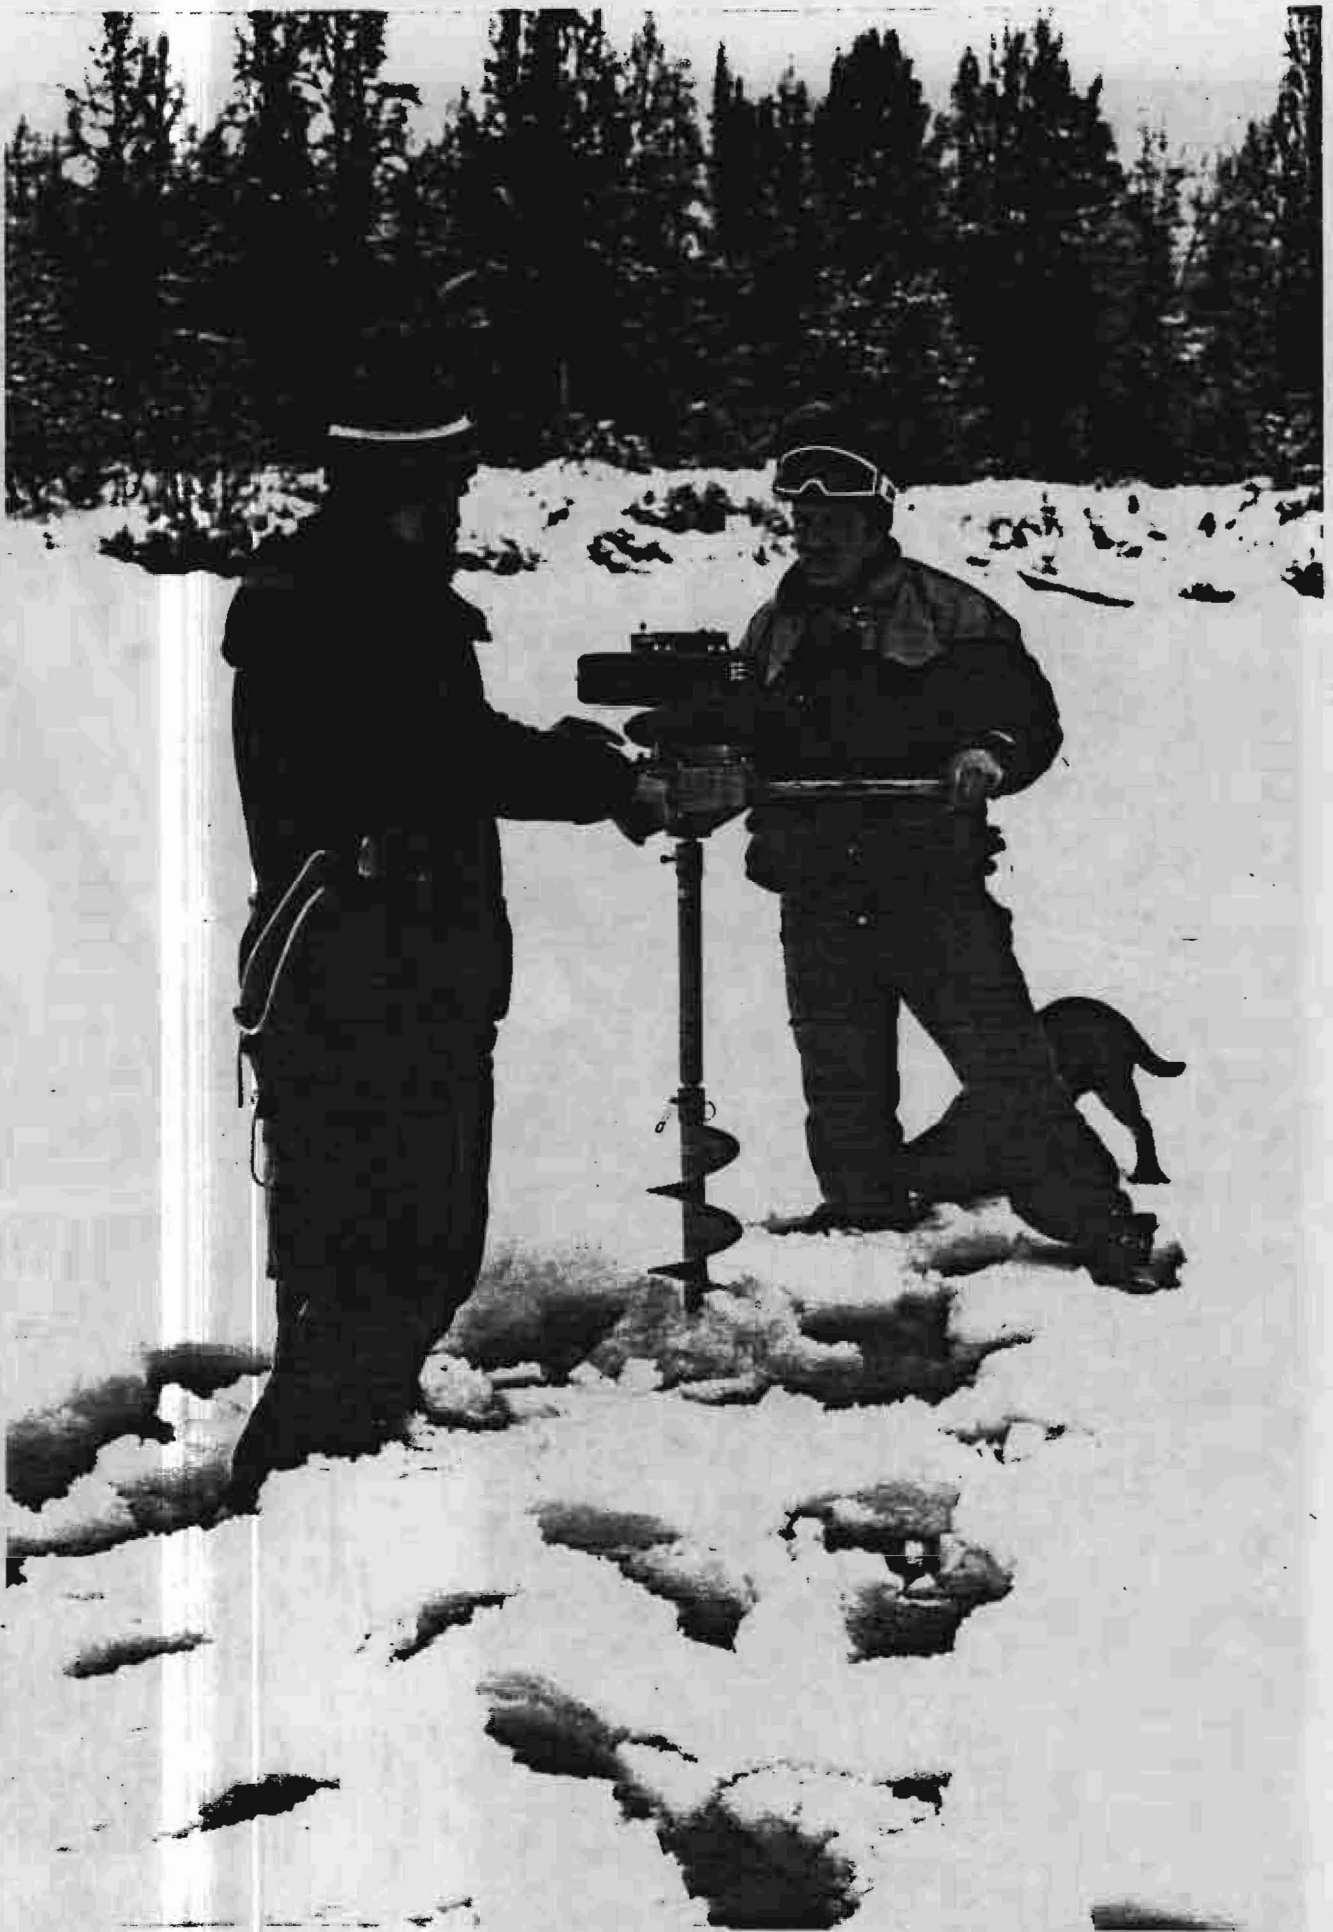
Plate 5. Use of an ice auger for winter sampling.

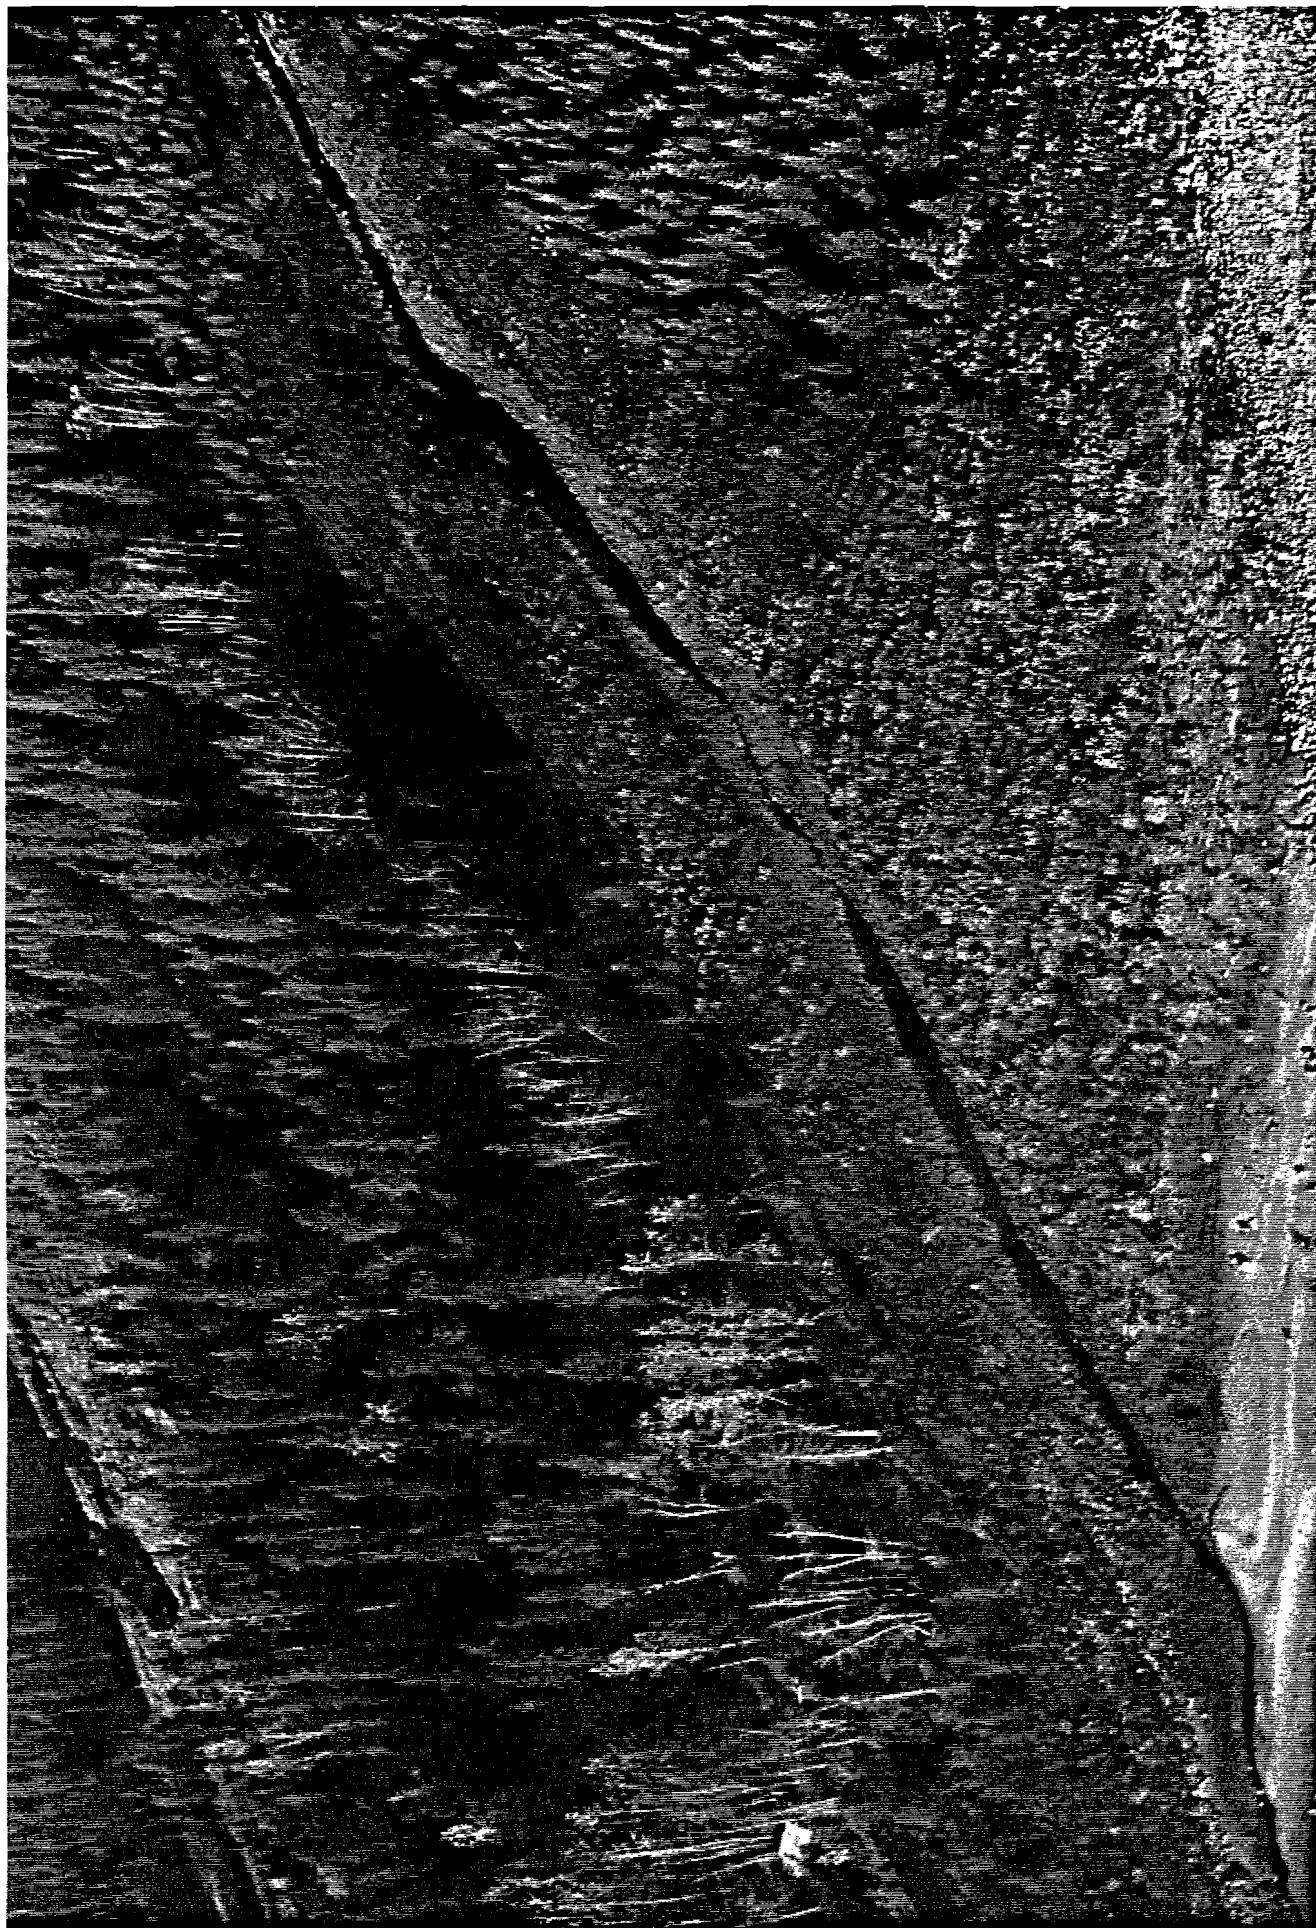
Plate 7. Jay Creek slough.

Jay Creek Slough is a small, spring-fed system which enters the Susitna River approximately 600 feet above the mouth of Jay Creek. It extends approximately 2500 feet from the Susitna River to its spring-fed source (Plate 7). The slough consists of one main channel 5-10 feet wide with average depths of 1-3 feet. The substrate in the lower 1000 feet of the slough consists mostly of mud and silt. In the upper areas more rock is exposed and the substrate consists of gravel and cobble embedded in mud and silt. During periods of low precipitation the water is clear and flows are negligible. With increasing precipitation the water can become extremely turbid. Influence from the main Susitna is minimal except during periods of extremely high flows when it may flow through the slough.

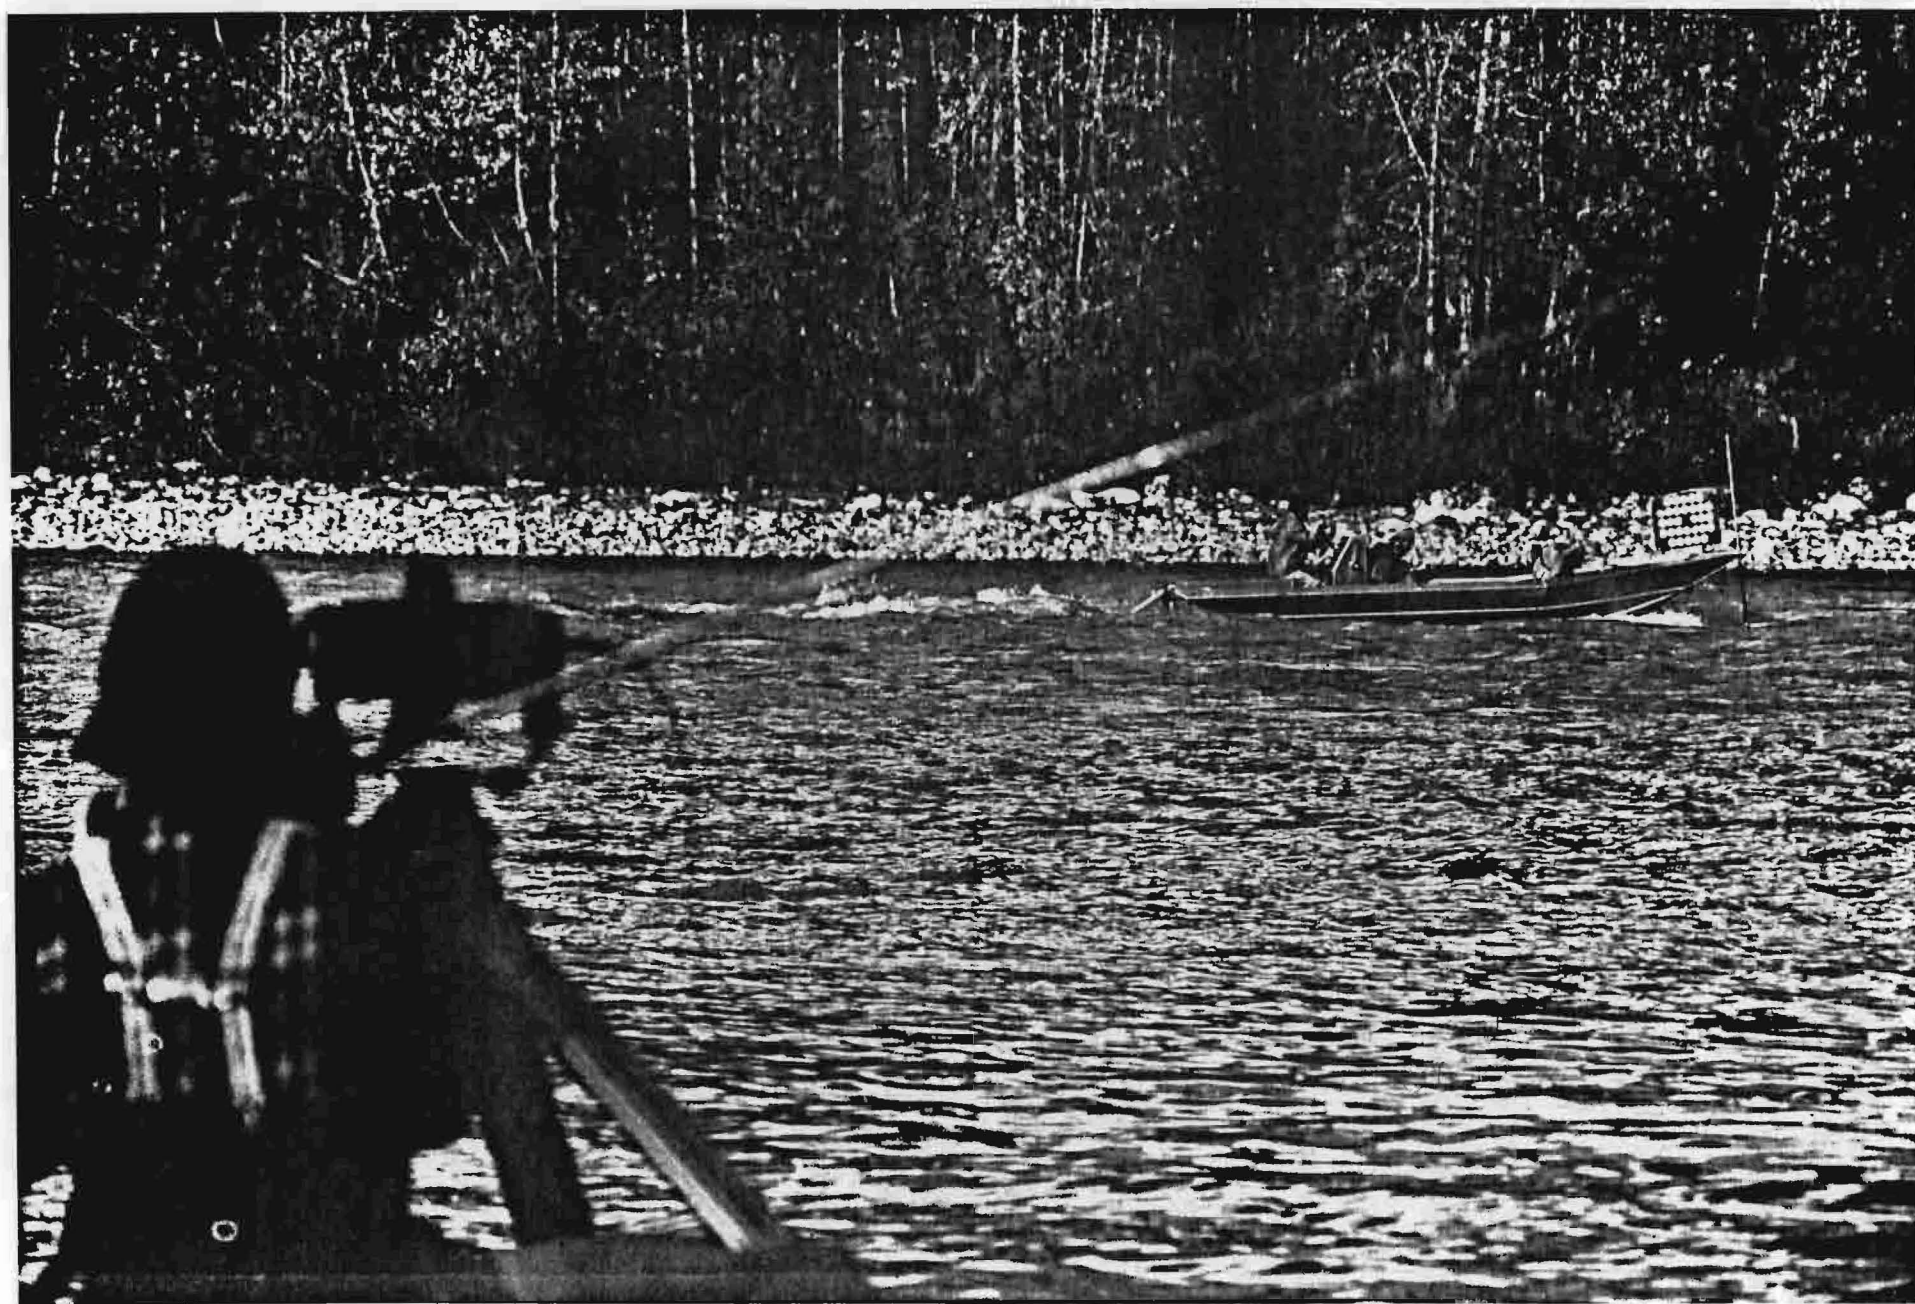
Plate 10. Use of an EDM distance finder for determining cross section profiles.

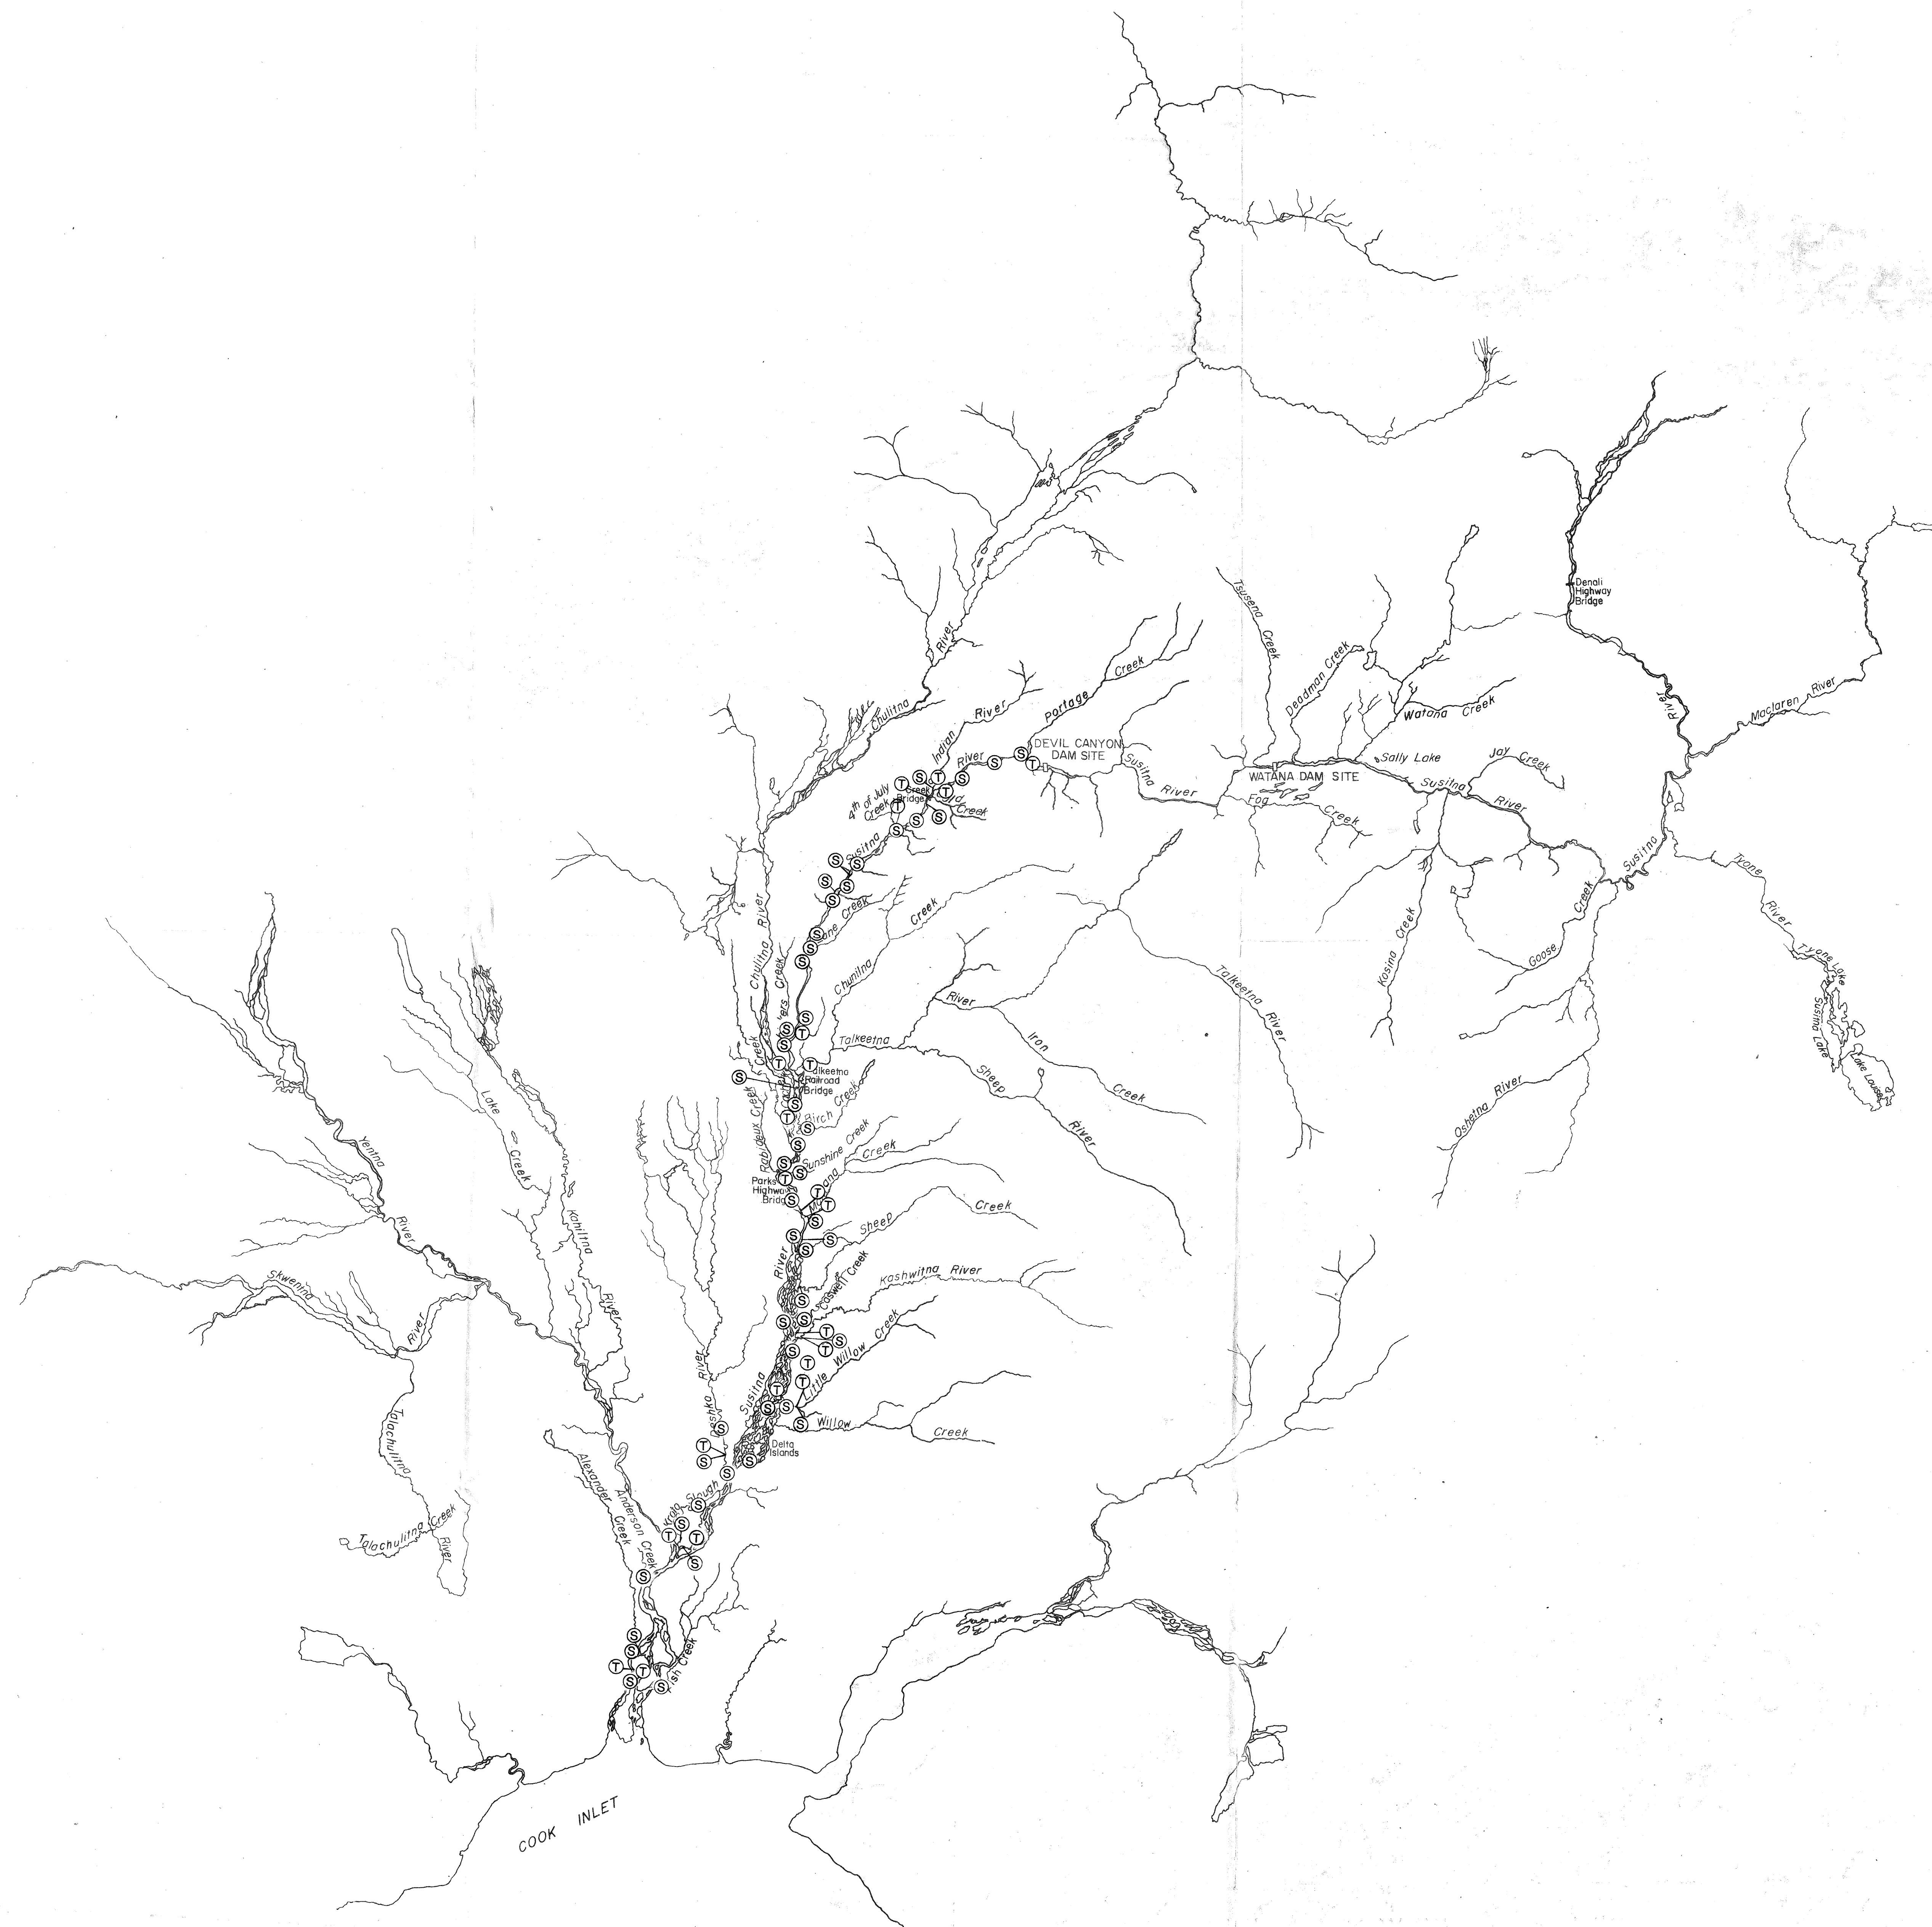
**SUSITNA RIVER
DRAINAGE BASIN**

**THERMOGRAPH AND
STAFF GAGE LOCATIONS, 1981**
