A RECONNAISSANCE OF TRACTOR TRAILS AND RELATED PHENOMENA ON THE NORTH SLOPE OF ALASKA

JEROME R. HOK

1969

U.S. DEPARTMENT OF THE INTERIOR
BUREAU OF LAND MANAGEMENT

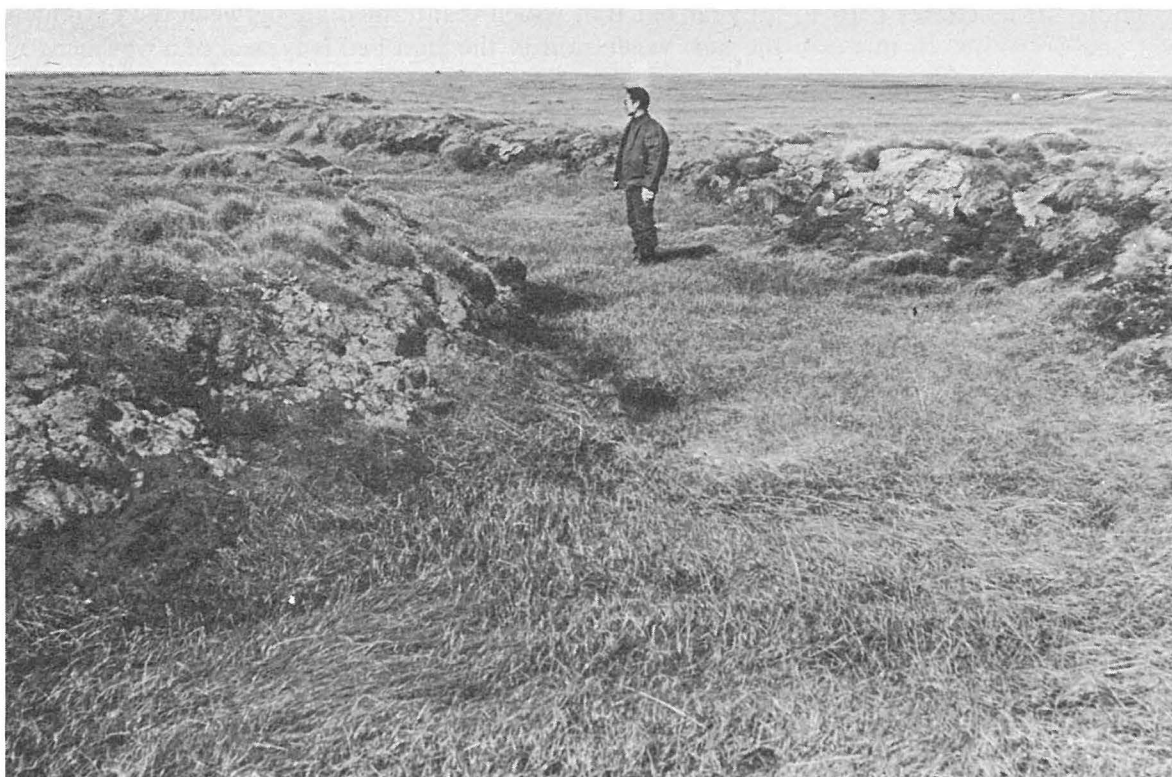
Photos 8 and 9 illustrate typical extremes in water saturation of bladed flatland trails: dry bed and submerged bed, respectively. In the dry bed trail, the return of ground cover is complete and appears quite similar to that of surrounding areas. In the submerged bed trails, however, no rooted plants have returned.

Photo 8: A dry bed summer bladed trail. 16-20 years old.

Photo 9: A submerged bed summer bladed trail. 7-14 years old.

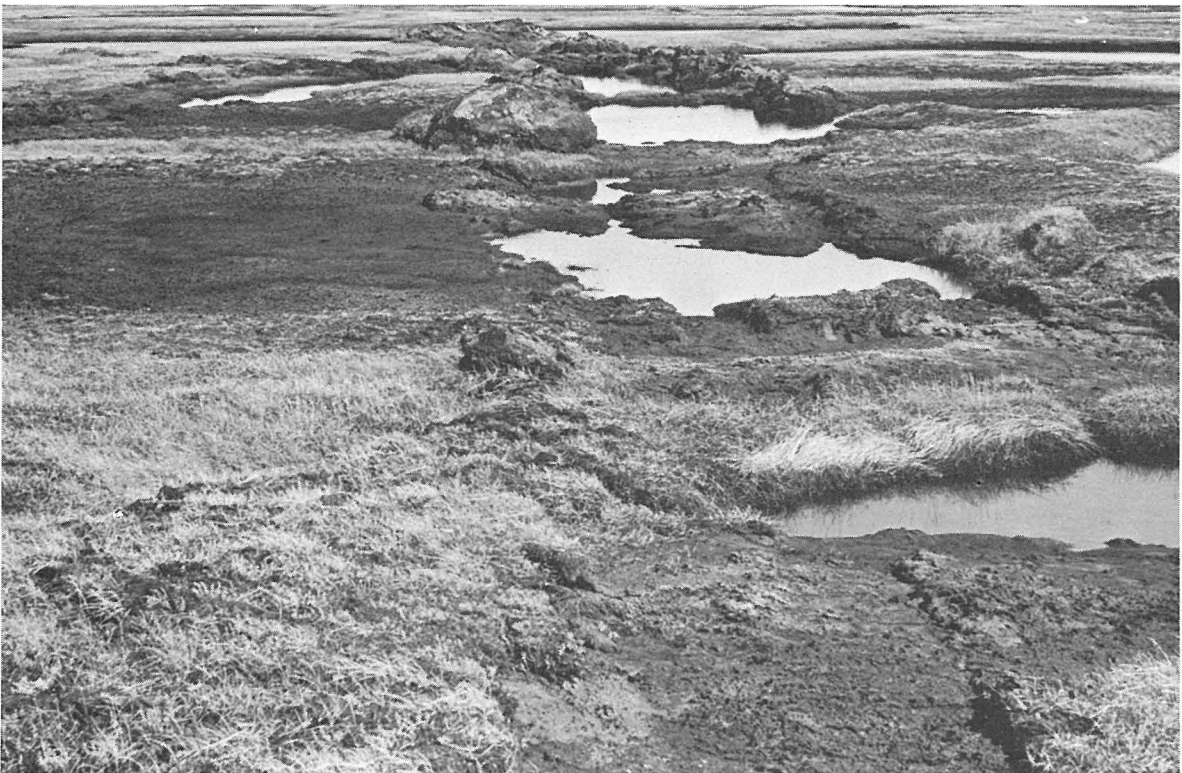
Photo 11: A bladed summer trail. 7-14 years old.

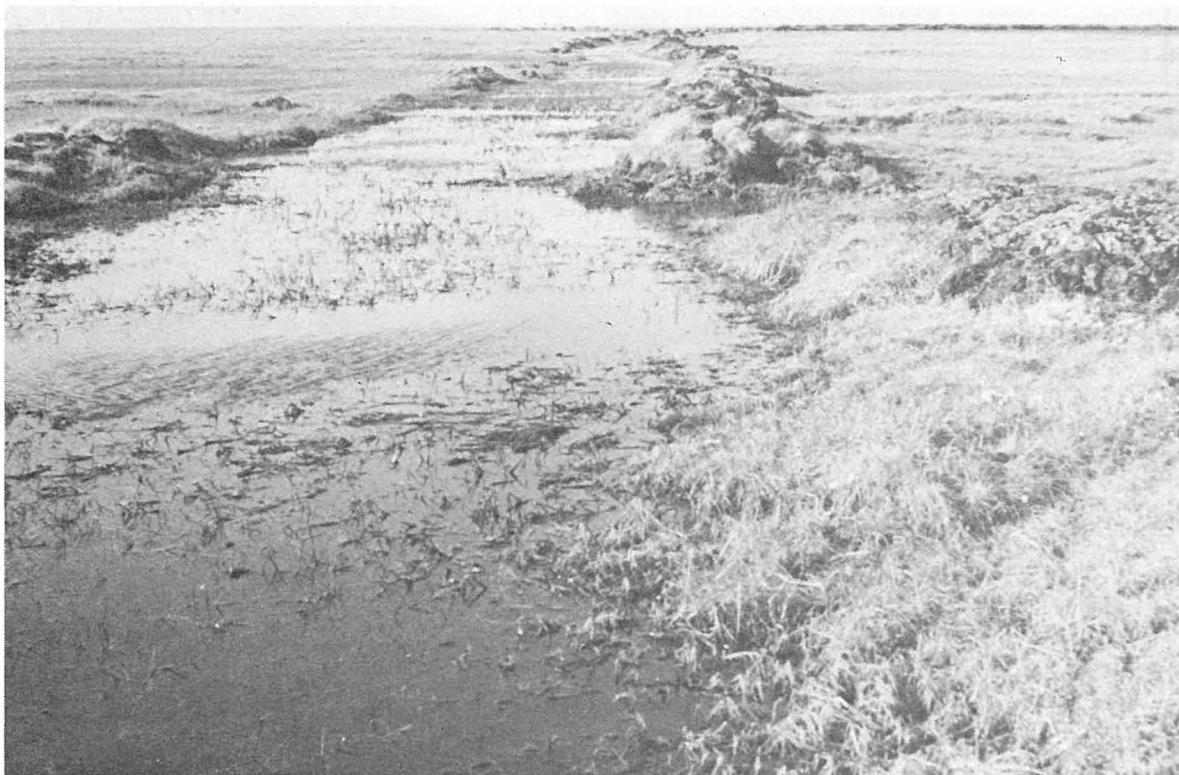
Photo 18: A bladed summer trail across wet sedge meadow. Lake is at upper right.

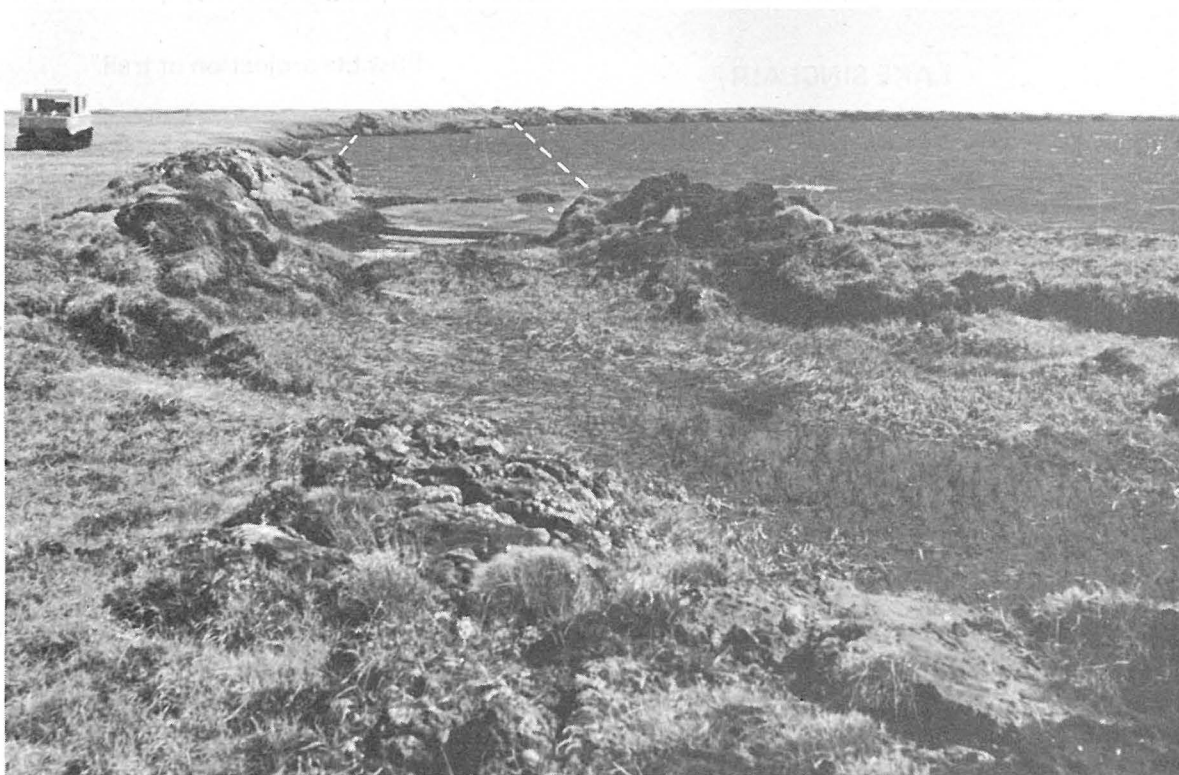
Photo 19: Trail shown in photo 18 where it intersects the lake margin. 16-20 years old.

A special case of a bladed summer trail across level, ice-rich terrain was noted at Cape Simpson. The trail's proximity to a lake margin may have stimulated slumping of the shore line (photos 19-23, Cape Simpson section). Such a possible connection between lake-margin instability and vehicle use was also suggested by Burns (1964: 81-82) as it pertained to destruction of mink denning areas on the Yukon-Kuskokwim Delta. The available evidence does not permit an evaluation of the rate of lake margin change in terms of natural and man-induced components, however.

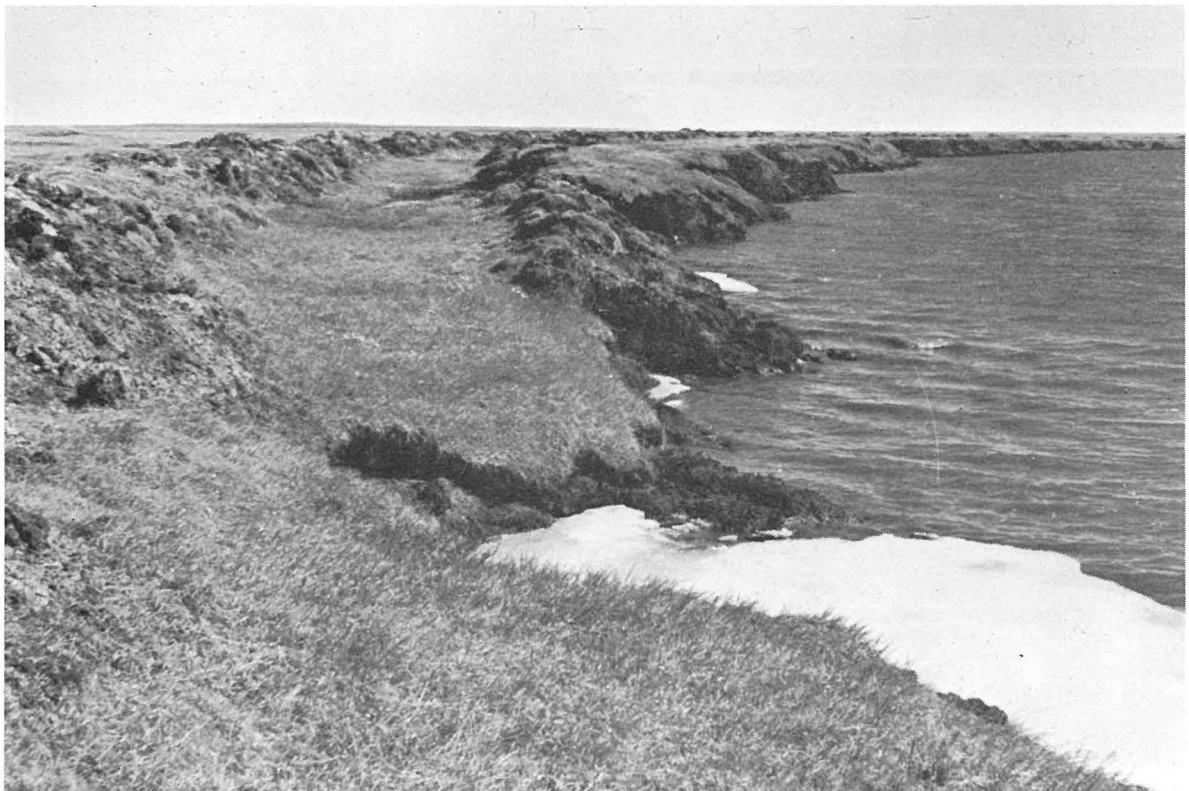
The probable past location of the trail is drawn on photo 20.

Photos 20 & 21: Bladed summer trail which skirts a lake margin (seen also in photo 19). 16-20 years old.

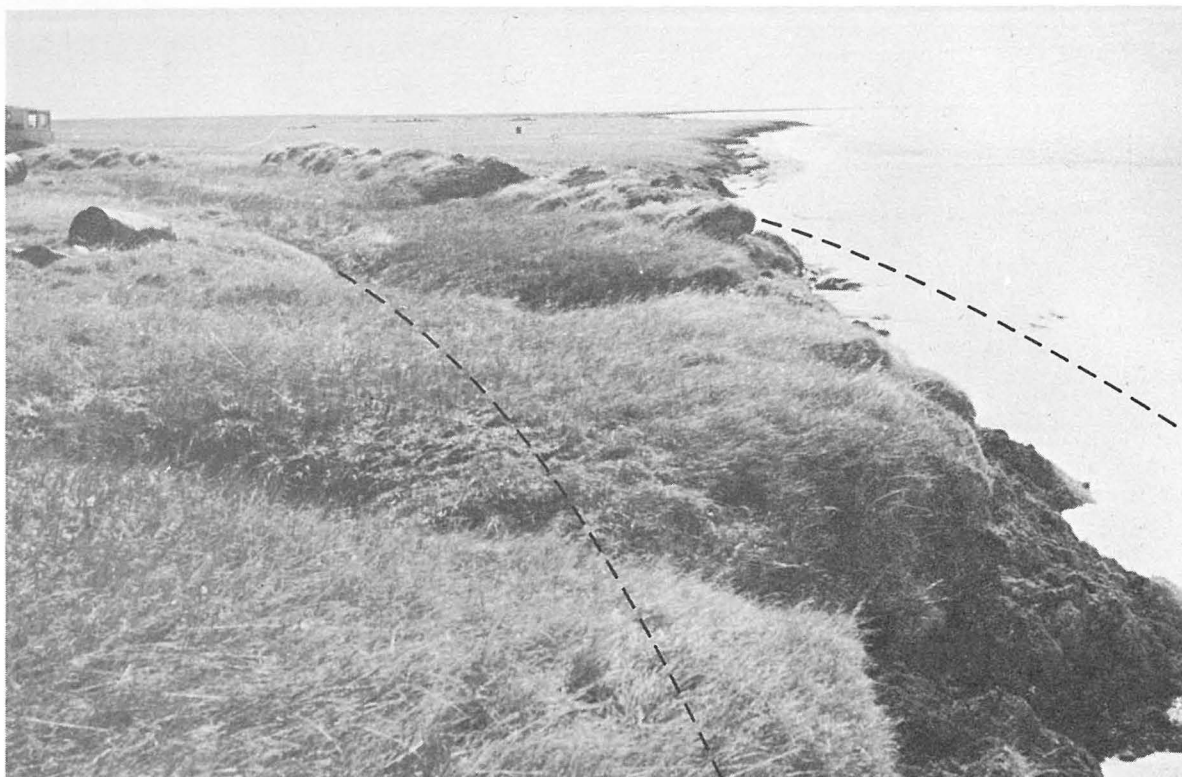
Photo 22: Bladed summer trail which intersects the shore of Sinclair Lake. 16-20 years old.

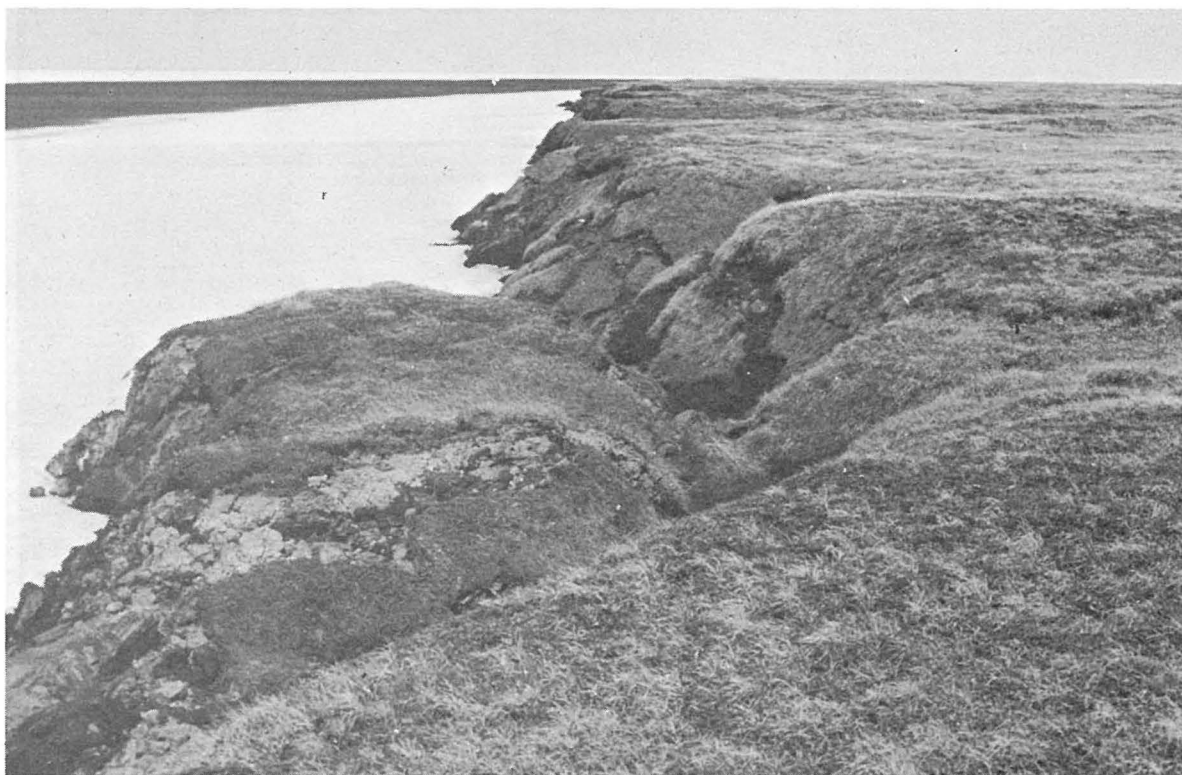
Photo 23: Lake margin in opposite direction as seen in photo 22.

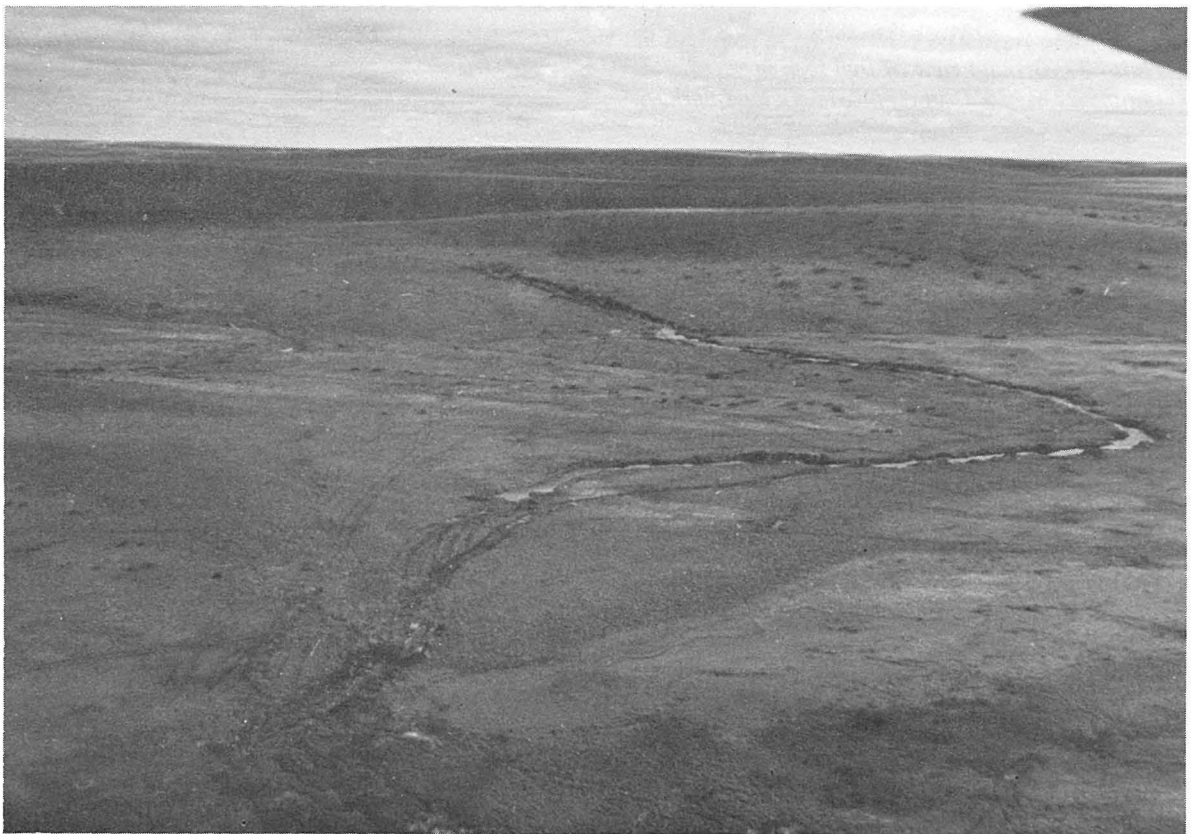
Although the flat section of the trail had achieved relative stability, a portion of the trail that traverses a gentle slope (photo 25) was still rapidly eroding in 1969. The approach to this section of trail is shown in photo 27. Photos 30, 32 and 33 are taken in sequence beginning at the depositional area at the base of the slope and proceed up the slope. The trail has developed into a stream course. Subsidence at the head of the existing gully suggests that erosion is continuing to encroach up the hill (photo 33).

Photo 25: Aerial view of one of several extended bladed trails. 17-19 years old.

Photo 26: Continuation of the trail seen in photo 25. Airstrip is outlined as a landmark. 17-19 years old.

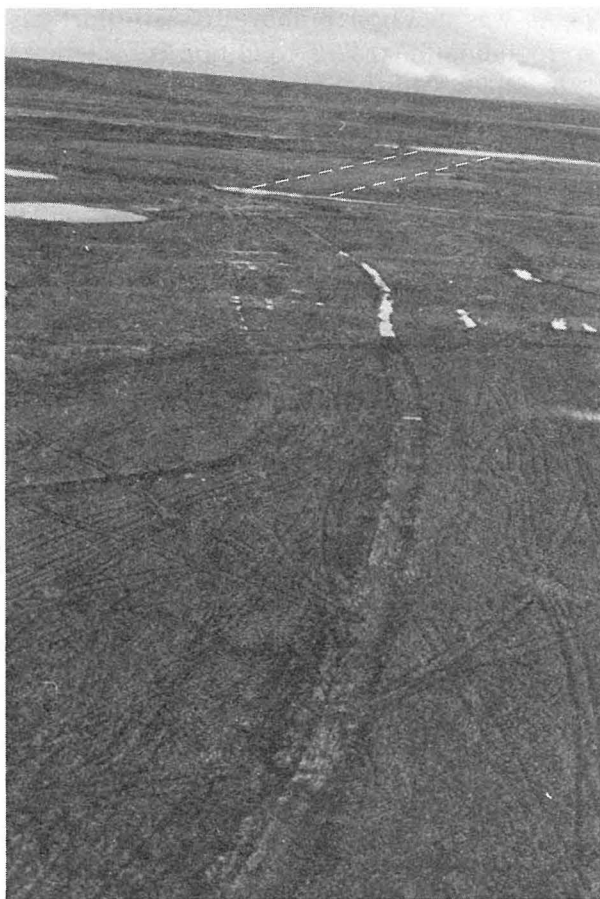
Photo 27: Ground view of trail seen in photos 25 & 26. Drill rig provides a landmark.

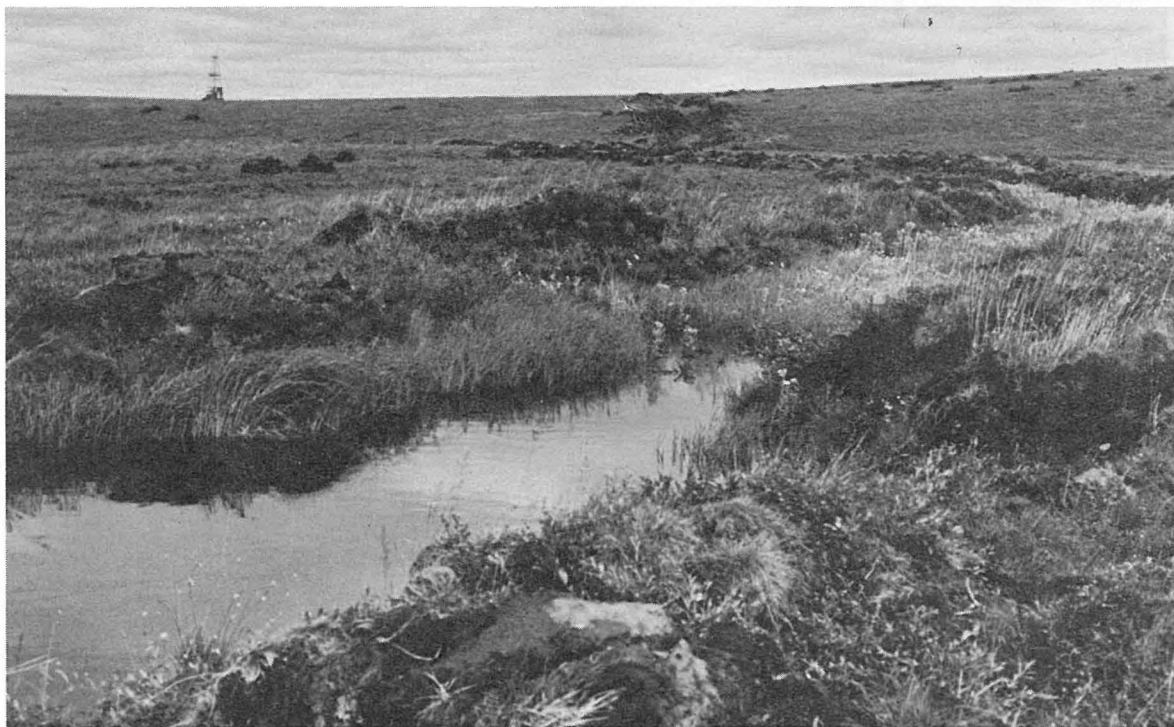
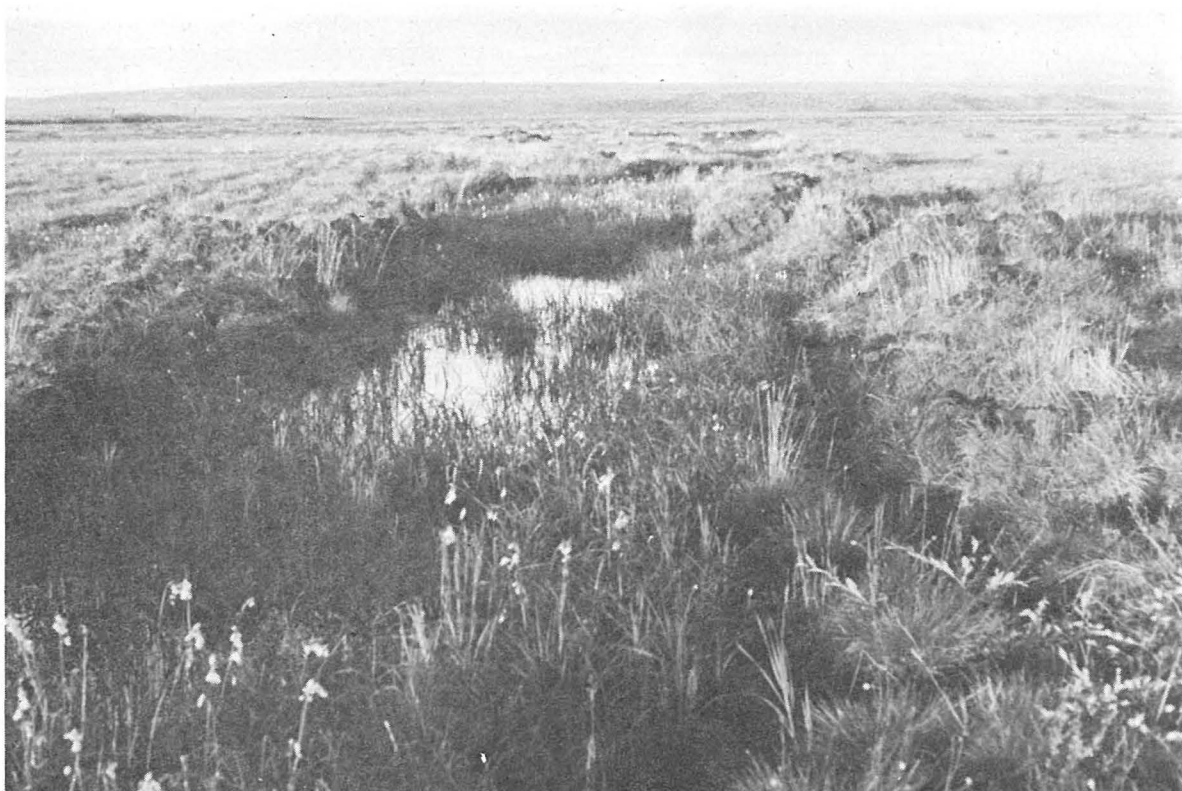
As was mentioned above, certain portions of the trail bed are distinctly greener than the surrounding flats. This condition is sometimes interpreted to mean that the greener vegetation is healthier. This is not always a valid conclusion. Photos 28 and 29 provide a close-up view of the rich green trail bed contrasted with the yellow-brown (darker green) areas which lie adjacent to it. The rich green vegetation in the trail bed is a nearly uniform stand of individual shoots of *Eriophorum angustifolium* rooted in a very wet habitat. Nearby are found tussocks and a mixture of other plants on a much drier surface. The richer green of the trail bed, therefore, does not necessarily indicate "healthier" vegetation.

Photos 28 & 29: Ground views of a section of the trail seen in photo 26. 17-19 years old.

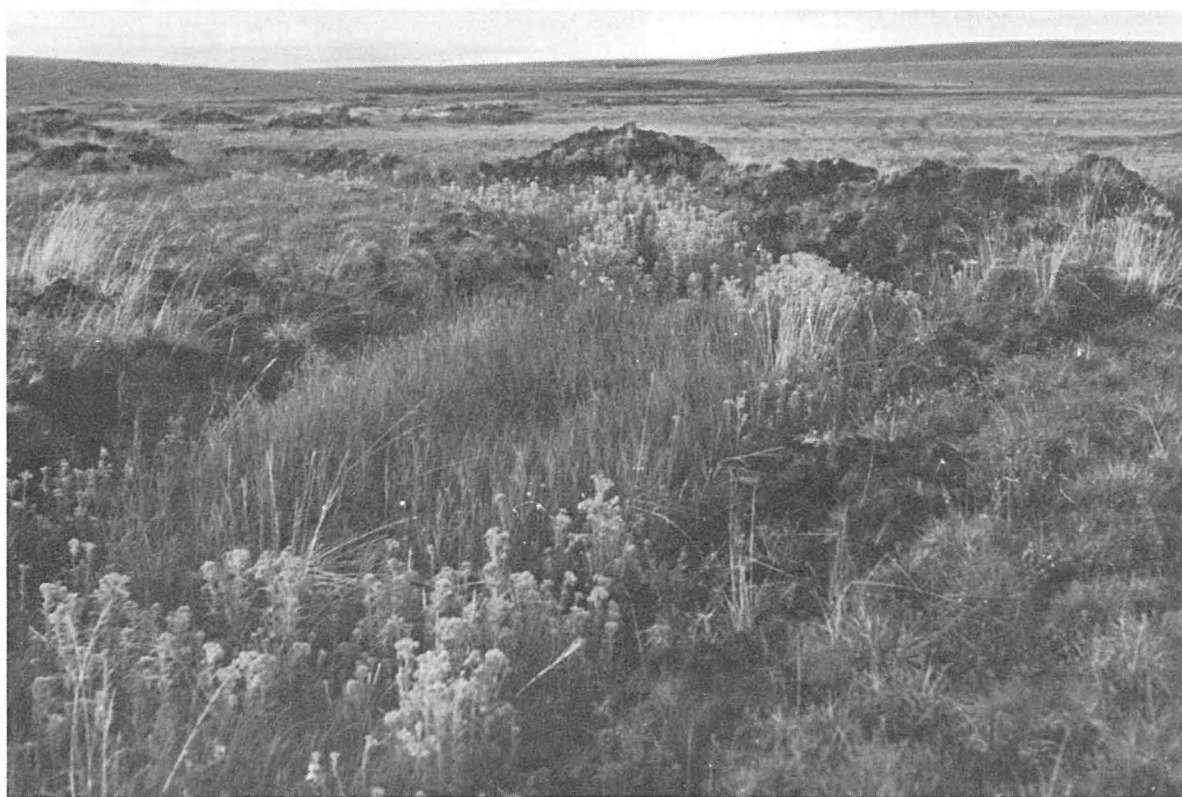
The sloping portion of the trail, although 7-10 years old, has not yet begun to approach a stable condition. This is indicated by the slumping surface cover (photo 33), the deep, unvegetated water channel (photo 32) and the accumulating outwash (photo 30). A yellow flowering plant *Senecio congestus*, is particularly prominent as a colonizer of silty mud outwashes in active eroding areas (photo 31). This plant is not found in the immediate area other than in this active outwash habitat.

Photo 30: Silt outwash from eroding trail at base of slope. 7-10 years old.

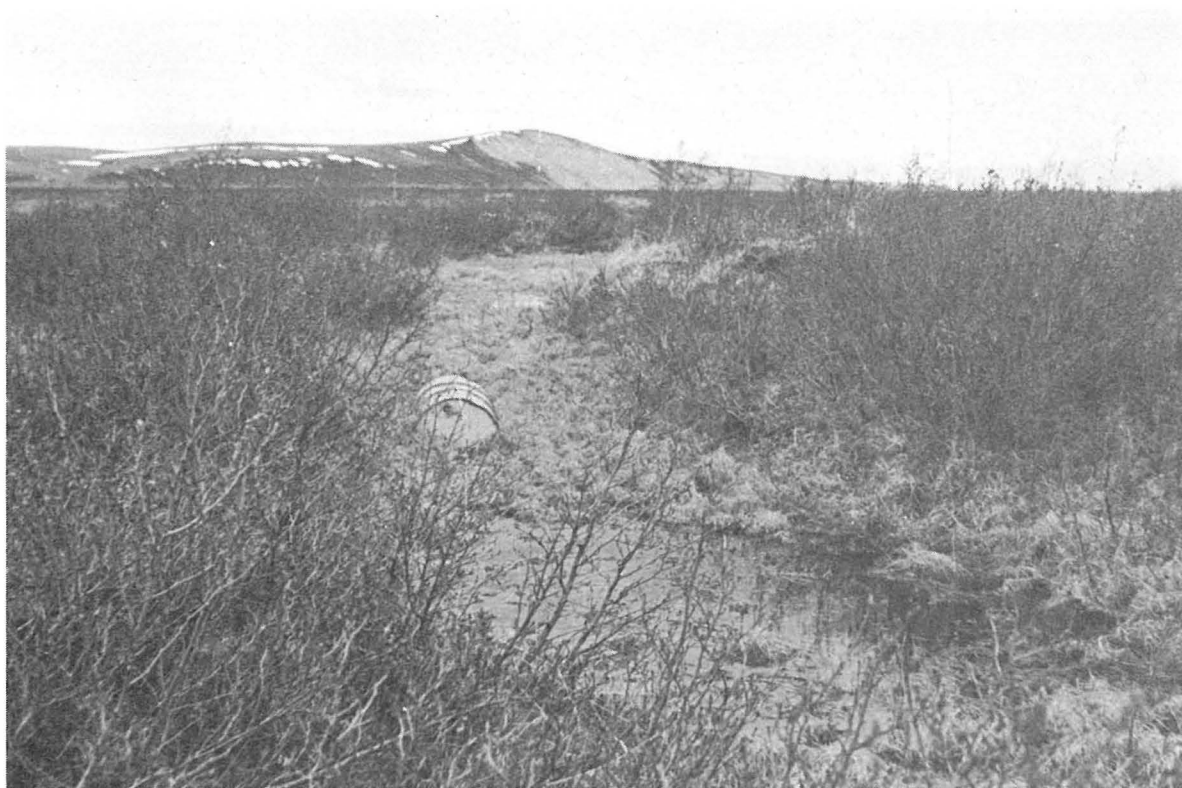
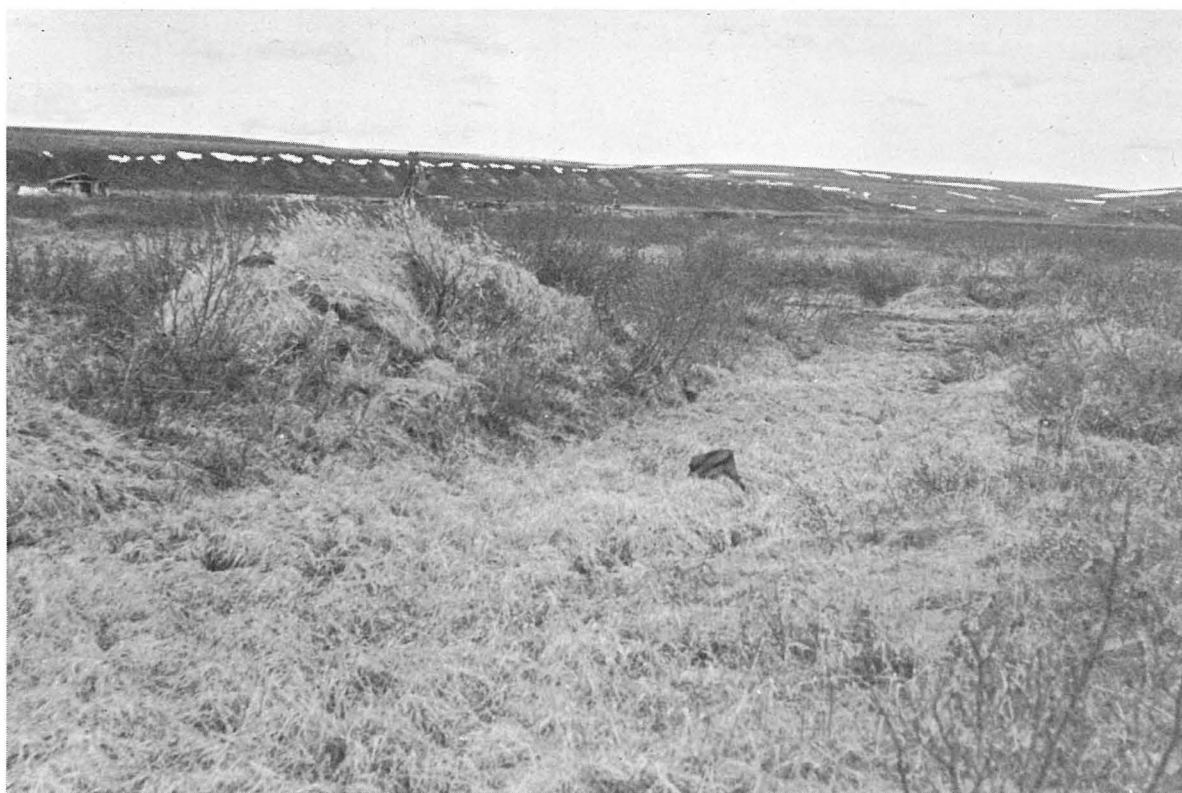
Photos 35 and 36 illustrate the result of blading a summer tractor trail through a tall-shrub willow area. The bed of the trail is at present a wet sedge meadow ankle deep in water, sharply differentiated from the drier adjacent areas. As can be seen in photo 35, the berm on the left side of the trail indicates a considerable quantity of material was pushed aside (a backpack in the center of the trail provides scale). A similar situation appears in photo 37 where an old river crossing is approached through a dense tall shrub thicket. Only a few willows are present in the bed of this trail.

Photos 35 & 36: Bladed summer trail through tall willow shrubs on flat land. 16-25 years old.

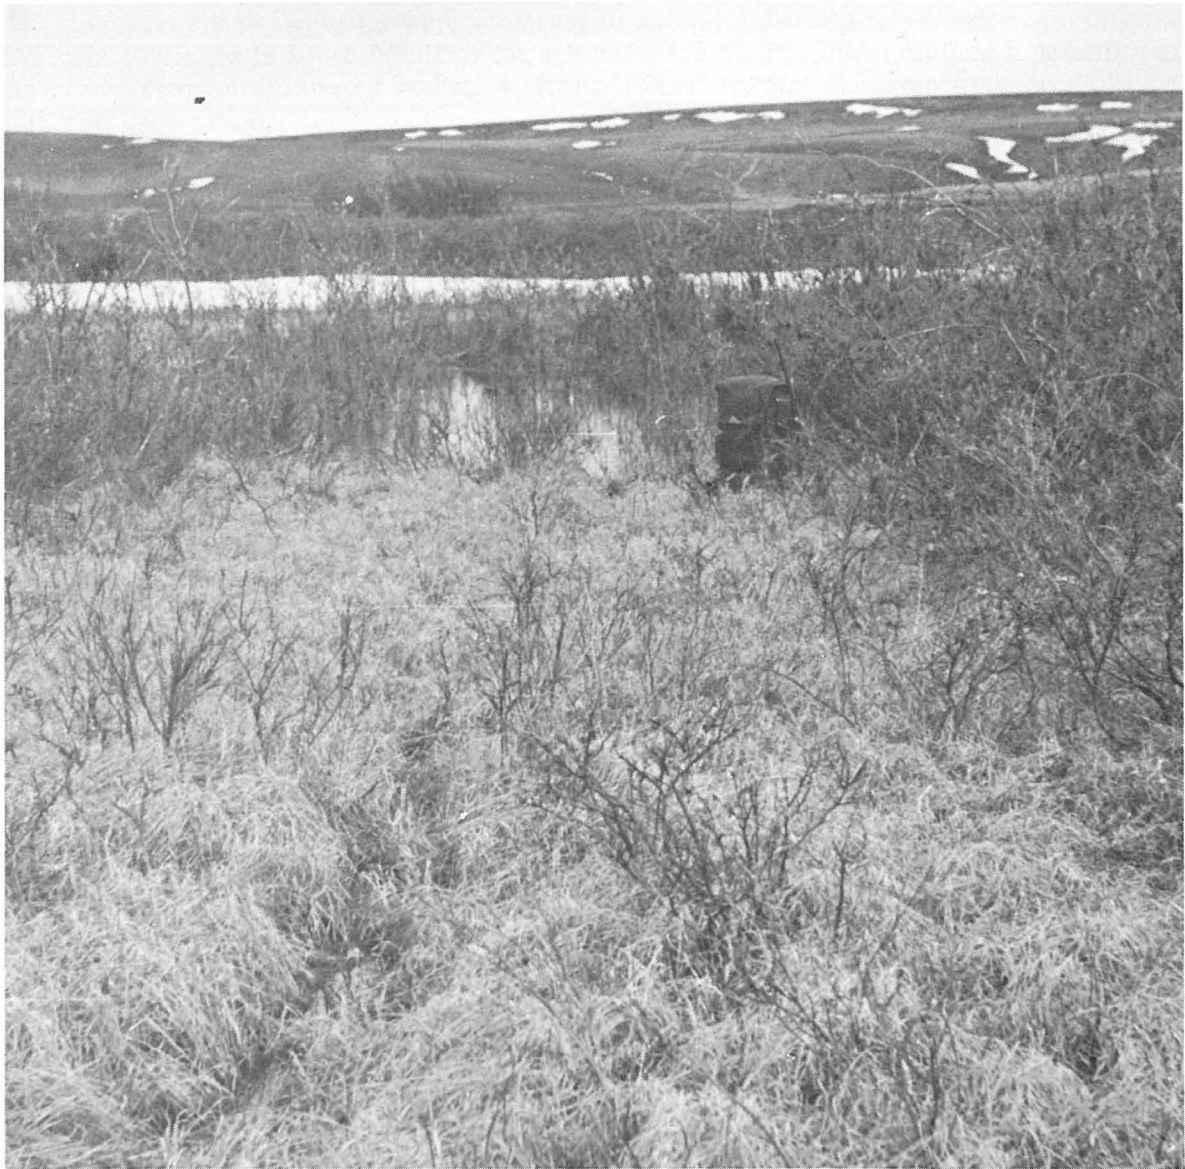
Photo 37: River crossing through tall-shrub willow community. Probably unbladed. 16-25 years old.

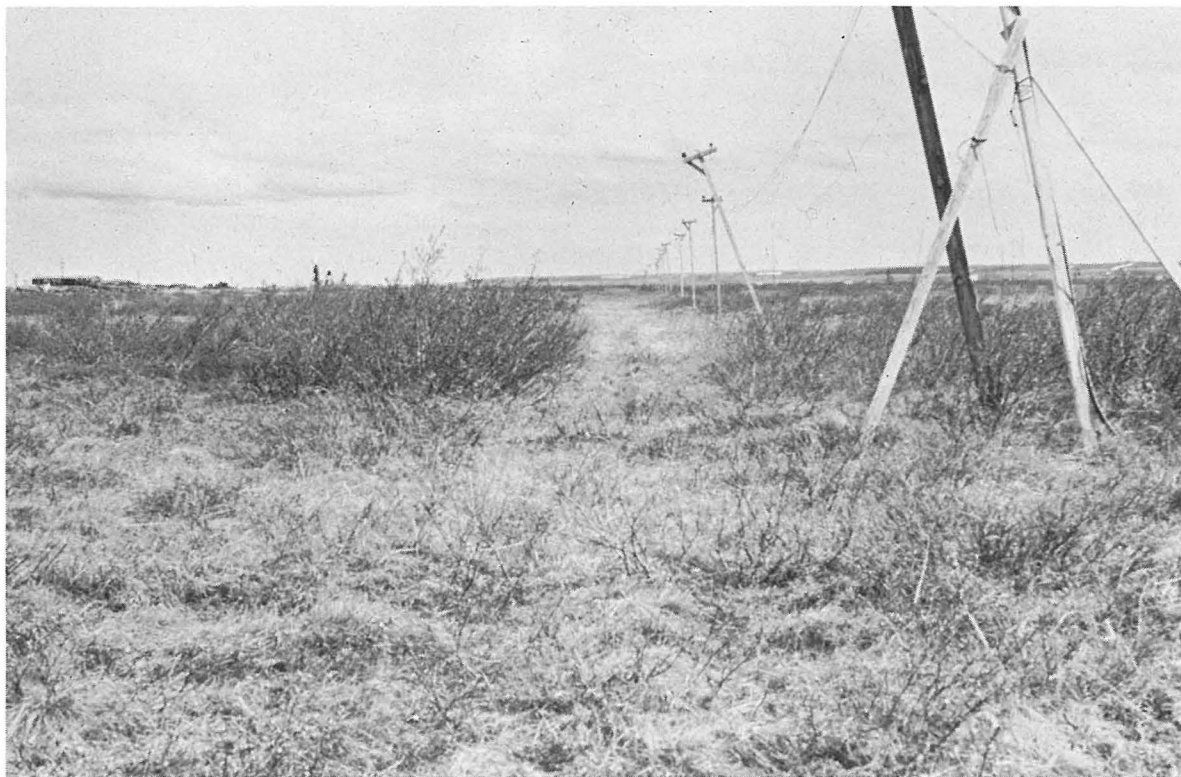
Photo 39: Personnel carrier (?) trail along abandoned electric line. 16-25 years old.

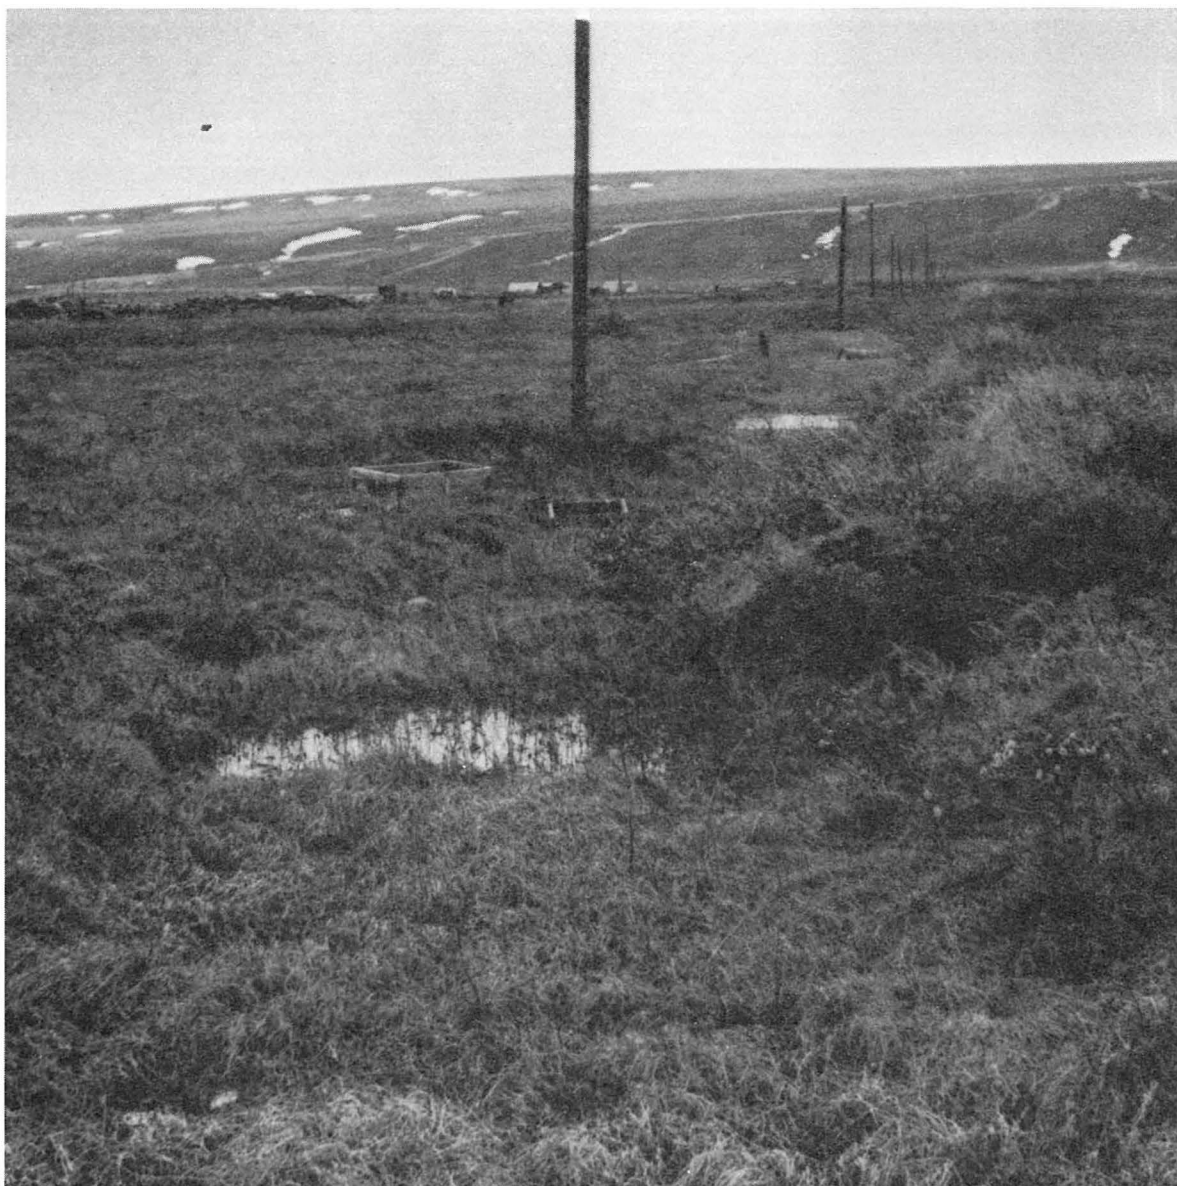
The result of blading a trail through the old flood plain vegetation type is seen in photo 40. Wet sedge meadow vegetation has become established in the trail bed.

Photo 40: The result of blading a trail through a low-shrub floodplain community. 16-25 years old.

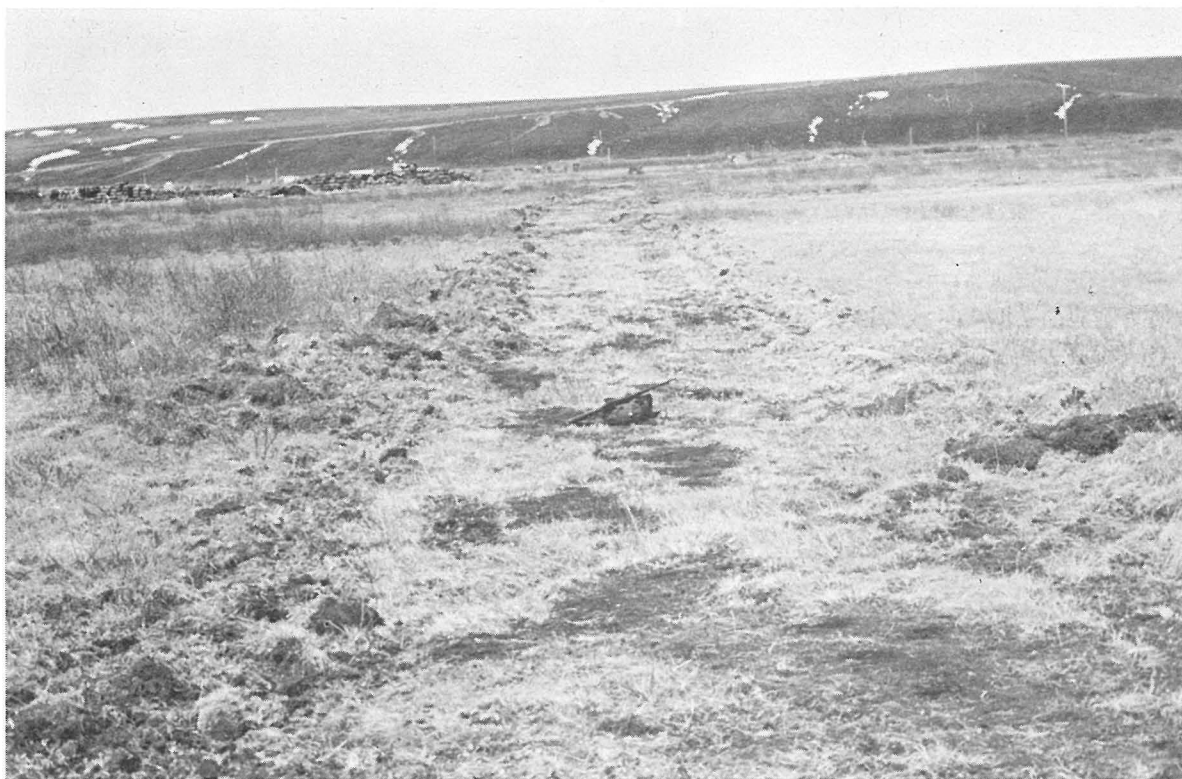
A winter haul road used during the winter of 1968-1969 is located near these older trails. Photos 41 and 42 were taken of this trail on June 11th, 1969. Photos 43 and 44 were taken from nearly the same spot several weeks later on July 7th. The small berm which consists almost entirely of vegetation (little or no peat included) is a typical feature of winter haul trails. It can be seen that a good deal of vegetation, particularly shrubs, was removed from the trail bed. Some areas were bladed completely bare. The condition of this trail, if it is not used again, will be interesting to follow and study in future years.

Photo 43: Same trail seen in photos 41 & 42 rephotographed on July 25th. Looking south.

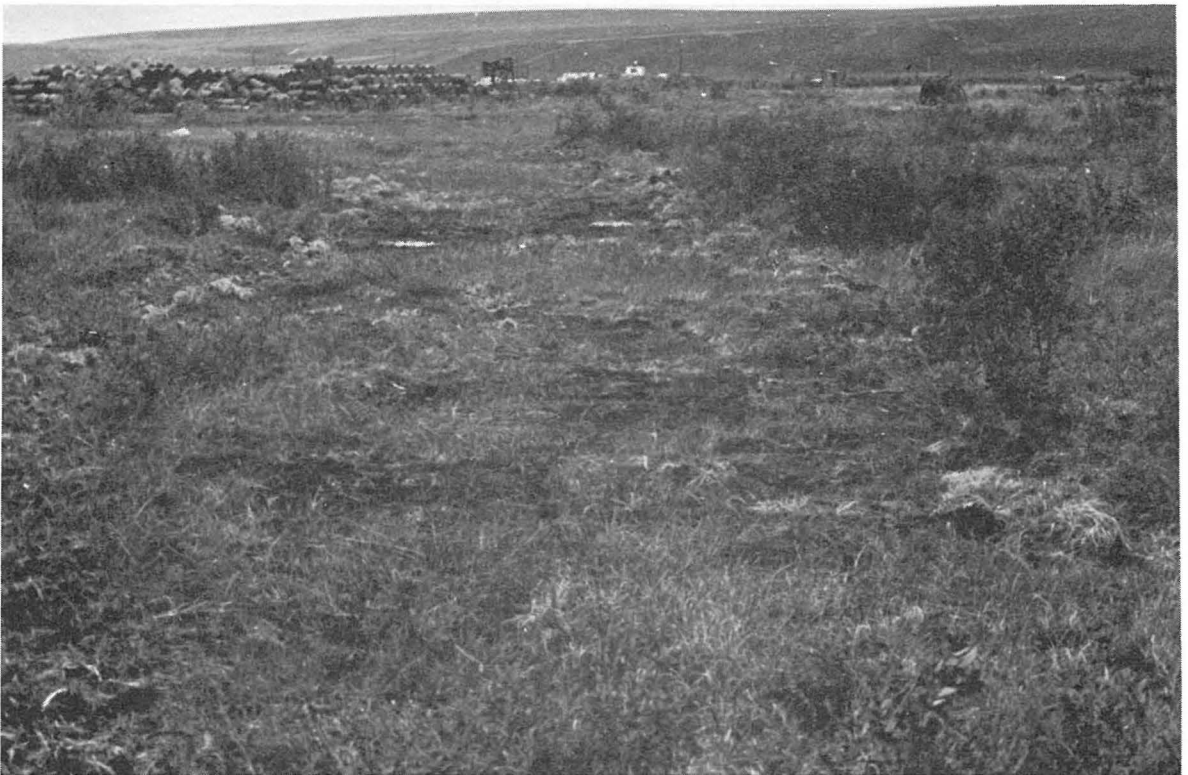
Photo 45: A bladed summer trail across tussock meadow, Umiat north ridge. 16-25 years old.

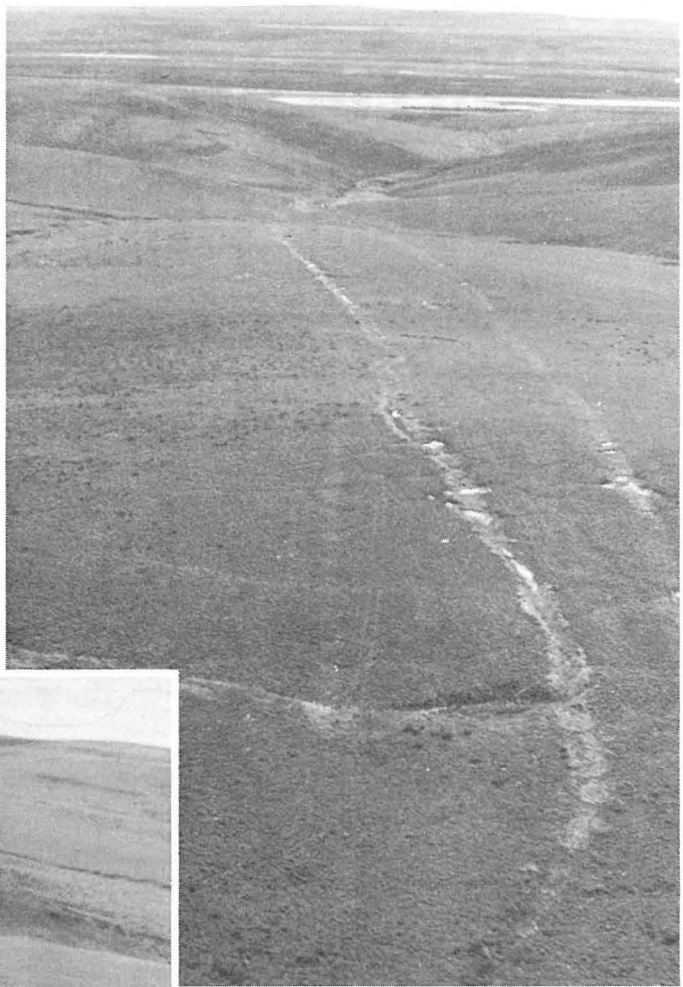
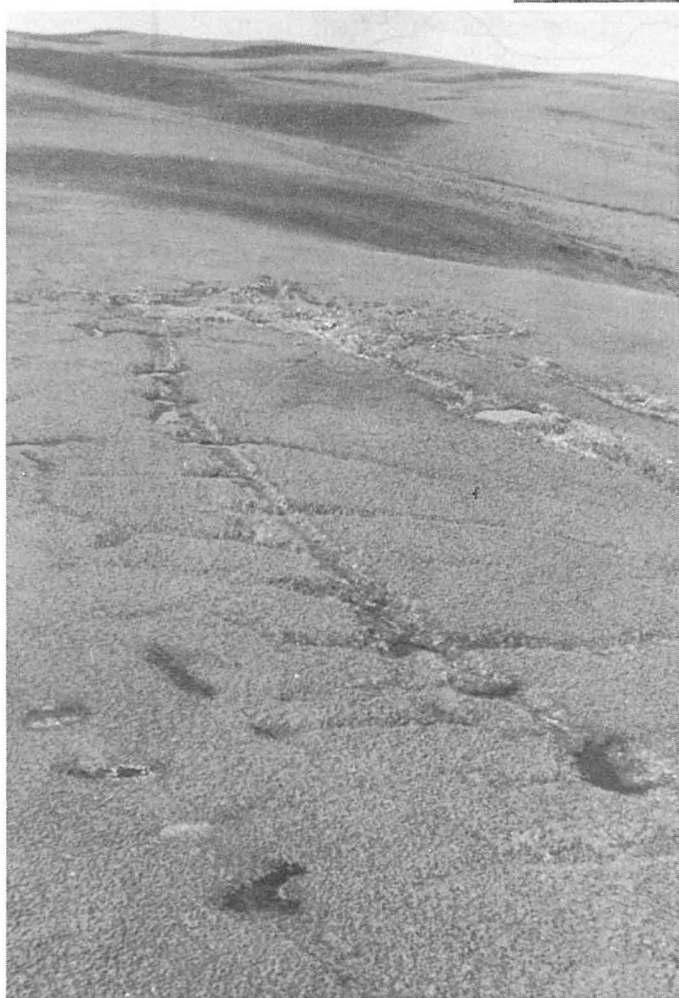
Photo 46: Bladed summer trails leading to an abandoned drilling site, Umiat north ridge. 16-25 years old.

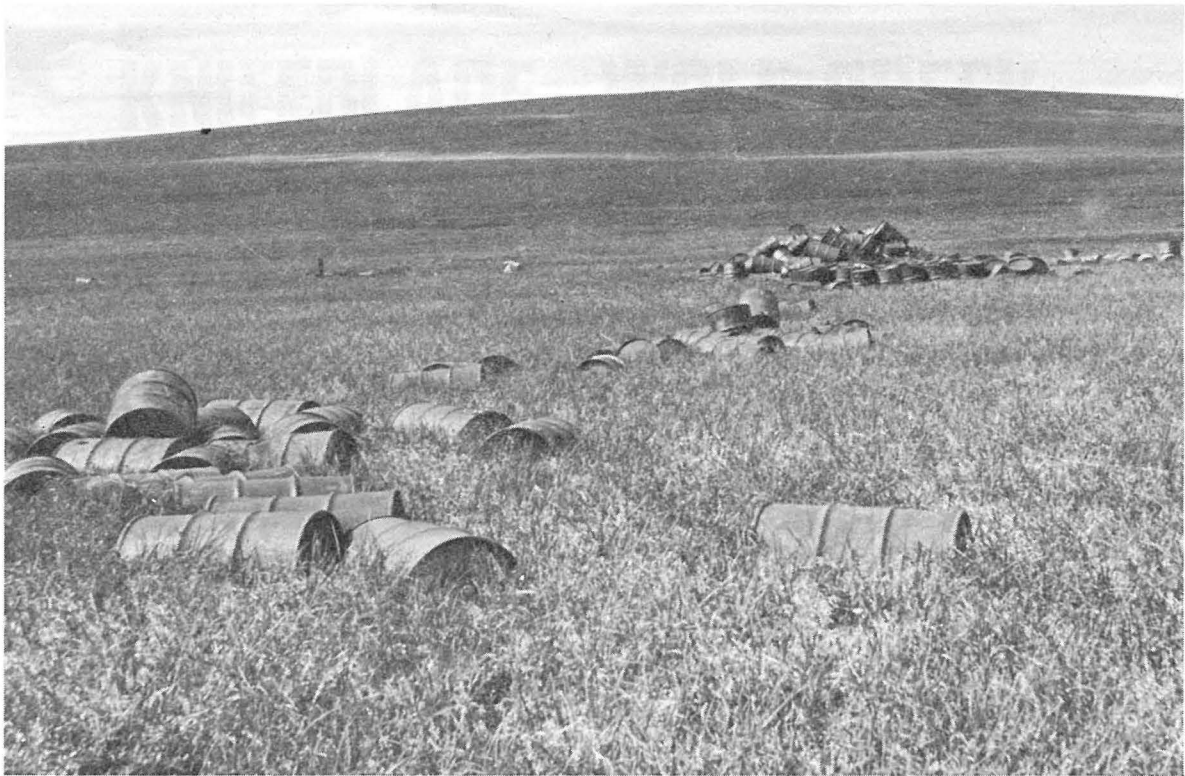
Of the three, it was possible to land only at Knifeblade. One of the three test holes at Knifeblade, situated in wet sedge meadow between two hills, is shown in photo 47. The vegetation around this test well shows little evidence of disturbance. One major trail exists at the Knifeblade site. This trail begins at the drill site shown in photo 47, climbs a gentle north facing slope which is covered with tussock meadow vegetation, crosses the top of the hill, and descends a dry, south facing slope which is covered with grass, low shrubs, cushion plants, and herbs. The photo sequence illustrates varied conditions along this trail. Photo 48 gives an overall view and photo 49 a detailed view of the north slope traversed by the trail. Photo 50 shows the trail bed on a wet portion of the hilltop. Photo 51 shows the trail on a dry part of the hilltop just prior to its descent to the south. Photos 52 and 53 were taken at progressively lower points on the dry south slope. Photo 54 shows the trail bed near the base of the slope. An aerial view of this trail, where it crosses the top of the hill, is provided in photo 55.

Photo 47: An abandoned test site at Knifeblade.

Photo 48: Bladed trail on wet, tussock slope to test well. 17 years old.
