A RECONNAISSANCE OF TRACTOR TRAILS AND RELATED PHENOMENA ON THE NORTH SLOPE OF ALASKA

JEROME R. HOK

1969

U.S. DEPARTMENT OF THE INTERIOR
BUREAU OF LAND MANAGEMENT

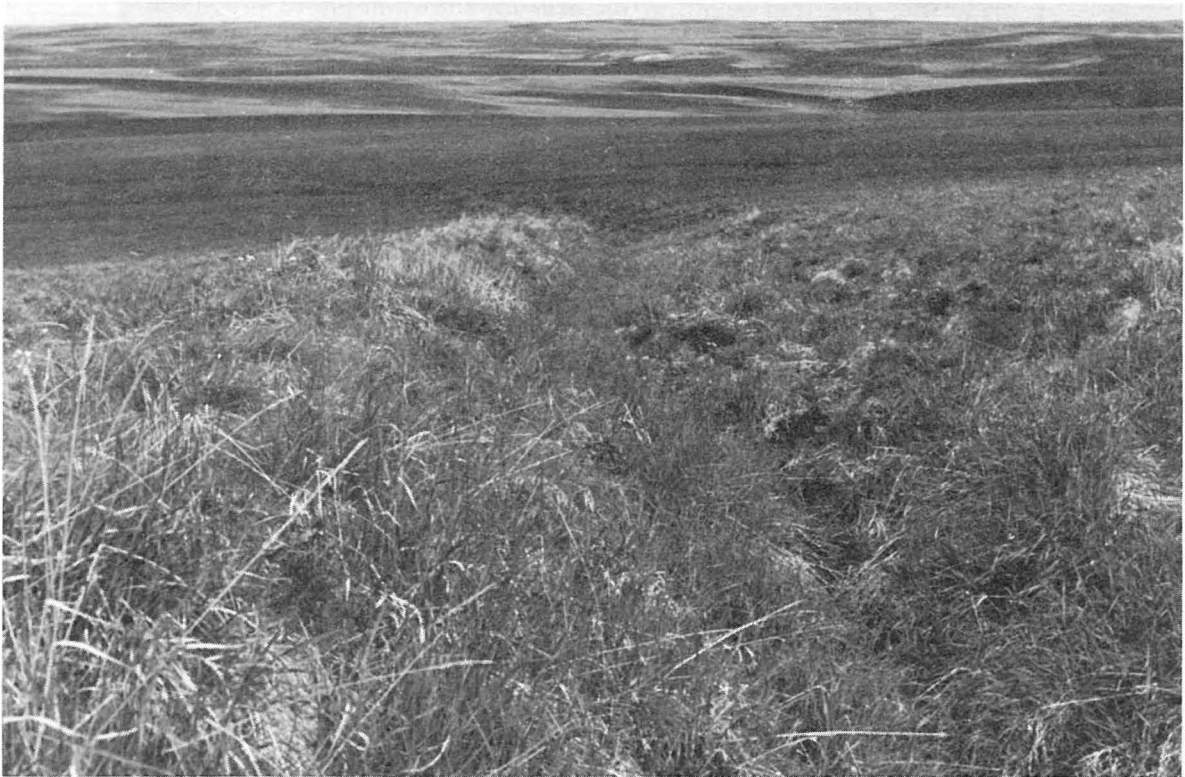
Photo 49: A close-up of unstable spot in bed of trail shown above.

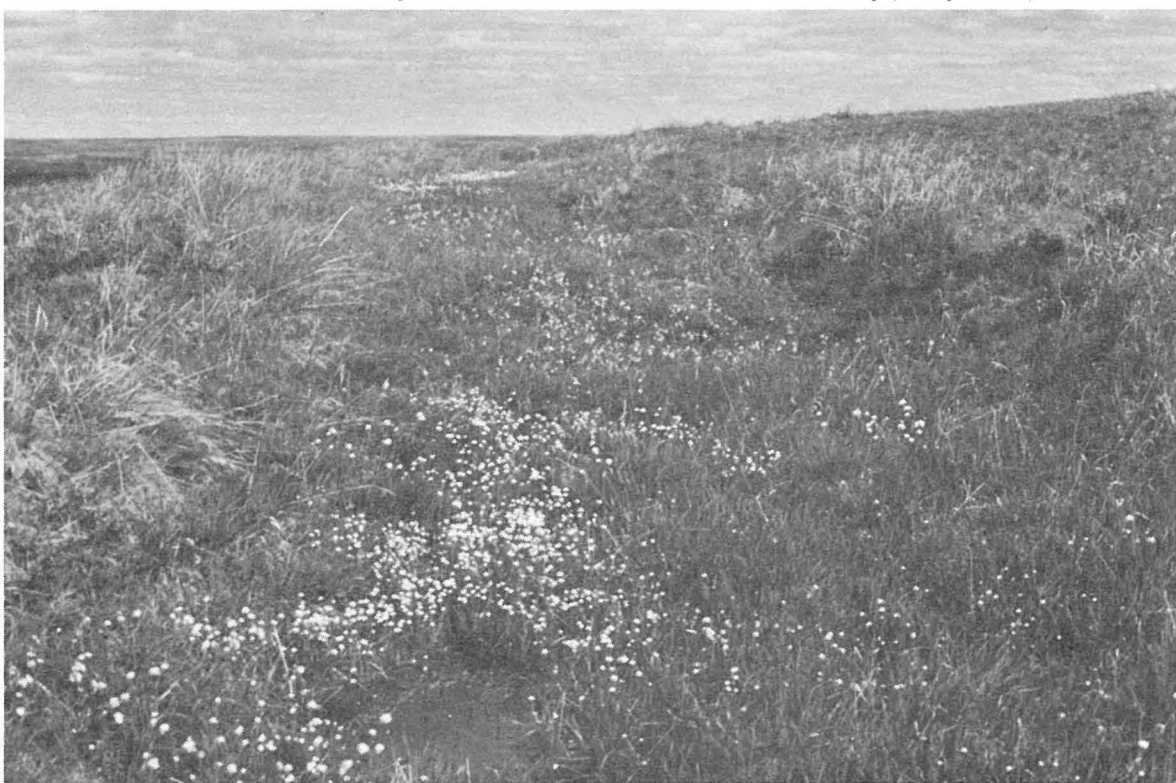
NORTH RIDGE: The conditions encountered on the ridge tops to the north of the Umiat camp area are quite different from the valley bottom. The old flood plain and wet sedge meadow community types of the low land are non-existent on these uplands. Instead one finds extensive tussock meadows which are occasionally broken by willow-choked drainage channels. Photos 45 and 46 illustrate bladed summer trails on level, tussock meadow vegetation. The richer green color of the trail beds is due to the predominance of individual shoots of an aquatic sedge which lack the brown component of the adjacent tussocks (a ground view of this is provided in photo 50).

Photo 50: Trail seen in photos 48 & 49 where it reaches level hill top (wet portion).

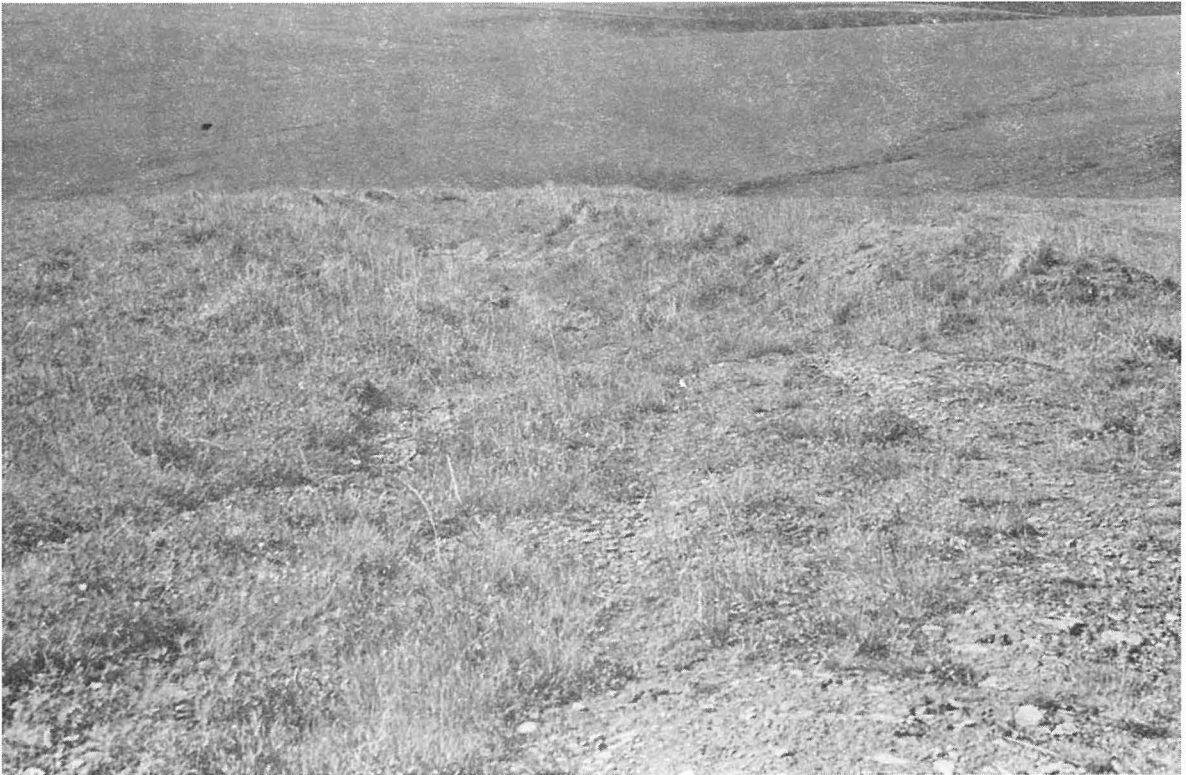
Photo 51: Same trail on dry portions of hill top.

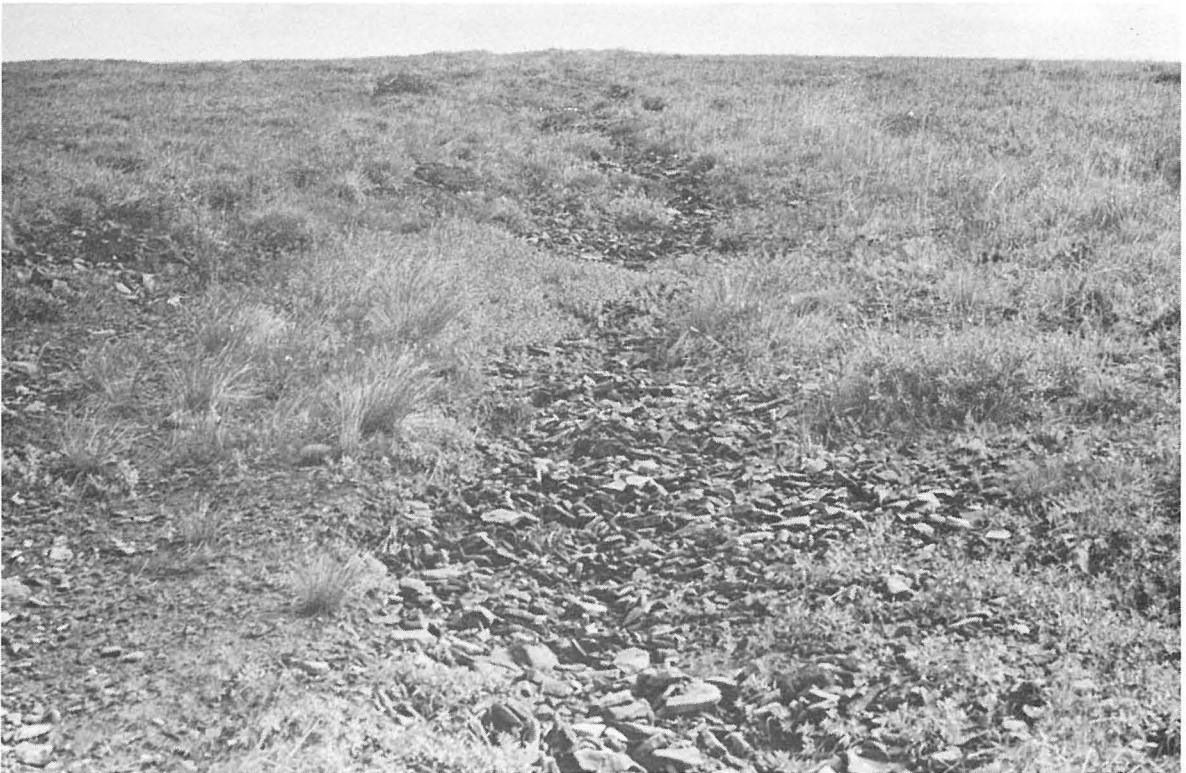
Photo 52: Continuation of trail seen on the preceding pages. Here seen descending a dry slope.

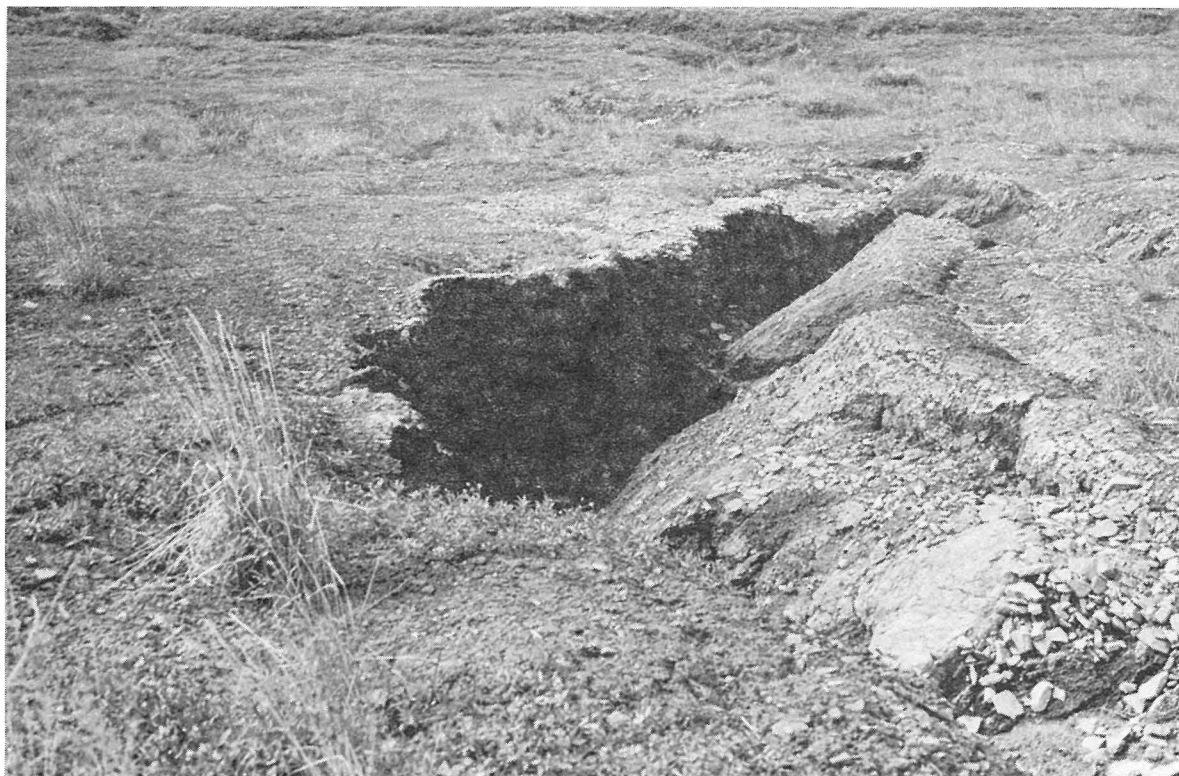
Photo 53: Same trail as above, farther down slope.

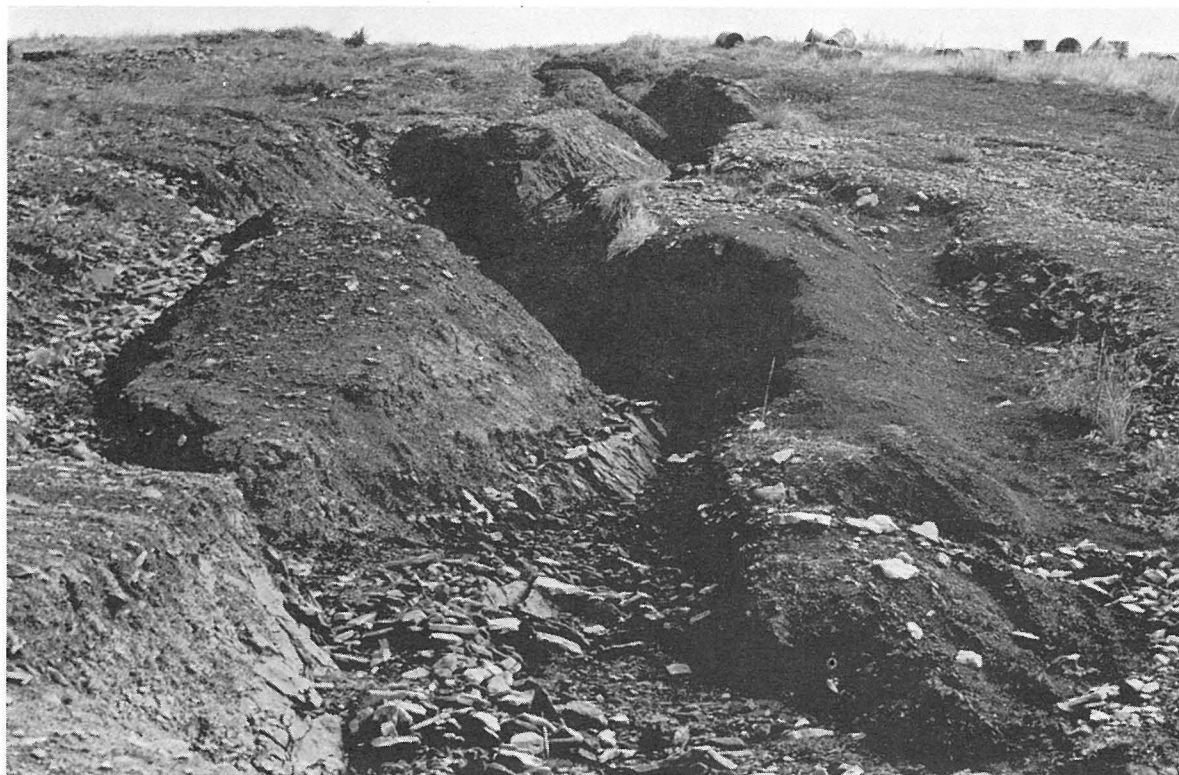
Photo 54: An upslope view of the preceding trail from the base of the hill. 17 years since disturbance.

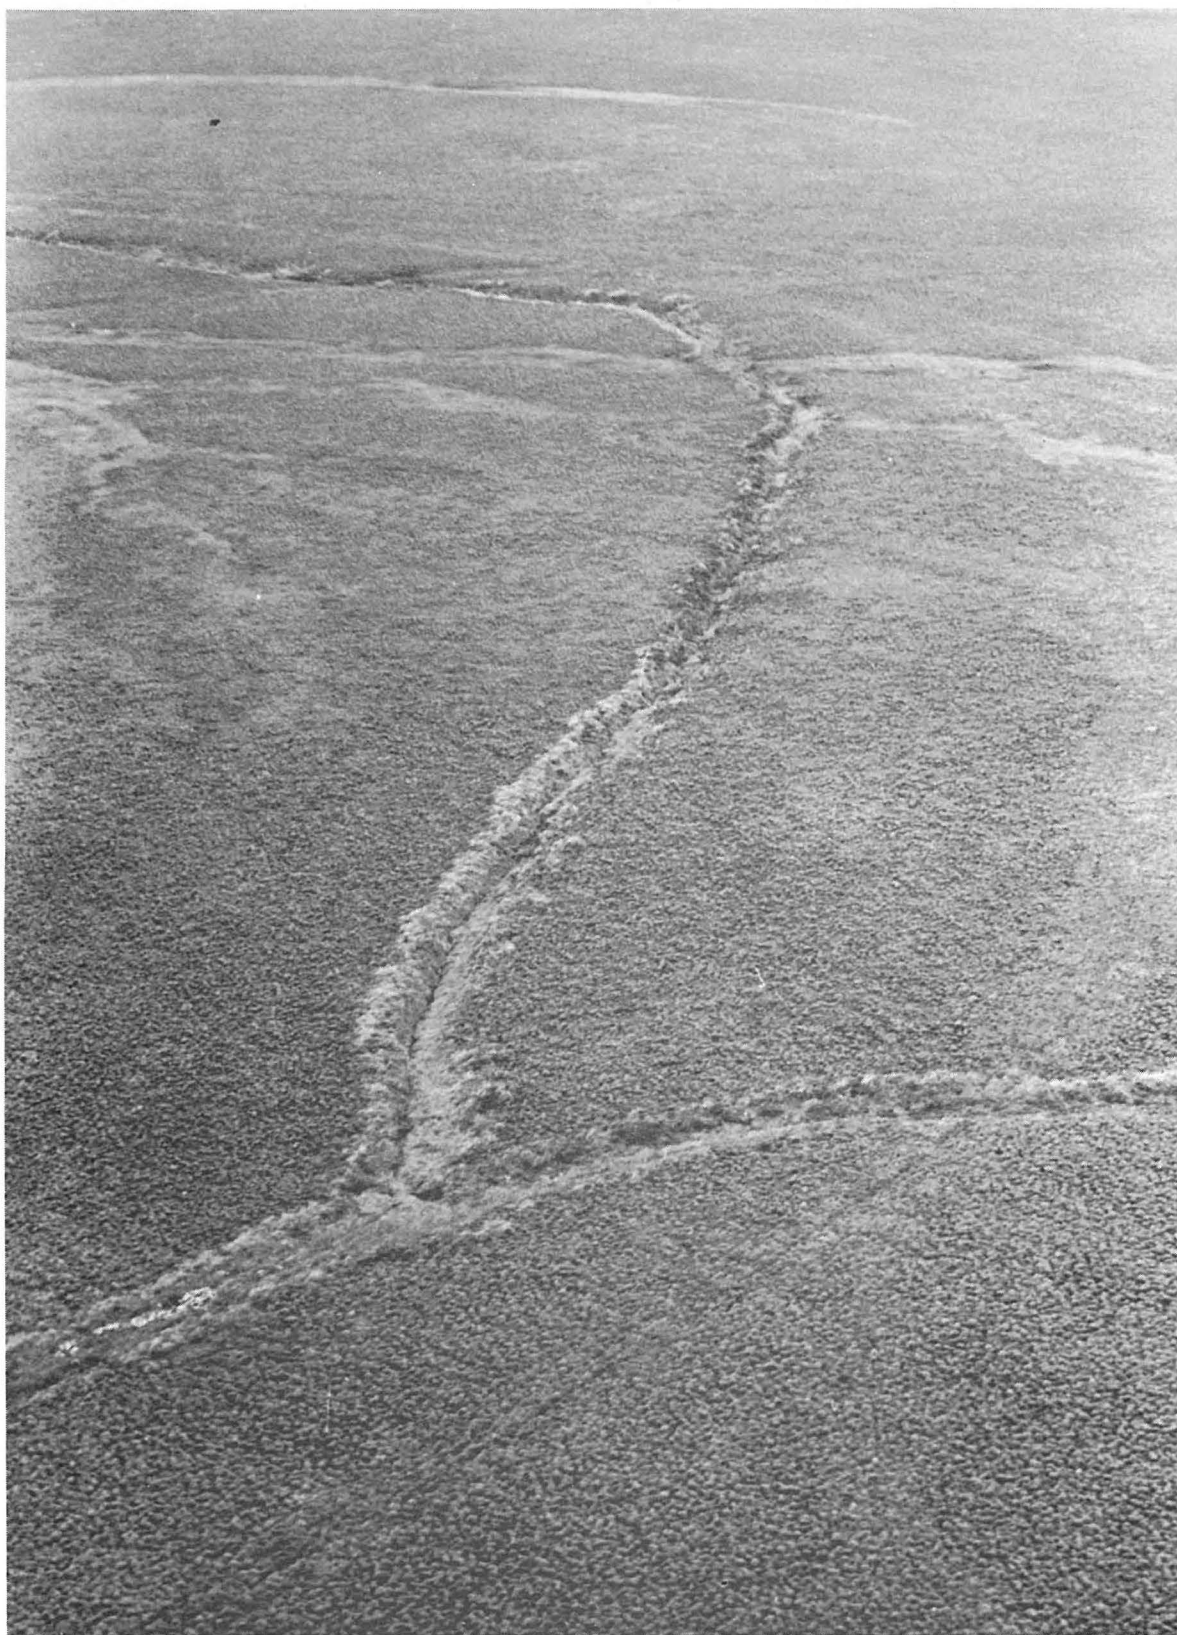
Of the three, it was possible to land only at Knifeblade. One of the three test holes at Knifeblade, situated in wet sedge meadow between two hills, is shown in photo 47. The vegetation around this test well shows little evidence of disturbance. One major trail exists at the Knifeblade site. This trail begins at the drill site shown in photo 47, climbs a gentle north facing slope which is covered with tussock meadow vegetation, crosses the top of the hill, and descends a dry, south facing slope which is covered with grass, low shrubs, cushion plants, and herbs. The photo sequence illustrates varied conditions along this trail. Photo 48 gives an overall view and photo 49 a detailed view of the north slope traversed by the trail. Photo 50 shows the trail bed on a wet portion of the hilltop. Photo 51 shows the trail on a dry part of the hilltop just prior to its descent to the south. Photos 52 and 53 were taken at progressively lower points on the dry south slope. Photo 54 shows the trail bed near the base of the slope. An aerial view of this trail, where it crosses the top of the hill, is provided in photo 55.

Photo 55: An aerial view of an intersection of trails at crest of hill. 17 years old.

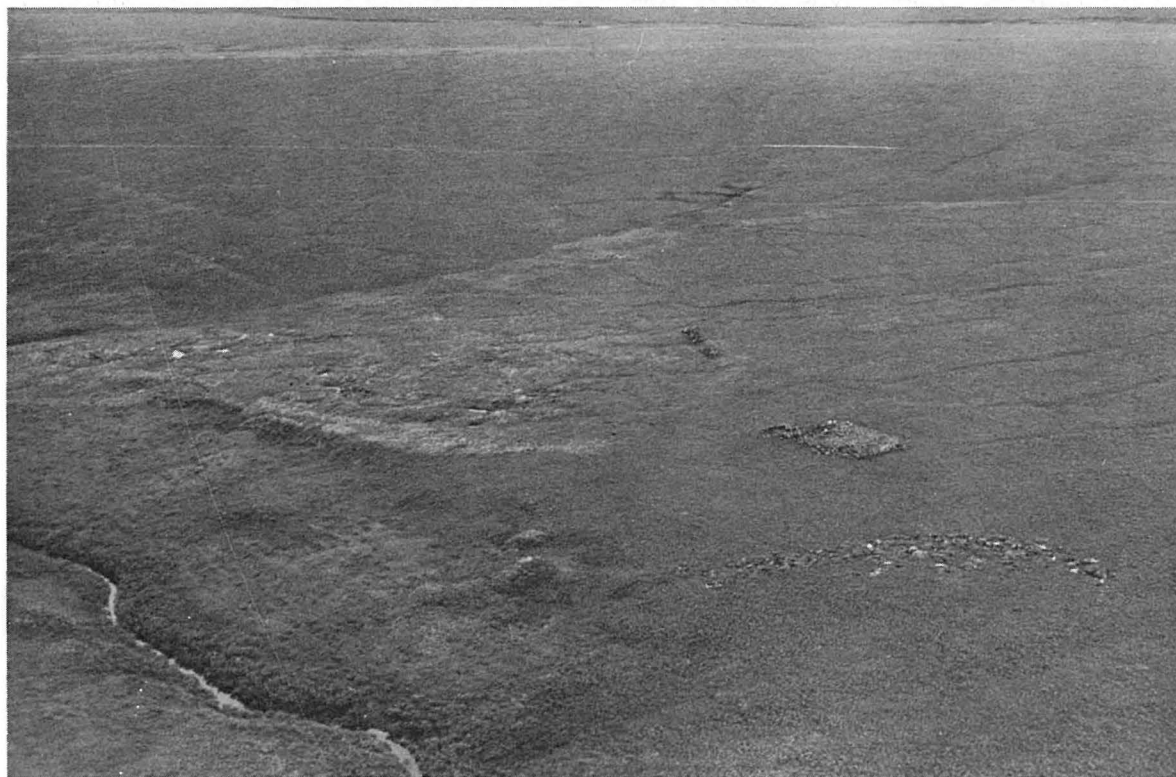
The Wolf Creek and Square Lake sites were not inspected on the ground, but are seen from the air in photos 56 and 57 respectively. Several very prominent trails are present at Wolf Creek (photo 58) a summer operation, but none are apparent at Square Lake, a winter site.

Photo 57: Aerial view of Square Lake test site. 17 years old.

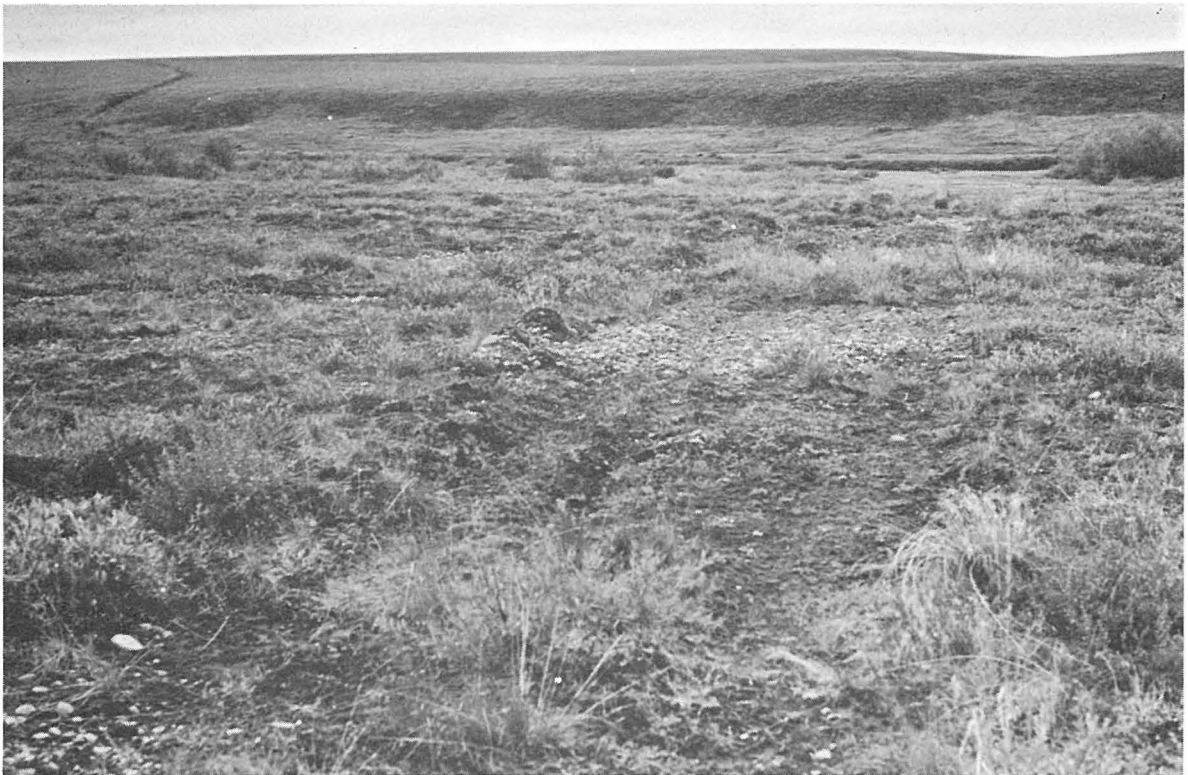
Two broad views of this trail are shown (photos 59 and 60) as it crosses a rolling tussock meadow, descends to the Toolik River, and continues on across a flat, well-drained flood plain. A cross section of the ice-rich slope which the trail descends, was viewed at a nearby natural slump (photo 61). At the upper center of photo 61 the thin layer of soil and vegetation can be seen covering frozen ground.

Photo 59: Bladed summer trail as it descends ice-rich, tussock covered slope. (Age unknown)

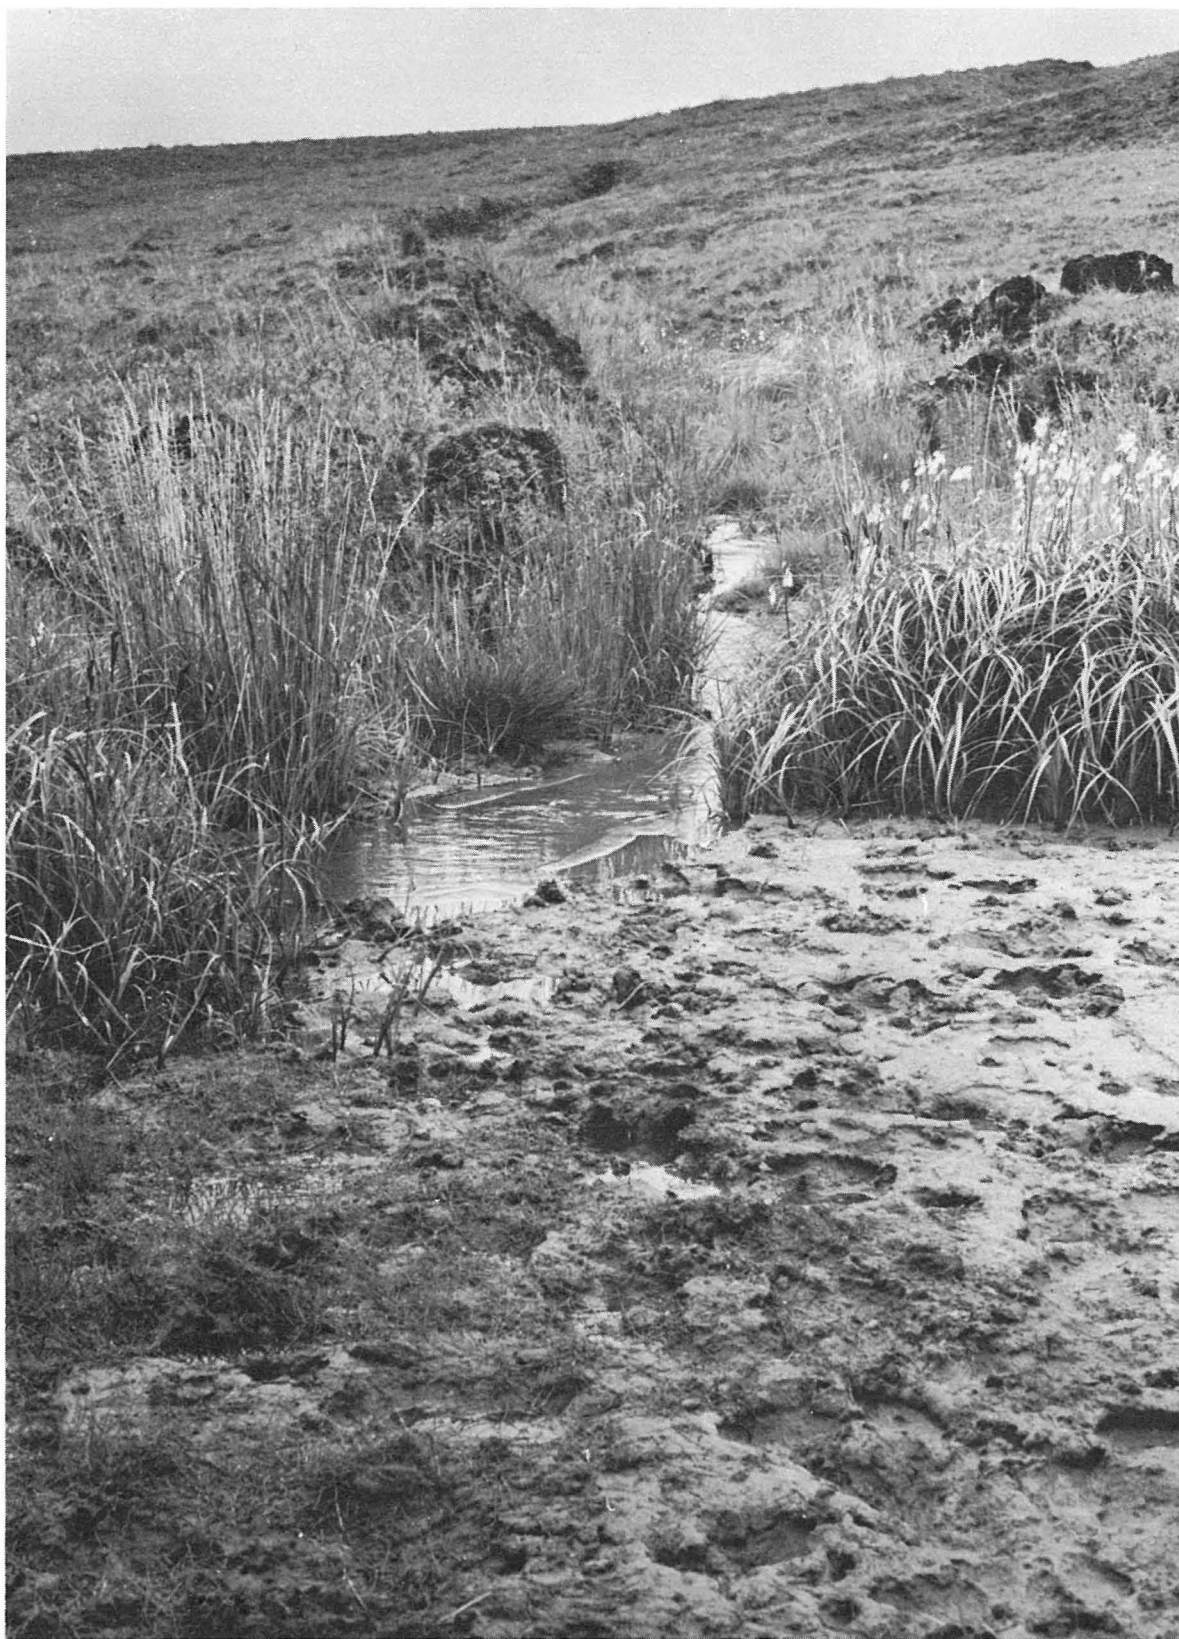
Photo 62: Summer trail as it leaves floodplain and crosses the Toolik River.

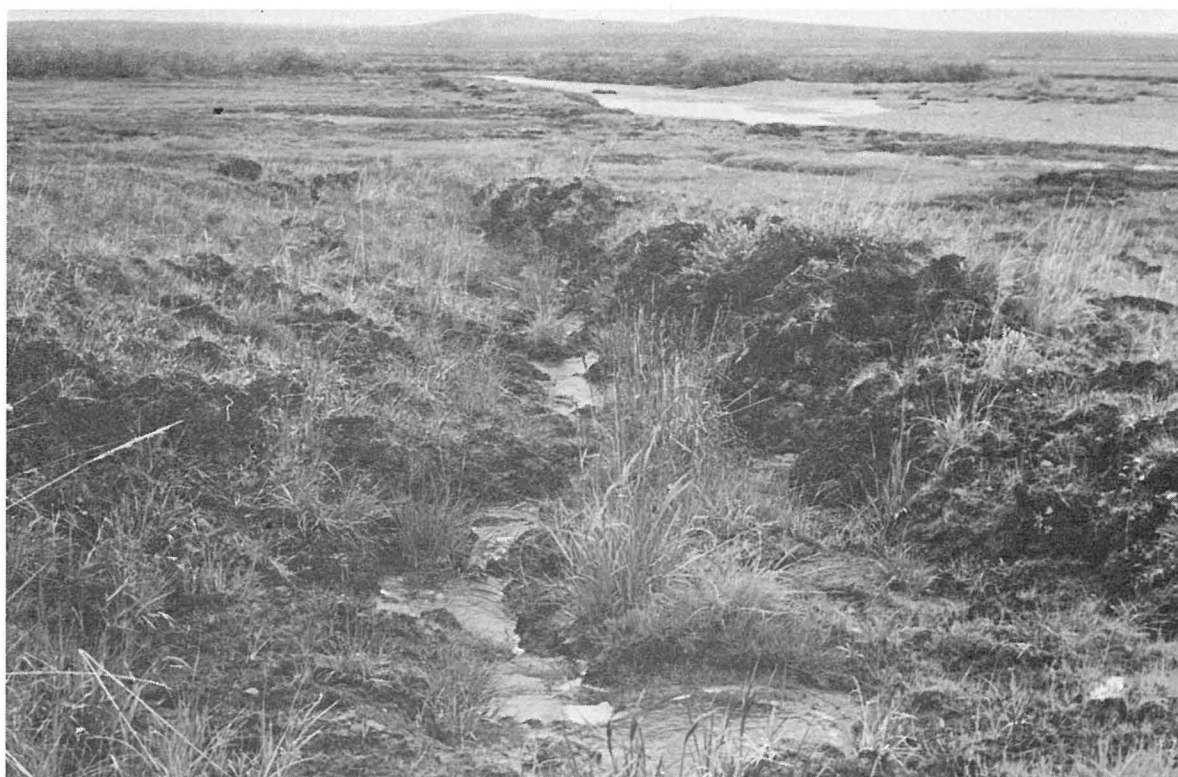
Photo 63: Depositional area at base of eroding slope where trail begins to ascend.

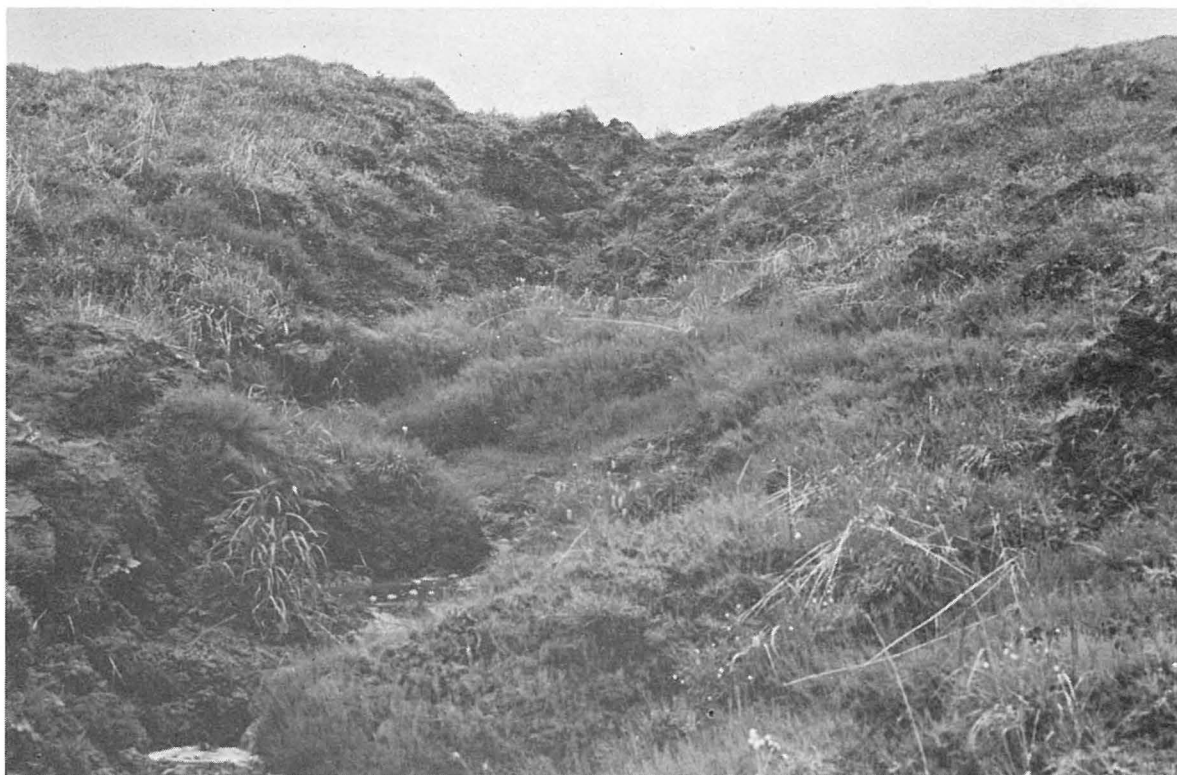
Photo 64: A view downhill of the unstable, sloping portion of the trail.

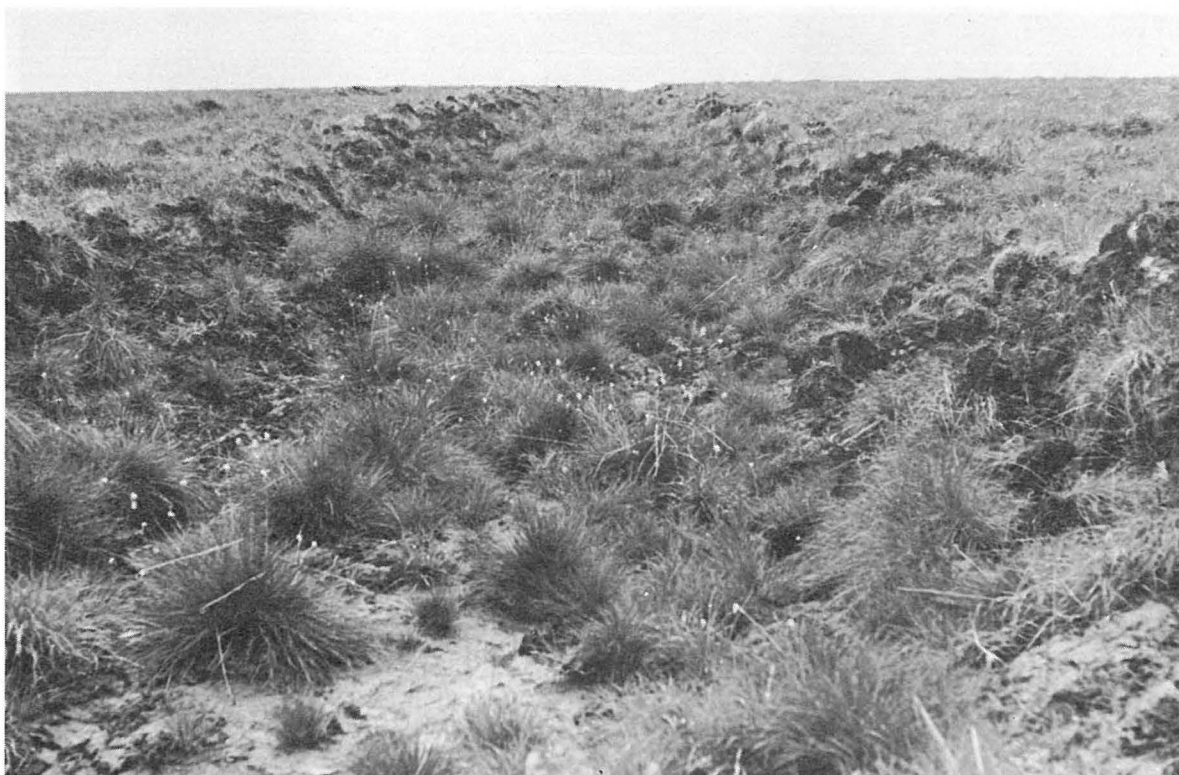
Photo 65: An uphill view at the upper end of the sloping portion of the trail.

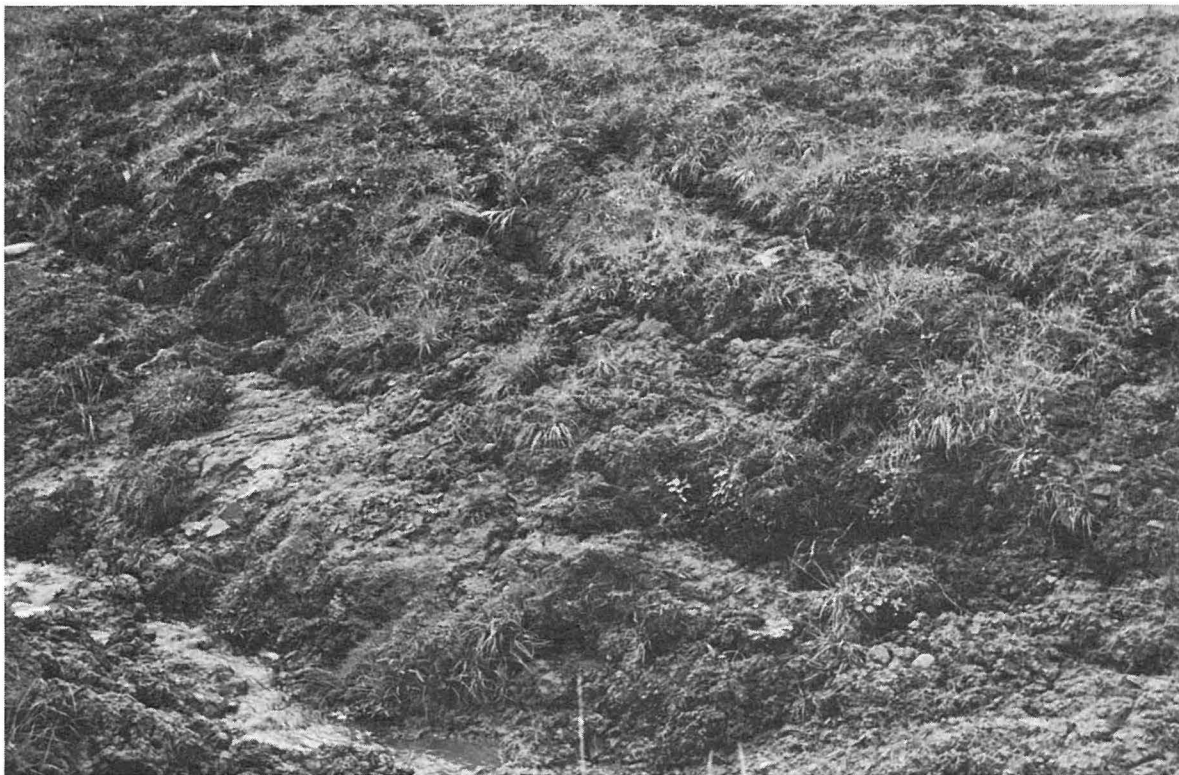
Perhaps the best indications of what originally occurred can be seen (photo 66) where erosion has not obliterated the original trail. The trail margins are formed by two small but distinct berms, each consisting of dead vegetation and a small amount of soil. In the trail bed the scattered tussocks appear more youthful (little or no accumulation of dead basal material) than those of adjacent areas. Present information indicates that this trail was created during the winter of 1968-69 in the process of moving a drill rig. (Brewer, 1971. Personal communication.)

Photo 66: The trail on nearly level ground above the previously seen sections.

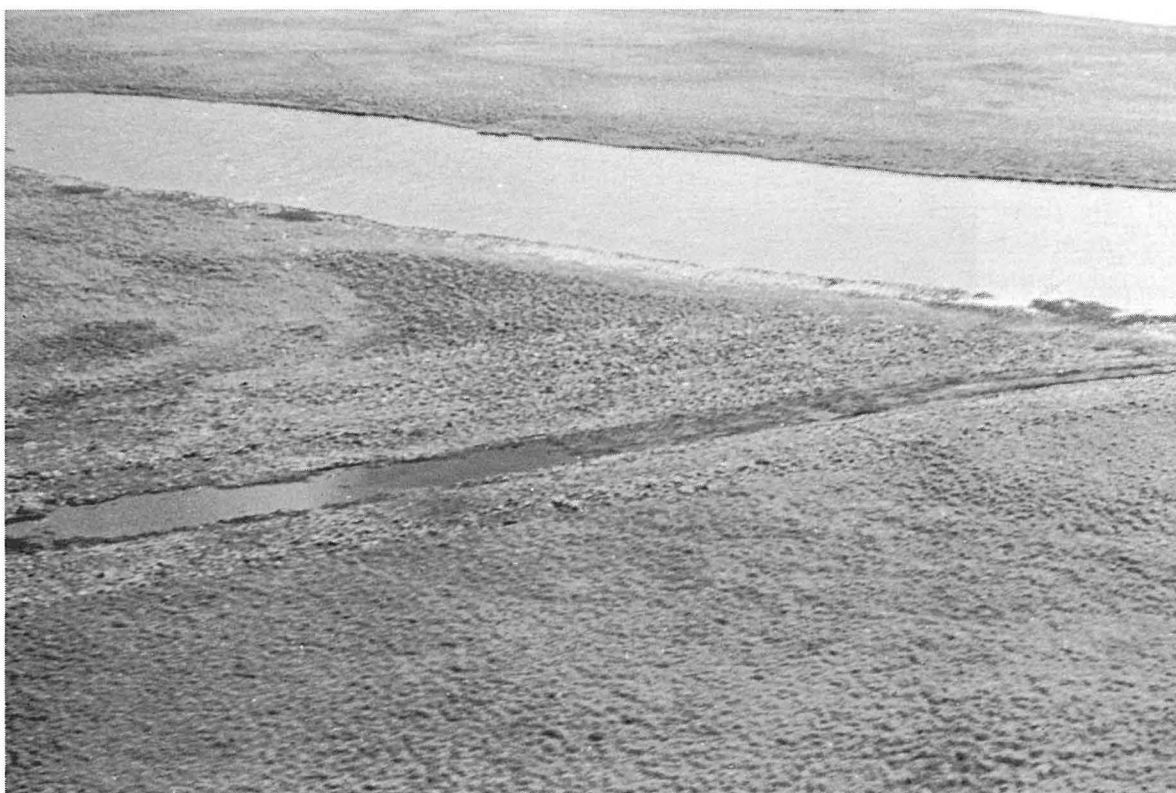
It is interesting to note in photos 70 and 71 (bladed winter trail) that the areas immediately adjacent to the actual road-bed, presumably where snow was heaped and packed while keeping the road open, have the same appearance as the packed-snow trail beds in photos 72 and 73. The cause of this phenomenon is probably a combination of mechanical pressure and shortened growing season (due to late melting of the packed areas). (Wiggins & Thomas -- 1962: 28-29)

Photos 70 & 71: Bladed winter trail. Winter 1968-69.

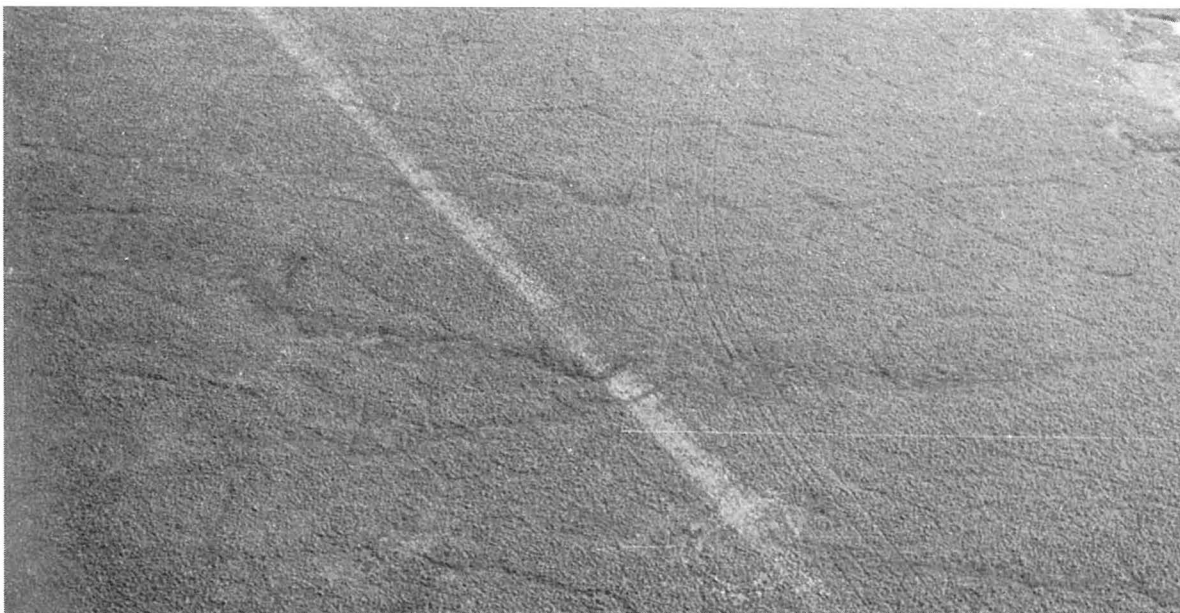
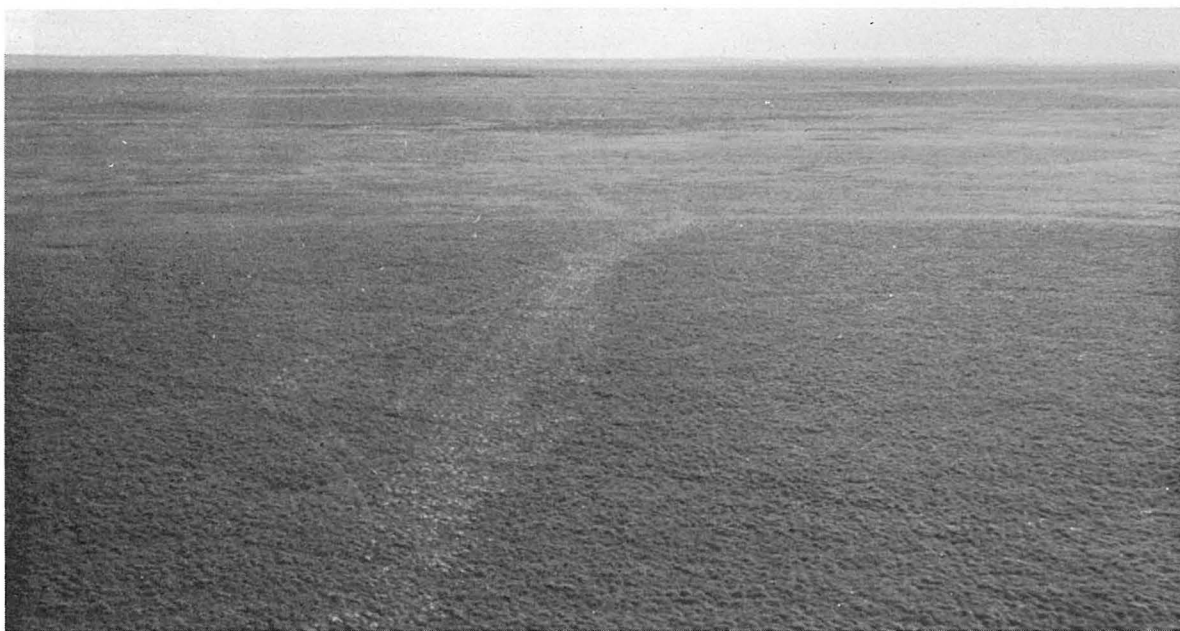
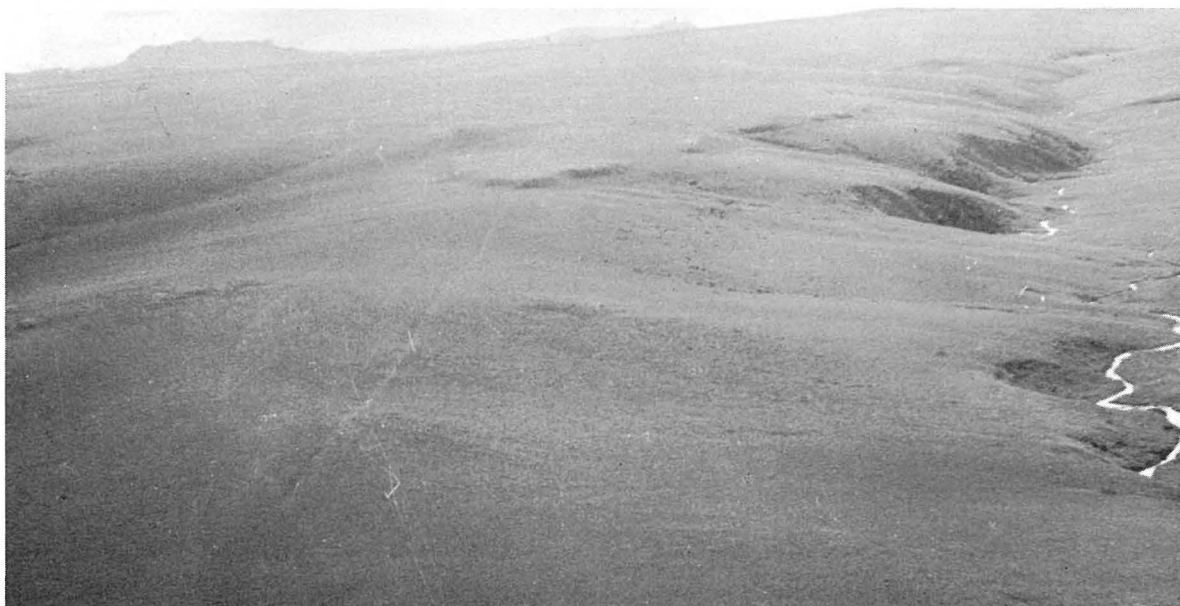
Photos 72, 73, 74: Packed-snow winter trails. About 20 years old.
