## Susitna-Watana Hydroelectric Project Document ARLIS Uniform Cover Page

| <b>Title:</b><br><br>Geomorphology study, Study plan Section 6.5, 2014-2015 Study Implementation Report. Appendix A. Susitna River upper river reconnaissance photographs | | <b>SuWa 289</b> |

## APPENDIX A: SUSITNA RIVER UPPER RIVER RECONNAISSANCE PHOTOGRAPHS

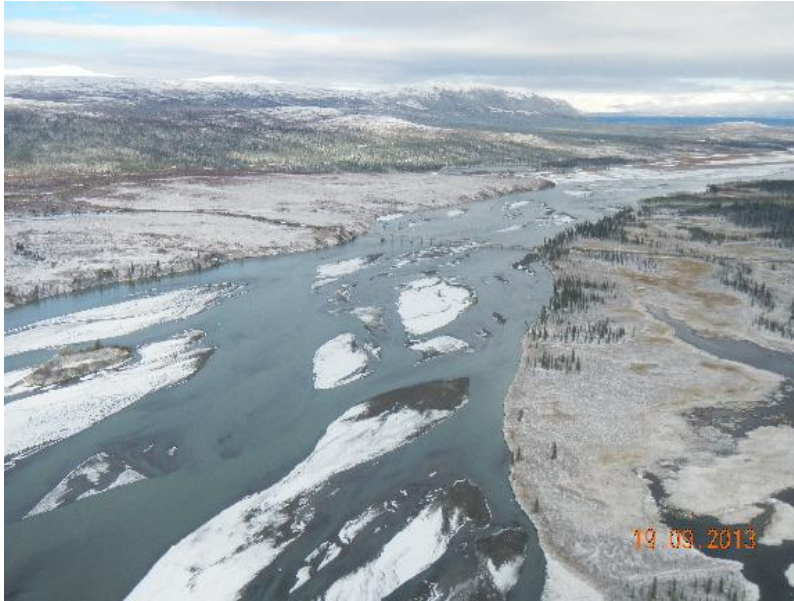
Figure A.1-1 – View upstream towards Denali Highway Bridge at PRM 292 (P5580)<sup>1</sup>.

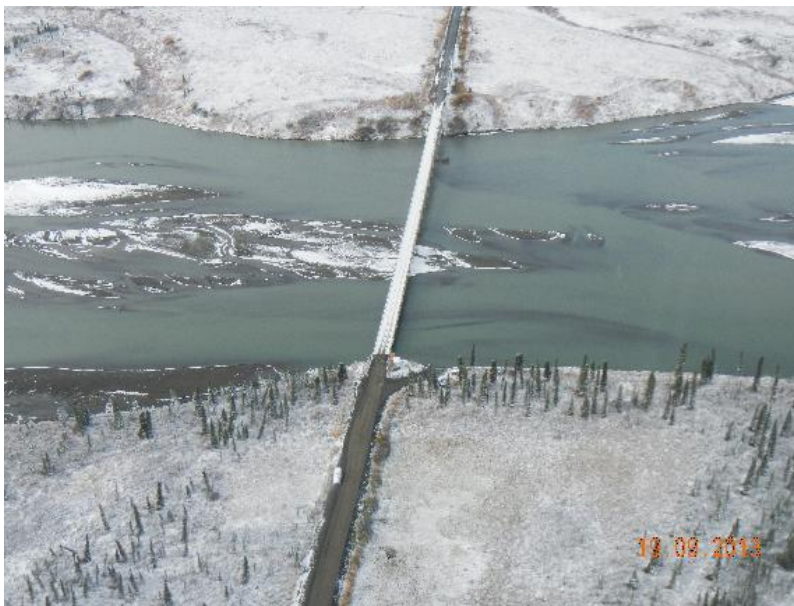
Figure A.1-2 – View east of Denali Highway Bridge at PRM 292. Susitna River, flow from right to left (P5582).

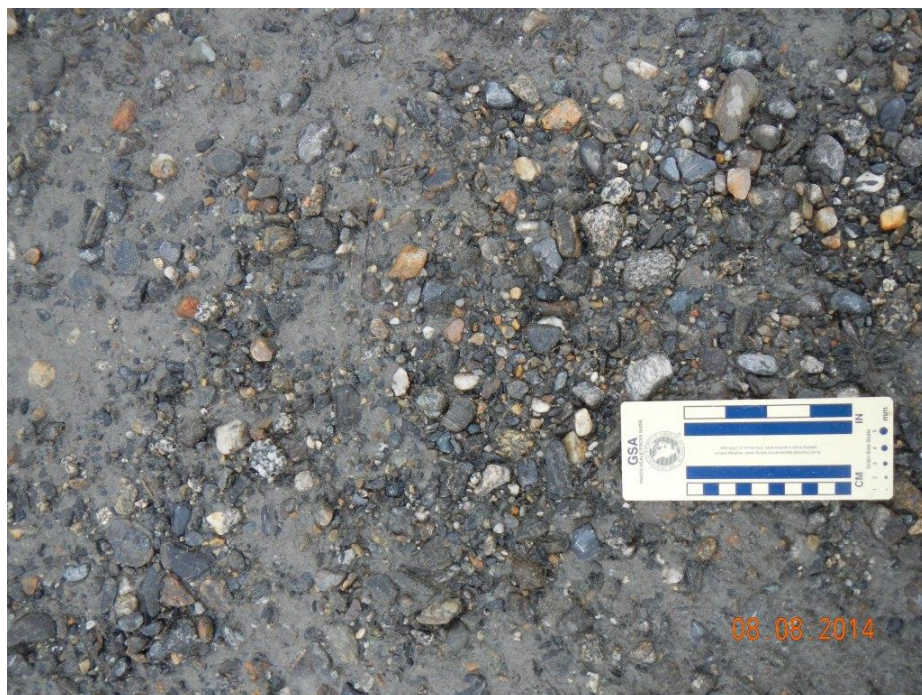
**Figure A.1-3 – Surface material on mid-channel bar near PRM 291. Largest bar head particle diameter (b-axis) approximately 22mm (P774).**

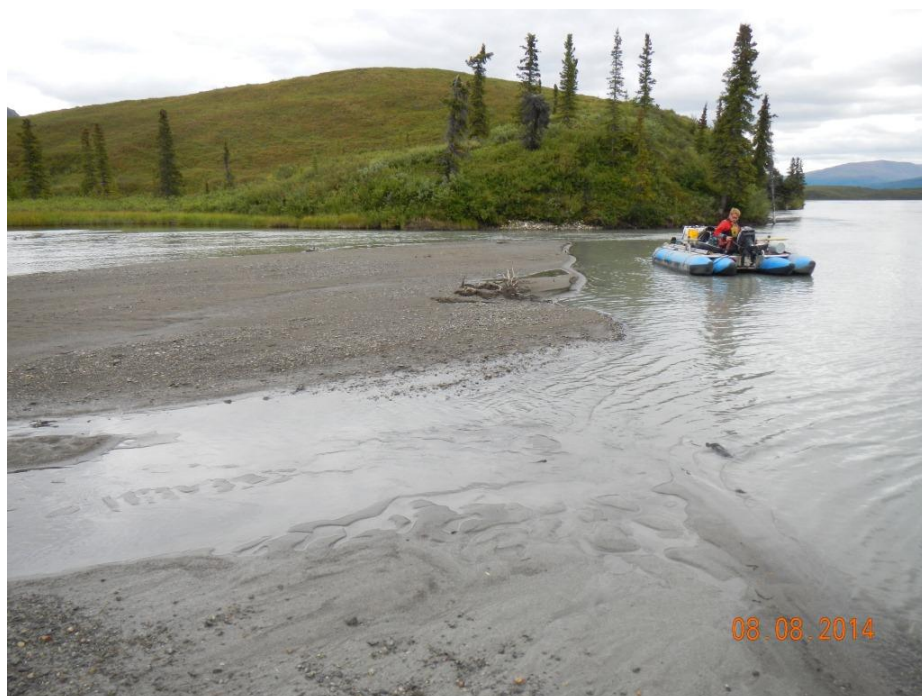
**Figure A.1-4 – View of mid-channel bar near PRM 291 (P775).**

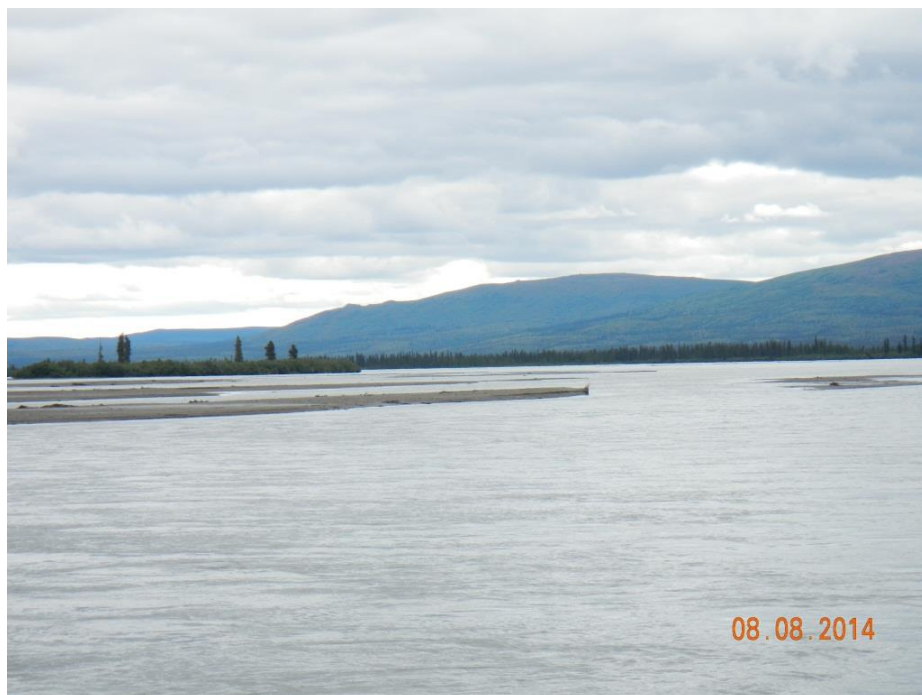
**Figure A.1-5 – View of flow expansion zone and low relief mid-channel sand bars near PRM 288 (P805).**

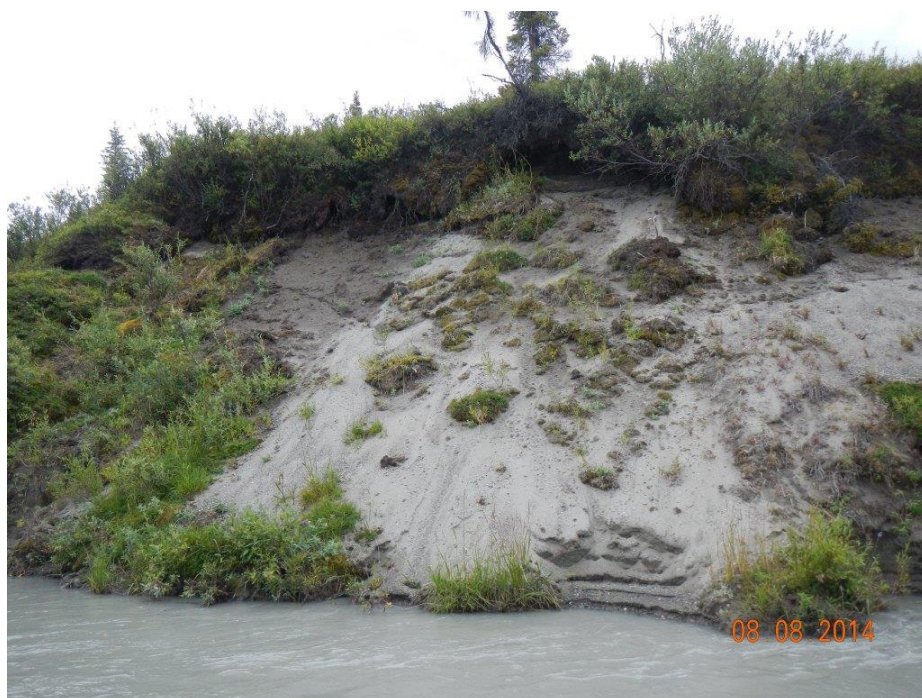
**Figure A.1-6 – Local sediment source (sand) at PRM 286– terrace erosion (P871).**

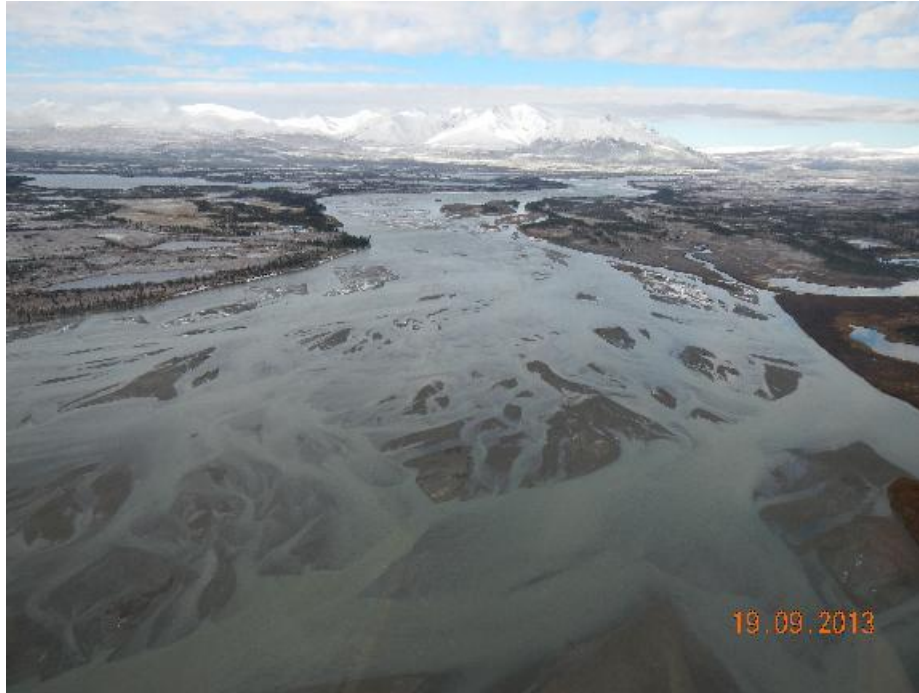
**Figure A.1-7 – View upstream near PRM 281. Note very wide channel and extensive sandy braid bars (P5570).**

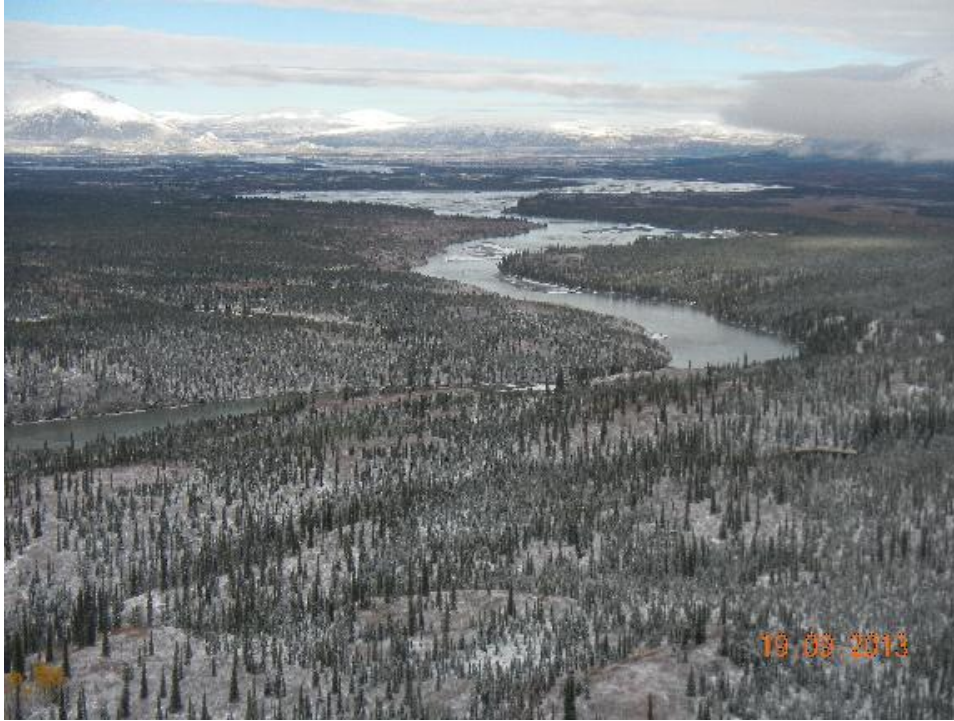
**Figure A.1-16 – View upstream at PRM 274. Forced sinuosity due to presence of tills and bedrock (P5559).**

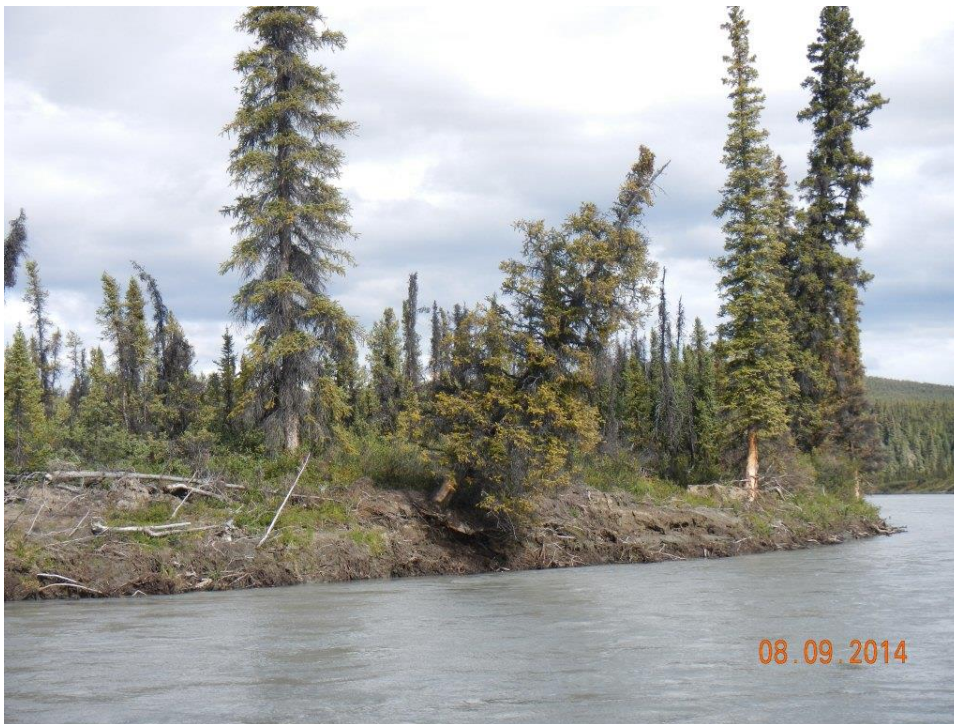
**Figure A.1-17 – Bank effects of ice processes – tree scars and some erosion, vegetation push near PRM 272.5 (P992).**

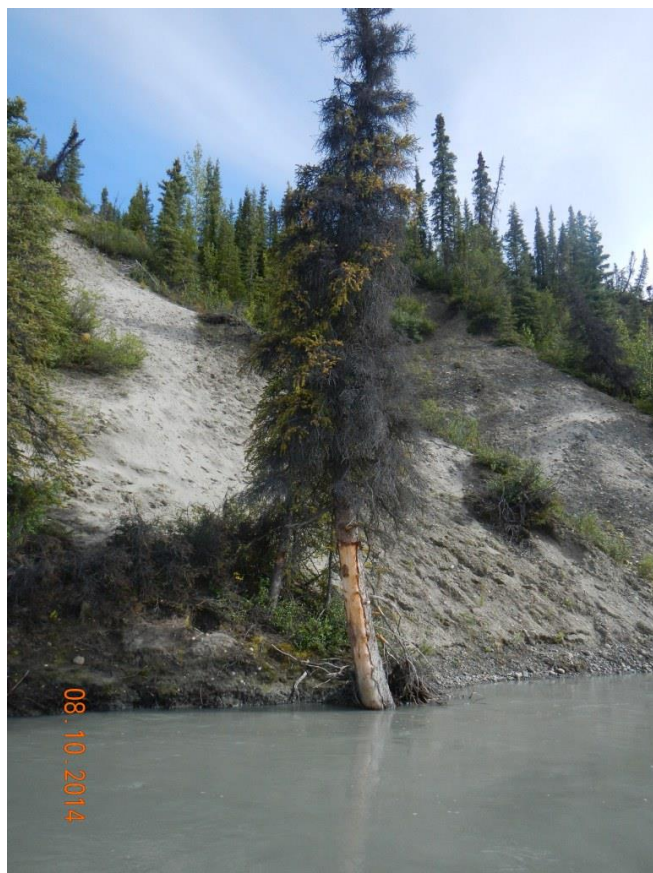
**Figure A.1-20 – Ice scarred tree and eroding moraine at PRM 269 (P038).**

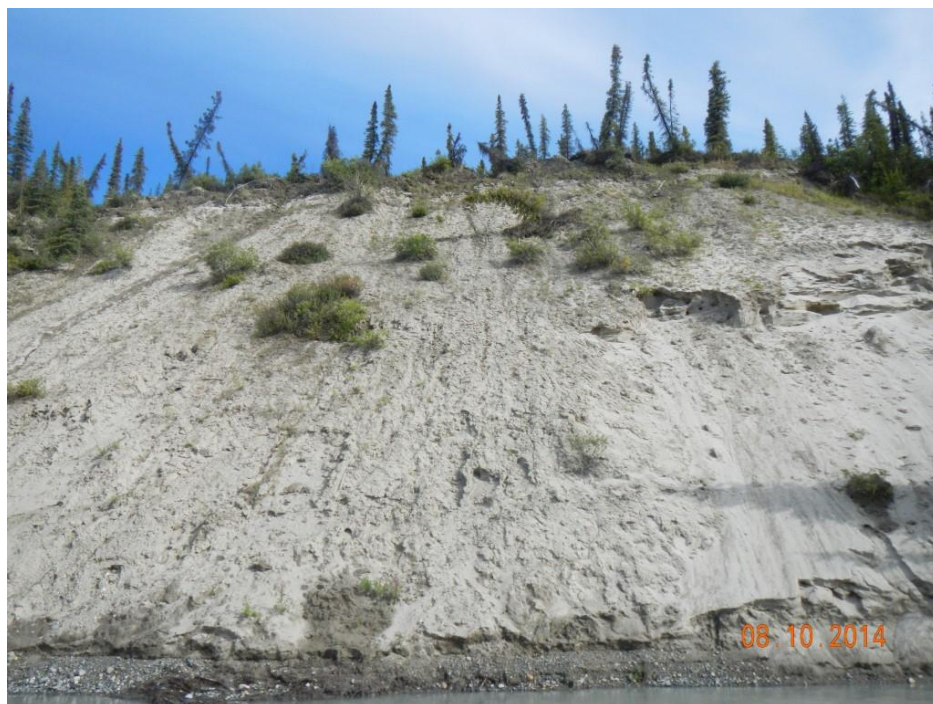
**Figure A.1-21 – Local sediment source – rill erosion moraine surface near PRM 269 (P040).**

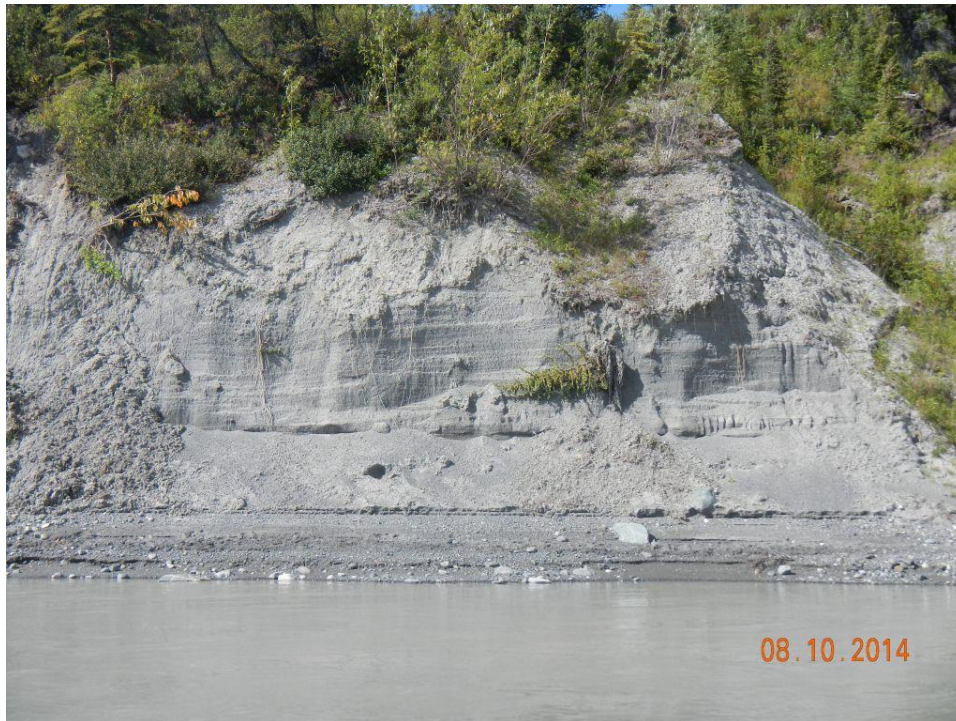
**Figure A.1-38 – Eroding outwash terrace surface near PRM 261.5– topsets visible in profile (P176).**

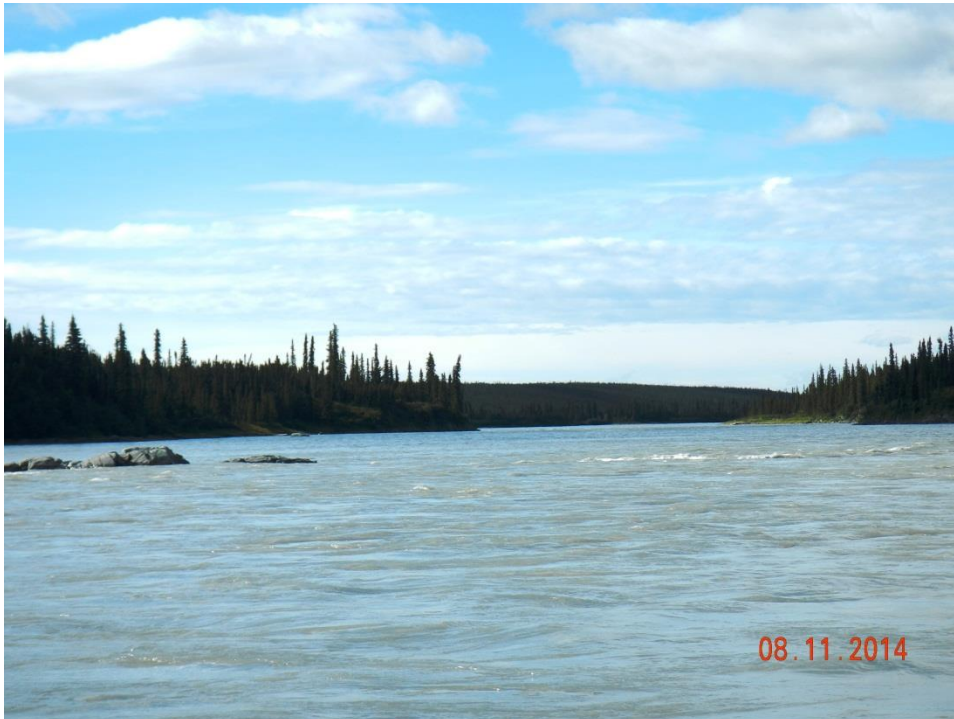
**Figure A.2-10 - Bedrock sill across the river at PRM 255.4 (P273).**

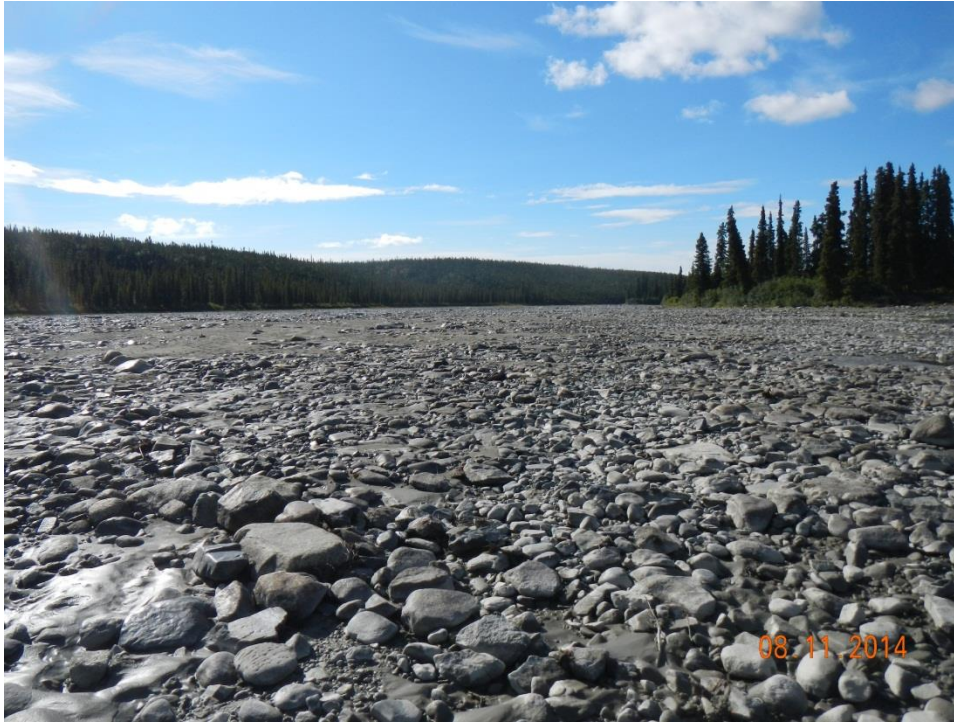
**Figure A.2-11 – Armored, ice driven side channel at PRM 254.5 (P293).**

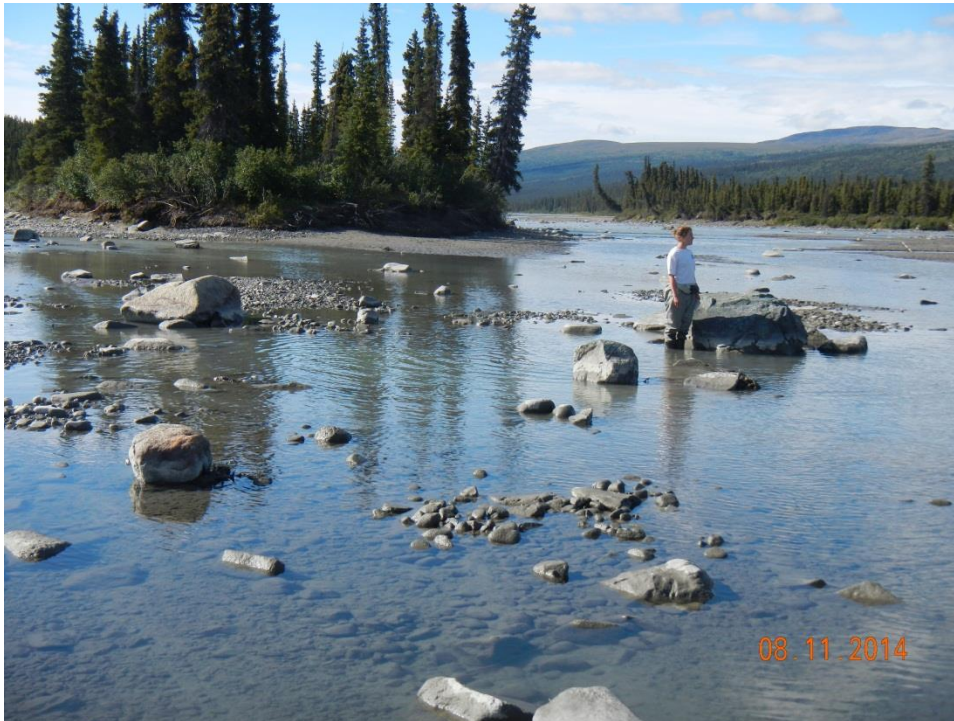
**Figure A.2-12 – Large boulders in ice driven side channels near PRM 254.5 (P314).**

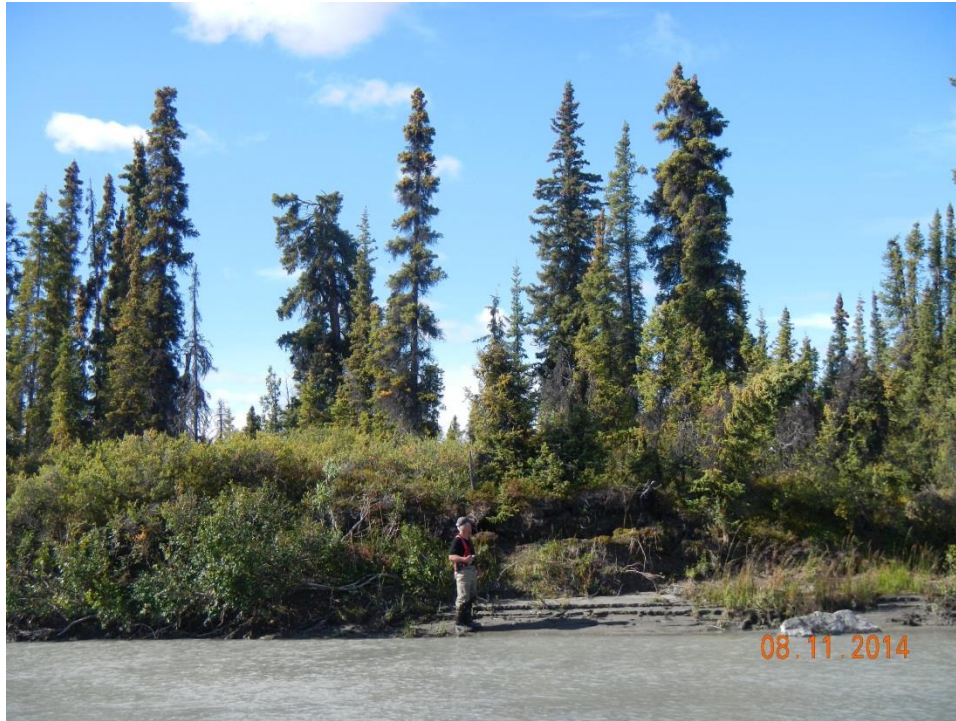
**Figure A.2-15 – Terrace elevation mid-channel islands in expansion zone at PRM 254 are typical terrace heights – note person standing in foreground for scale (P319).**

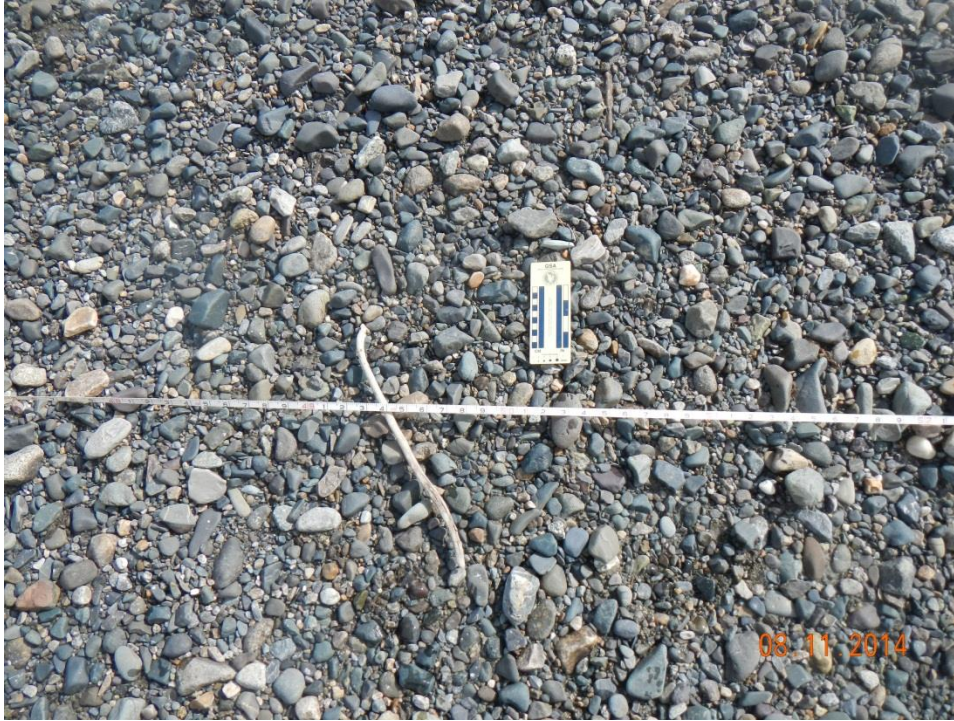
**Figure A.2-19 – Surface material on bar surface at PRM 250.9. Median particle diameter ( $D_{50}$ ) is 30.0 mm (P425).**

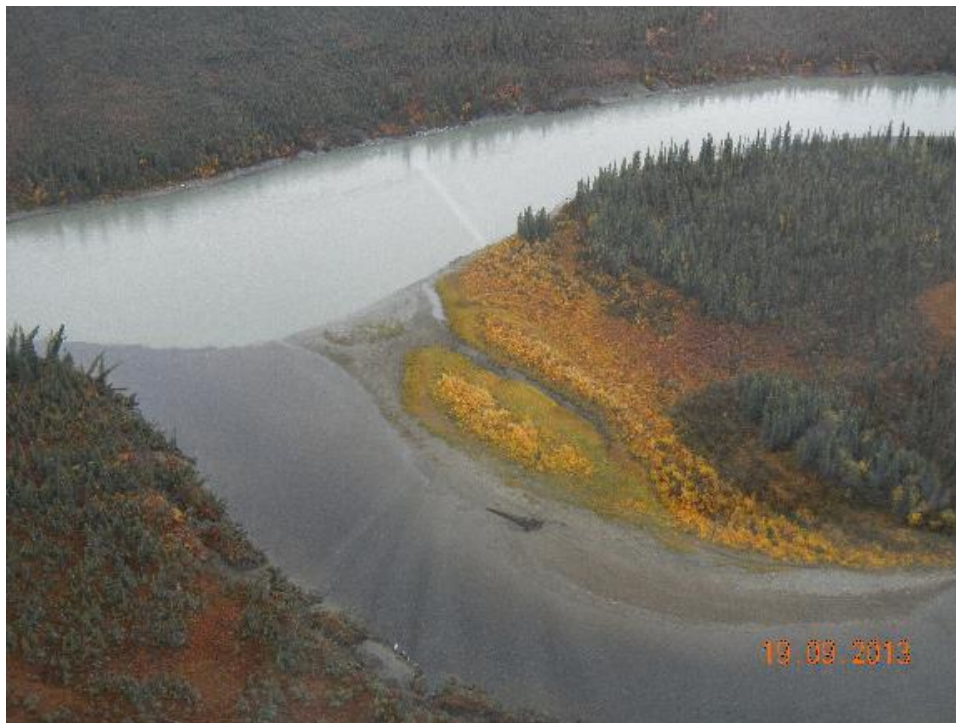
Figure A.2-22 – Tyone River confluence with Susitna at PRM 247.3 (P5530).

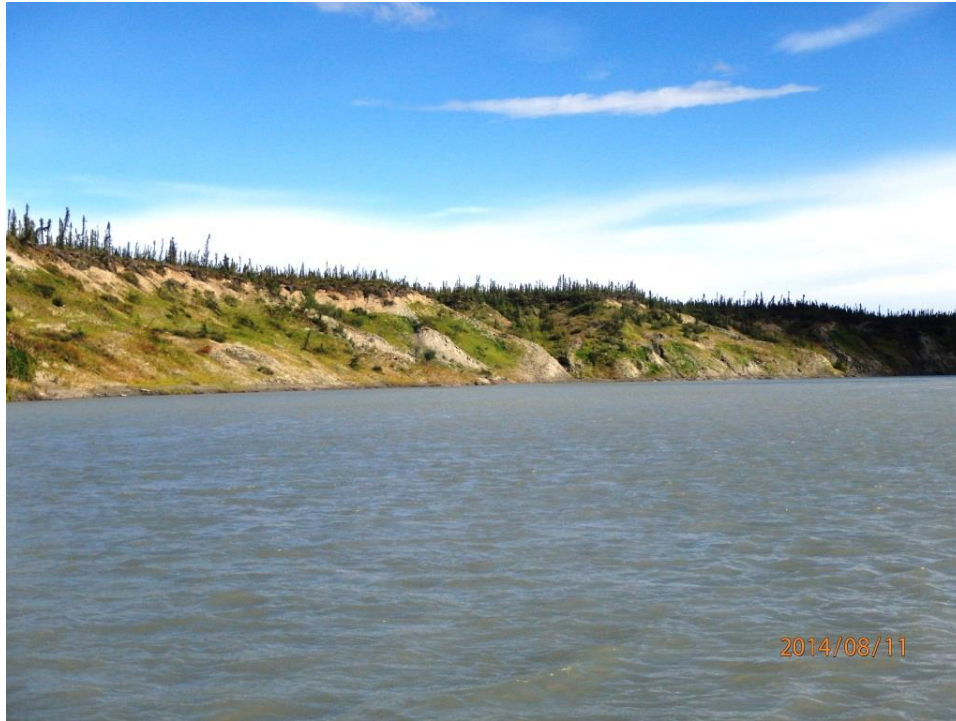
**Figure A.2-23 – Eroding glacio-lacustrine deposits at PRM 248 (P898).**

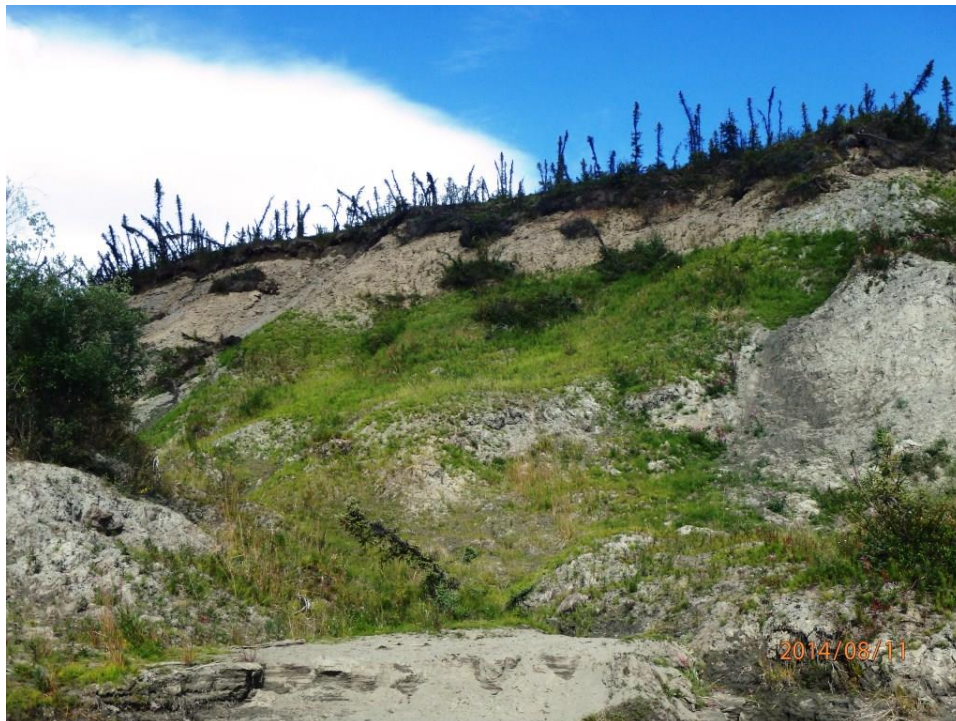
**Figure A.2-24 – Vegetation unable to establish on very actively eroding unstable bank face (P903).**

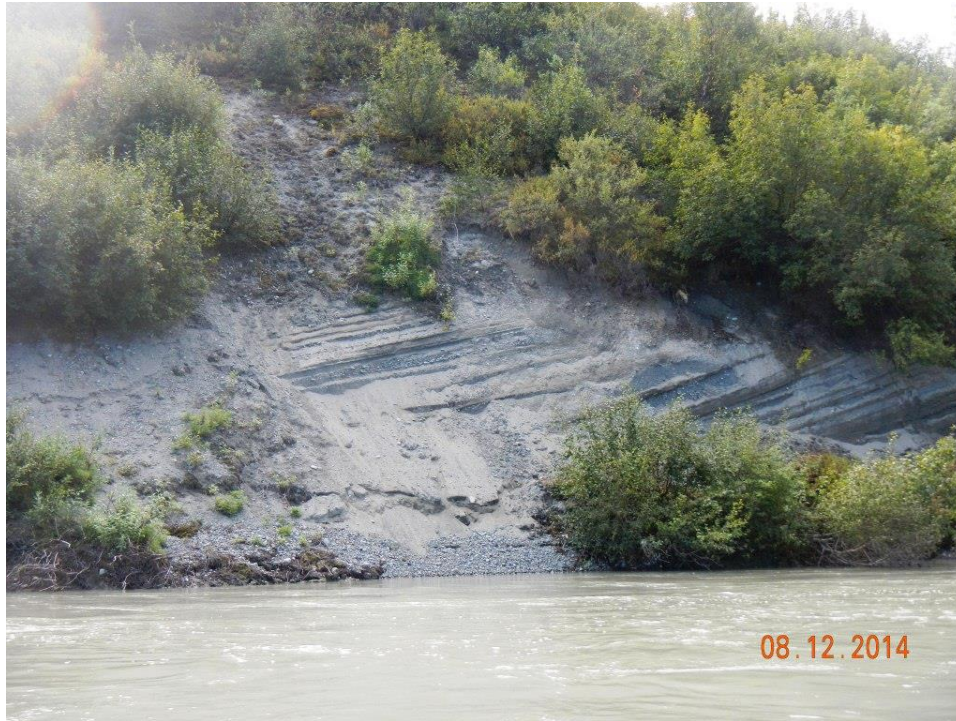
**Figure A.2-27 – Eroding supply of fine grained sediment and gravels from glacio-lacustrine sediments at PRM 245.2 (P448).**

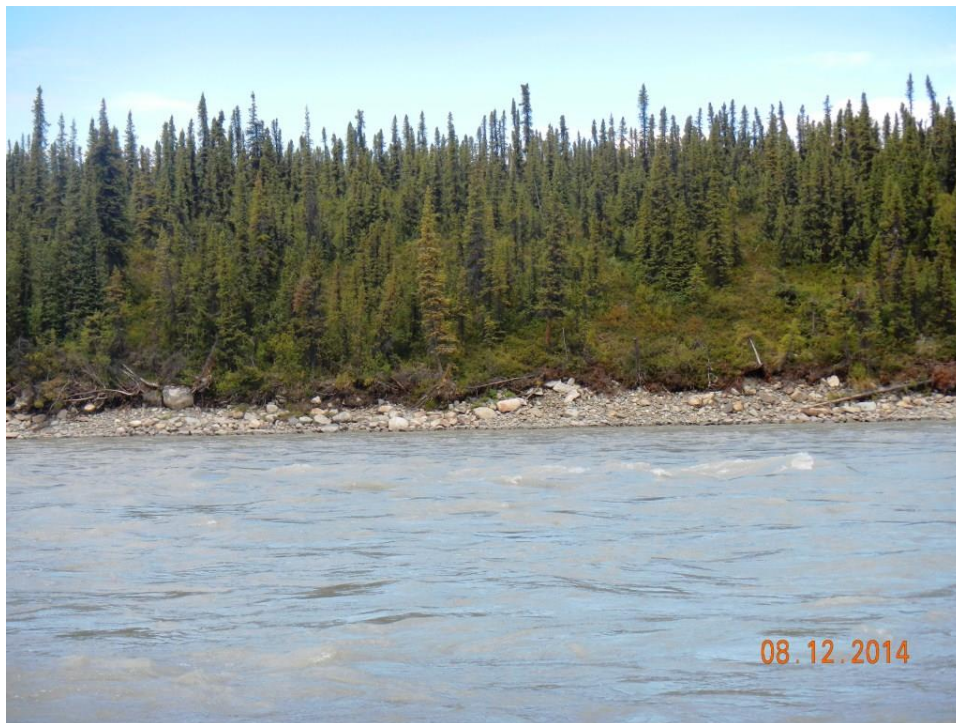
**Figure A.2-28 – Typical ice scraped bank with large cobble and boulder deposits and ice pushed vegetation near PRM 244.5 (P458).**

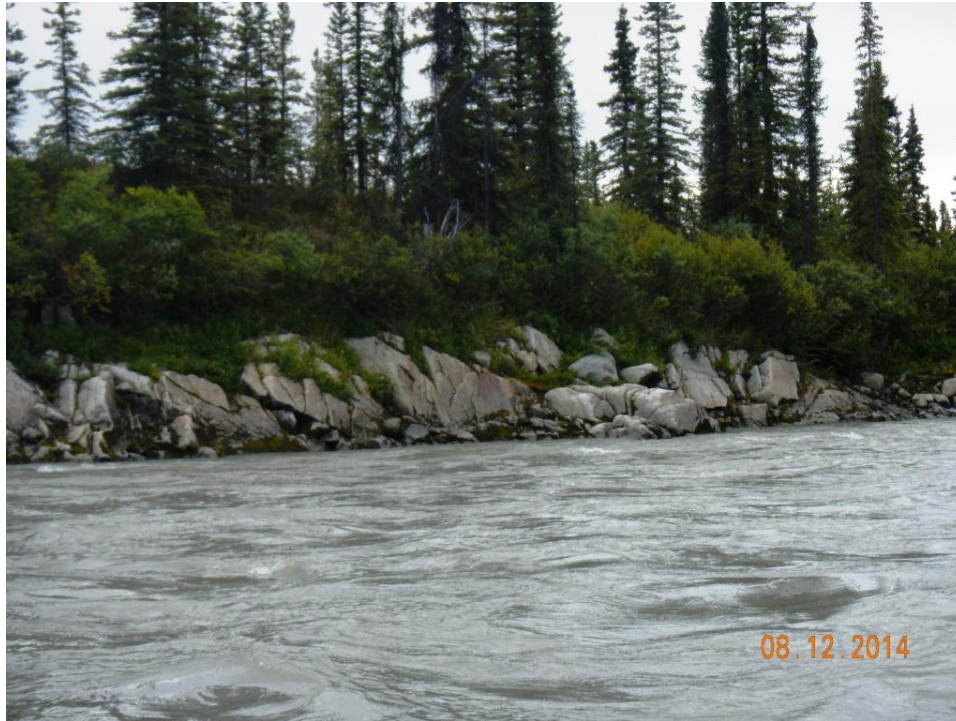
**Figure A.2-29 – Bedrock outcrop in right bank near PRM 243.5 (P473).**

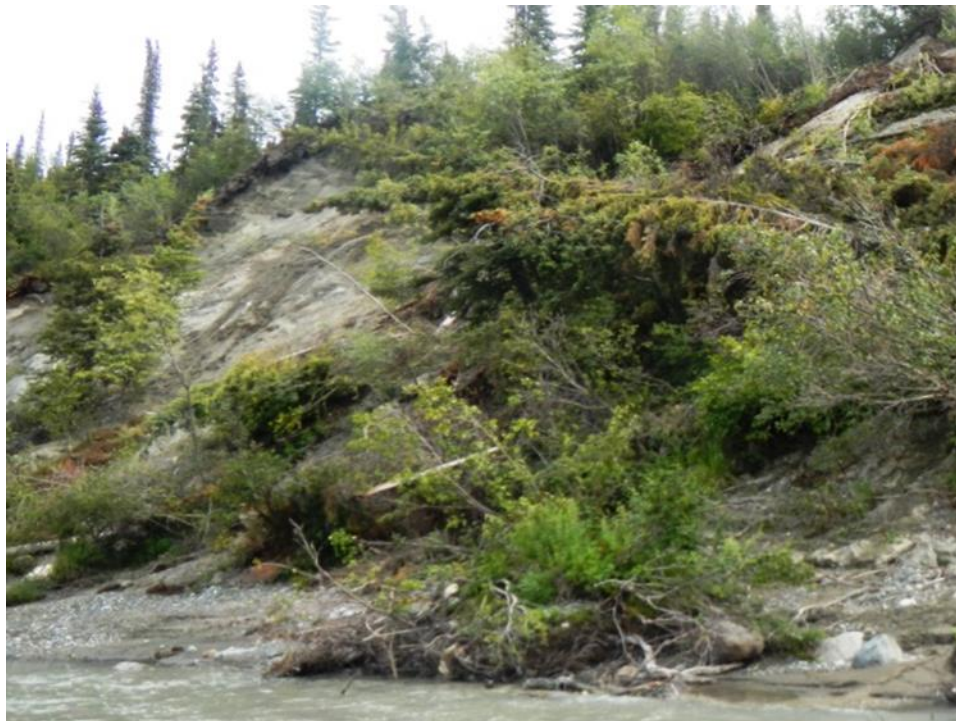
**Figure A.2-30 - Active landslide in till supplying fine sediment, gravels, cobbles, and large wood near PRM 242.5 (P507).**

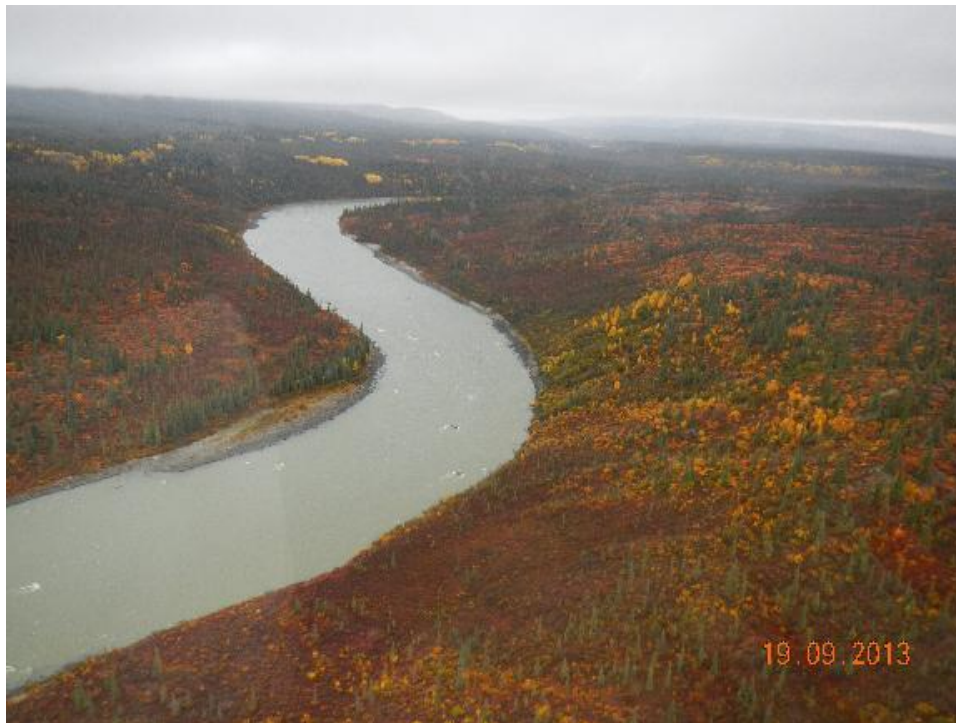
**Figure A.2-32 – Confined channel with no islands or bars at PRM 240. Note large ice-deposited boulders in channel (indicated by surface disturbance in flow) (P5526).**

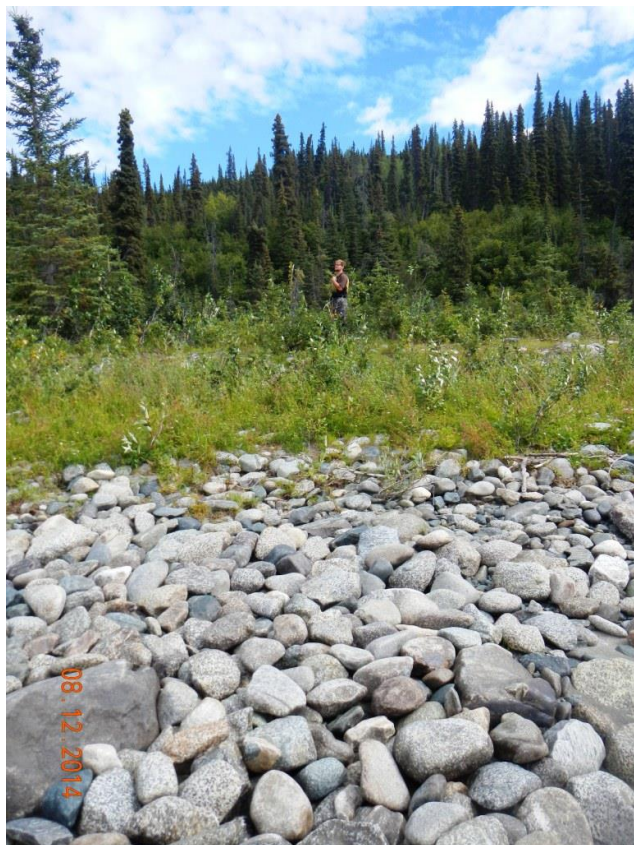
**Figure A.2-33 – Ice paved bank on high island surface with mowed vegetation near PRM 238.2 (P618).**

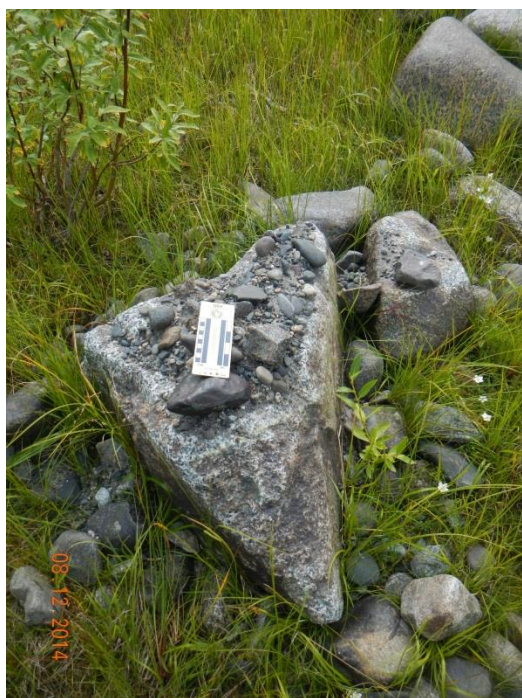
**Figure A.2-34 – Ice deposited material on top of high island surface near PRM 238.2 (P611).**

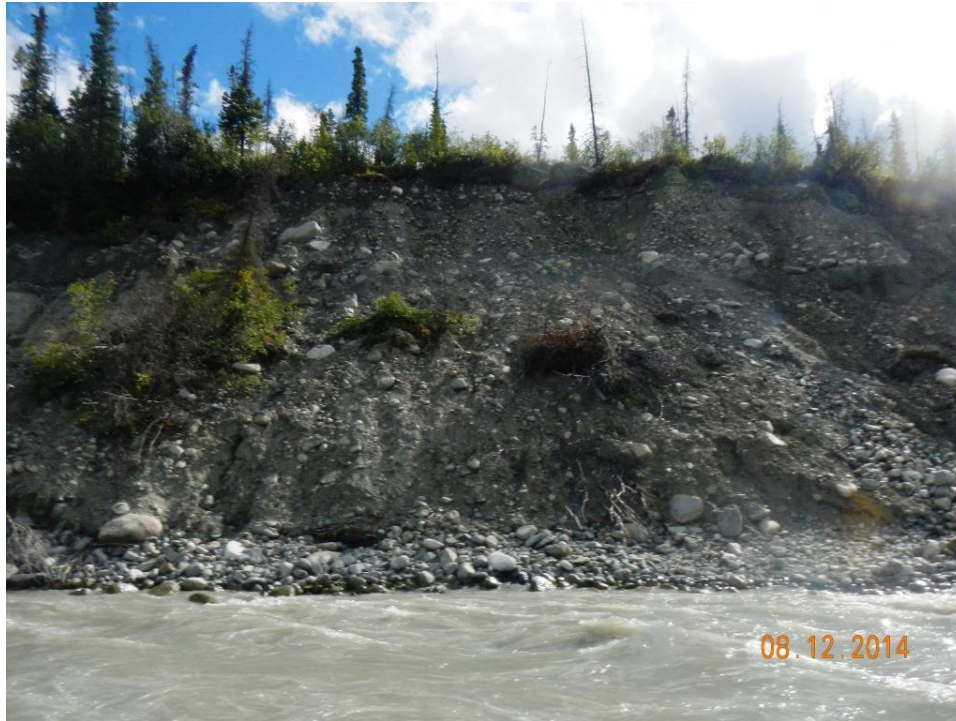
**Figure A.2-37 - Course grained sediment (cobbles and boulders) source (till) near PRM 235.6 (P701).**

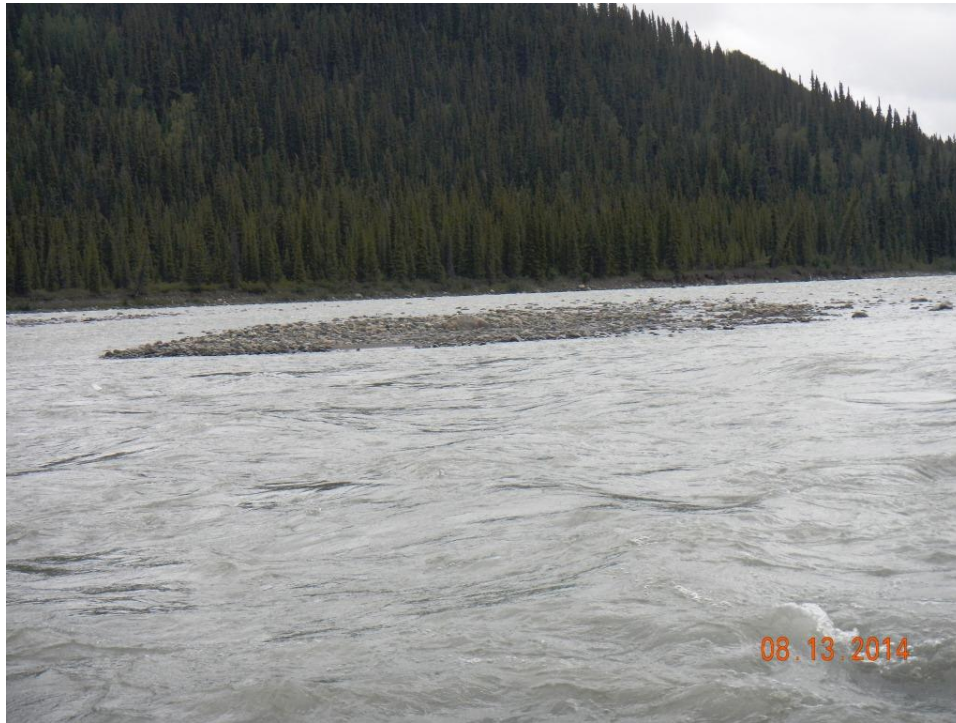
Figure A.2-39- Fine to medium gravel storage in mid-channel bar in expansion zone near PRM 233.5 (P782).

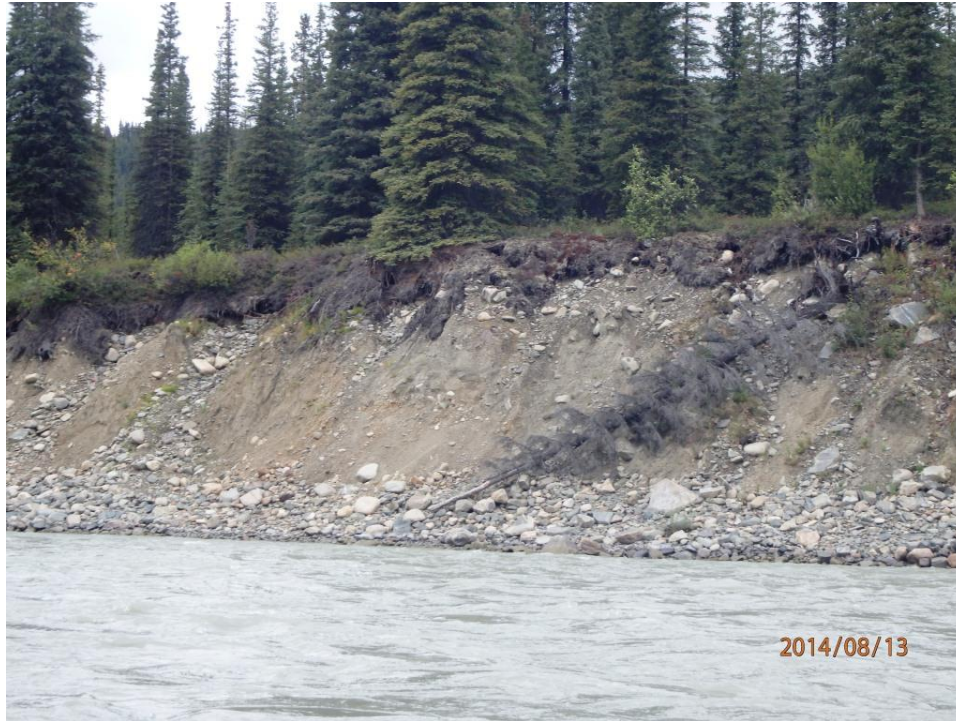
**Figure A.2-45 - Eroding outwash terrace near PRM 229 – local fine and coarse grain sediment supply (P069).**

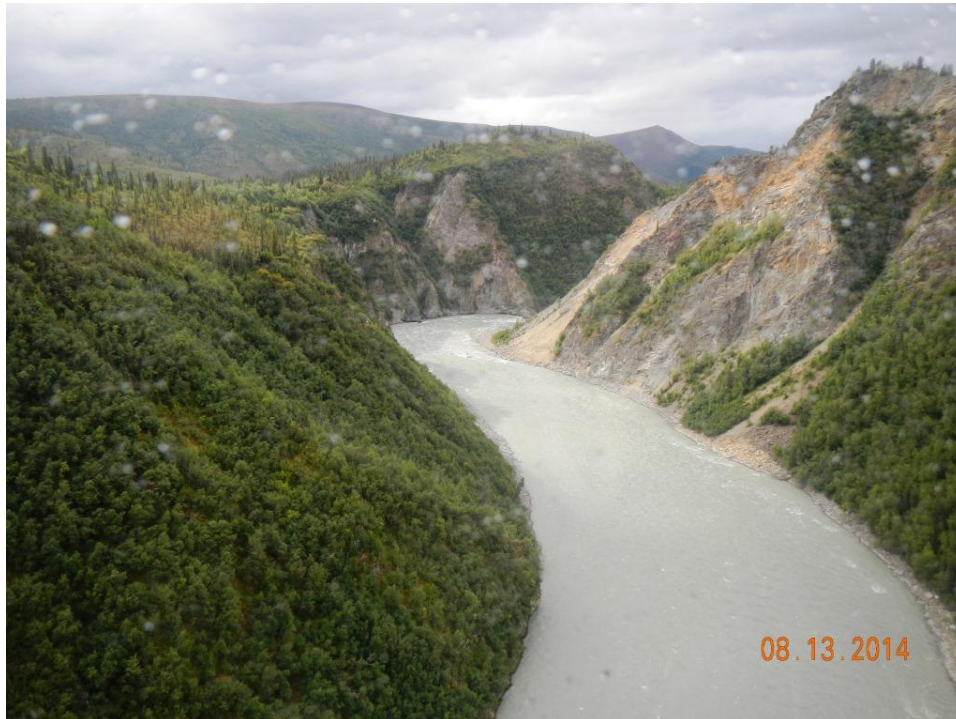
**Figure A.2-46 – View downstream at PRM 226 of bedrock outcrop and vegetated bedrock slopes on right and left banks in Vee Canyon (P750).**

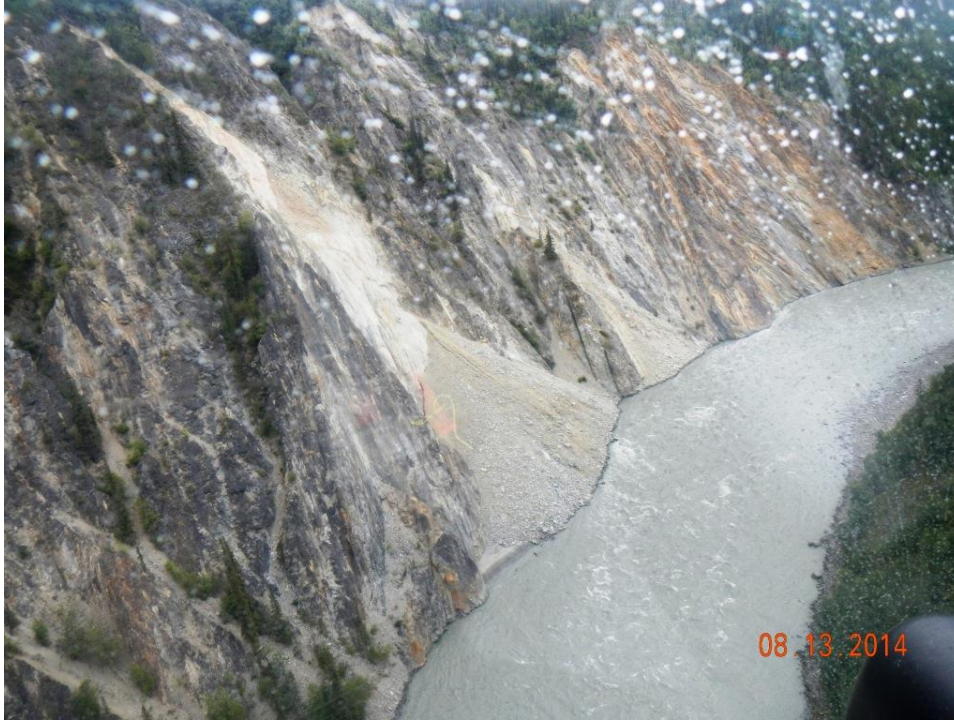
**Figure A.2-47 – View upstream near PRM 226 at right bank colluvial cones in Vee Canyon – local bedrock source of large sediment (P757).**

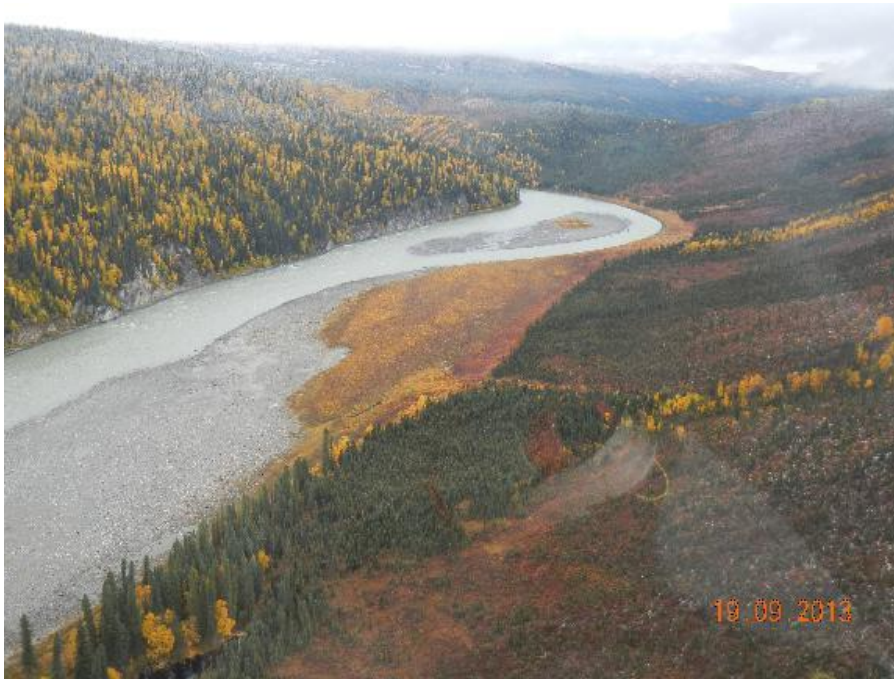
Figure A.2-48 – View upstream of the expansion zone in UR-4 at the bottom end of Vee Canyon (UR-3/UR-4 reach break) (P5498).

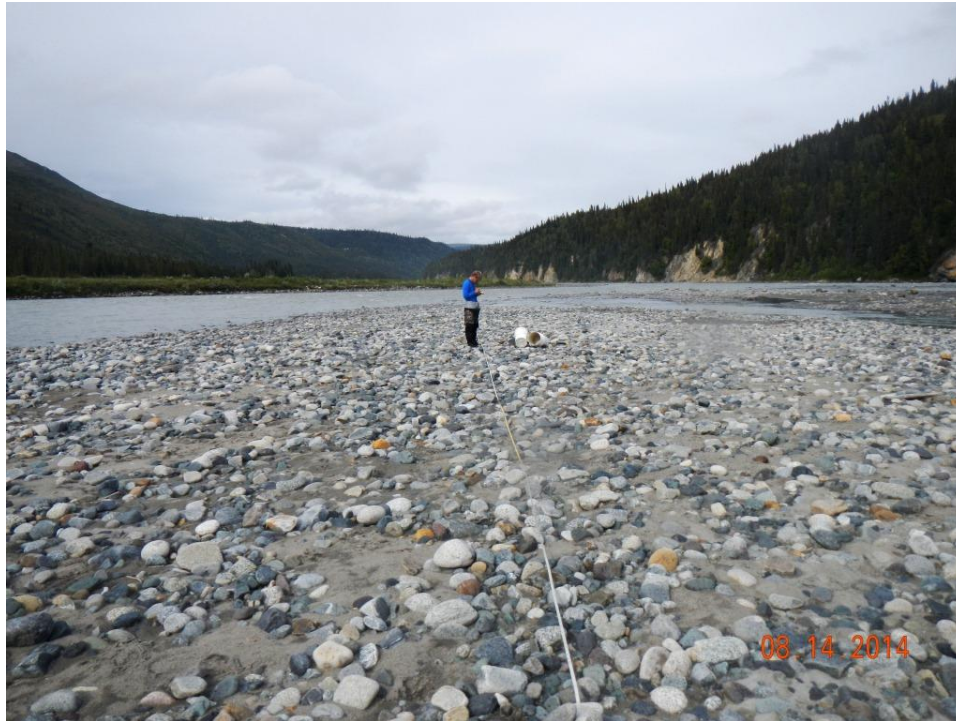
**Figure A.2-50 – Imbricated surface material on gravel bar (PRM 224.6) in expansion zone downstream of Vee Canyon. Site of surface and subsurface sampling. Median particle diameter ( $D_{50}$ ) of surface bed material is 68.3 mm. Median particle diameter ( $D_{50}$ ) of subsurface bed material is 27.3 mm (P877).**
