## Susitna-Watana Hydroelectric Project Document ARLIS Uniform Cover Page

| <b>Title:</b><br><br>Geomorphology study, Study plan Section 6.5, 2014-2015 Study Implementation Report. Appendix A. Susitna River upper river reconnaissance photographs | | <b>SuWa 289</b> |

## APPENDIX A: SUSITNA RIVER UPPER RIVER RECONNAISSANCE PHOTOGRAPHS

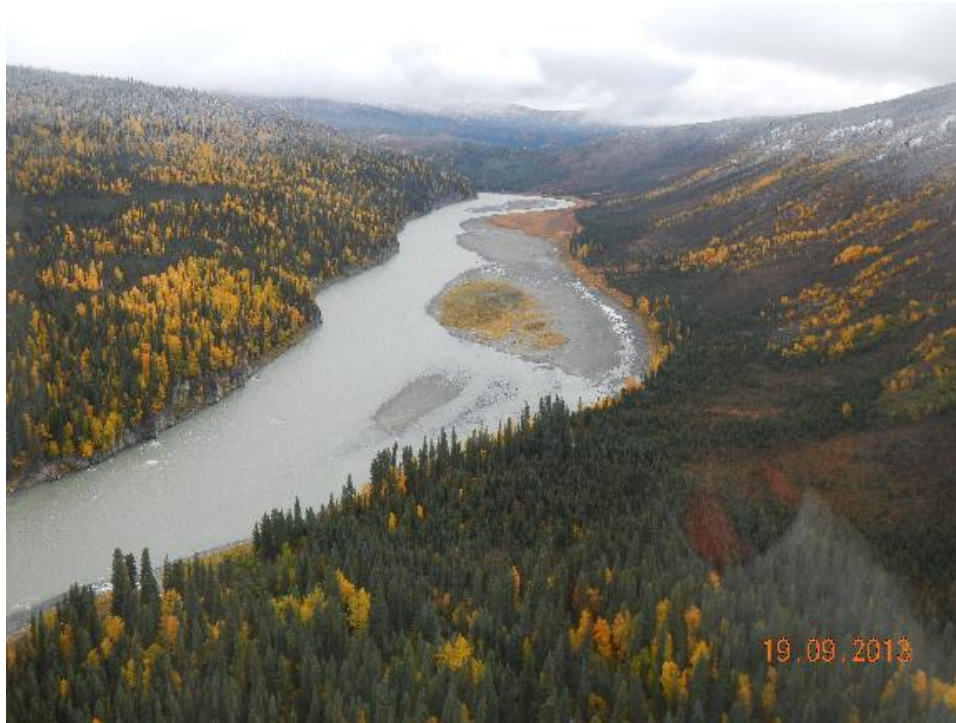
**Figure A.2-51 – View upstream at PRM 223 of an expansion zone and vegetated island (P223).**

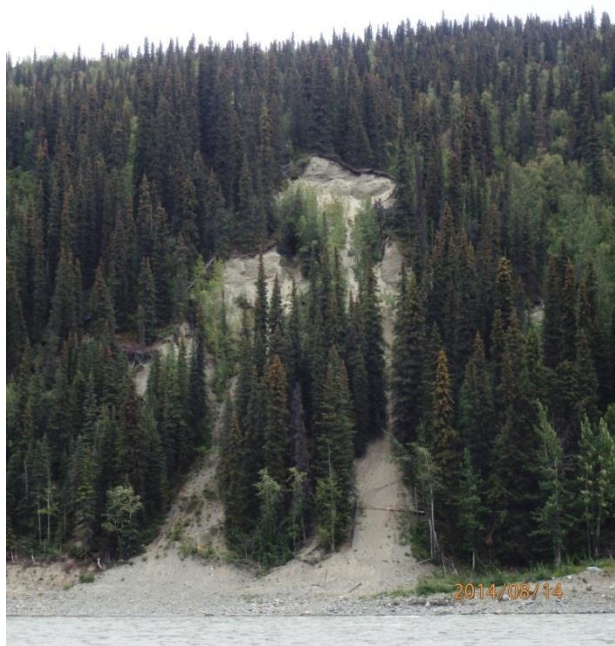
Figure A.2-52 – Active slide in till near PRM 221 (P114).

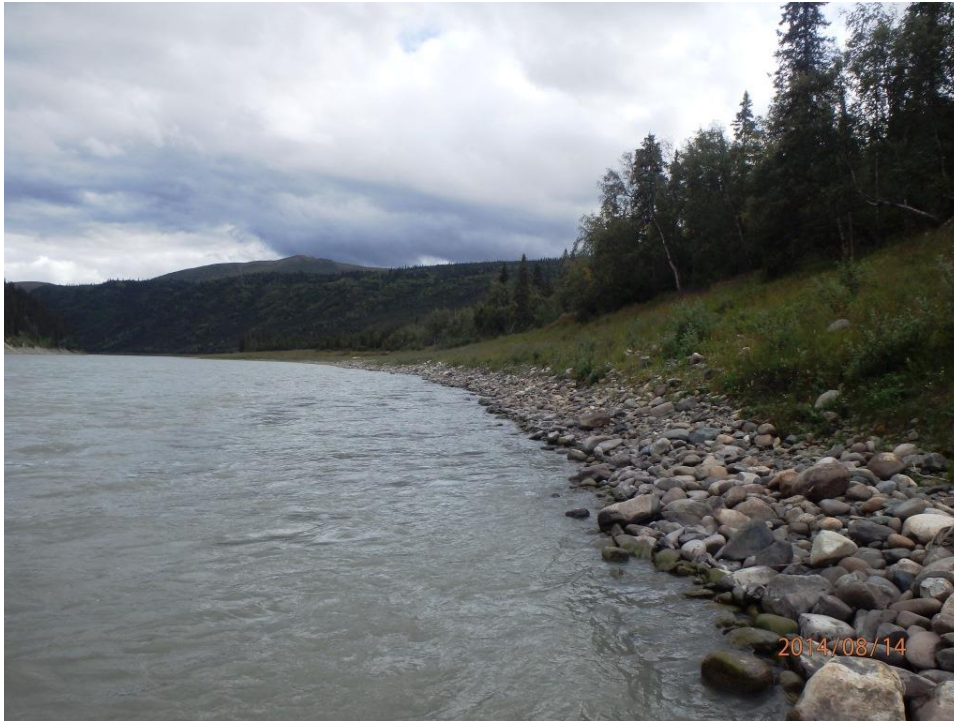
**Figure A.2-56 – View upstream at PRM 220.7 of ice paved gravels and ice-sheared vegetation. Trim line about 15 feet above water surface (P161).**

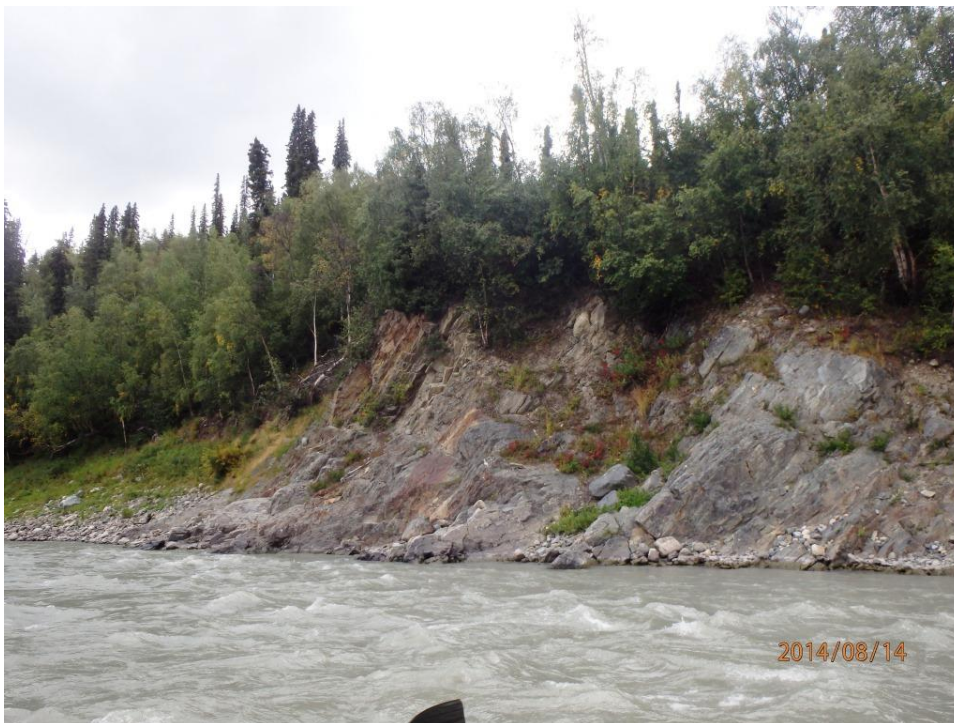
**Figure A.2-57 – Bedrock outcrop near PRM 220.2. Ice shear line present on vegetated surface and outcrop surface on right bank (P177).**

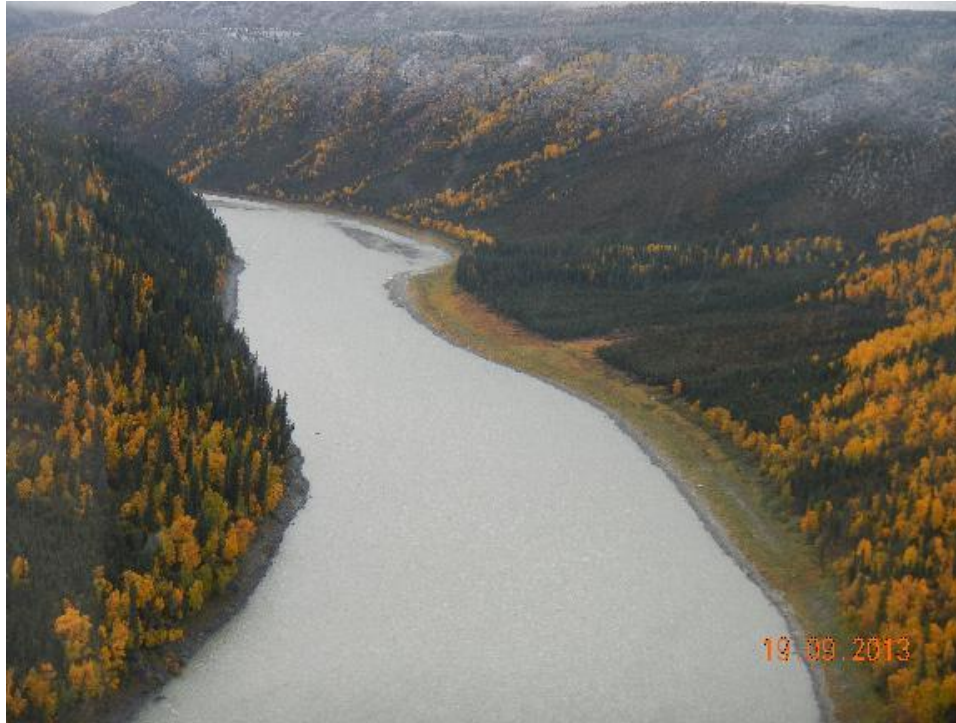
**Figure A.2-58 – View upstream at PRM 220. Old fan surface illustrated on left bank (P5491).**

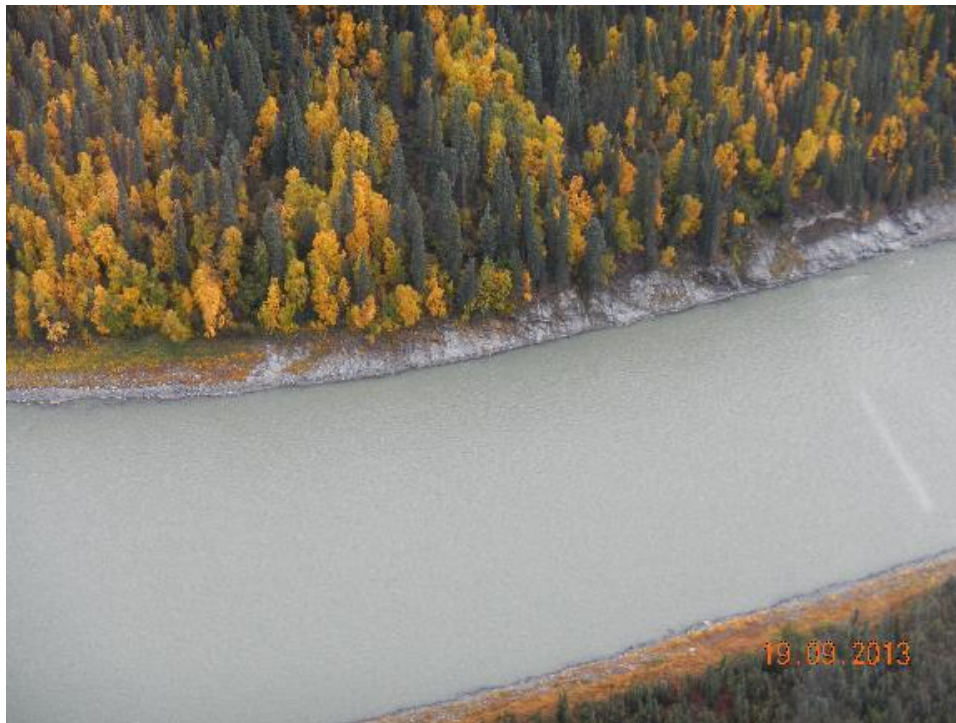
**Figure A.2-59 – Aerial view of lateral bedrock controlled channel at PRM 219 (P5490).**

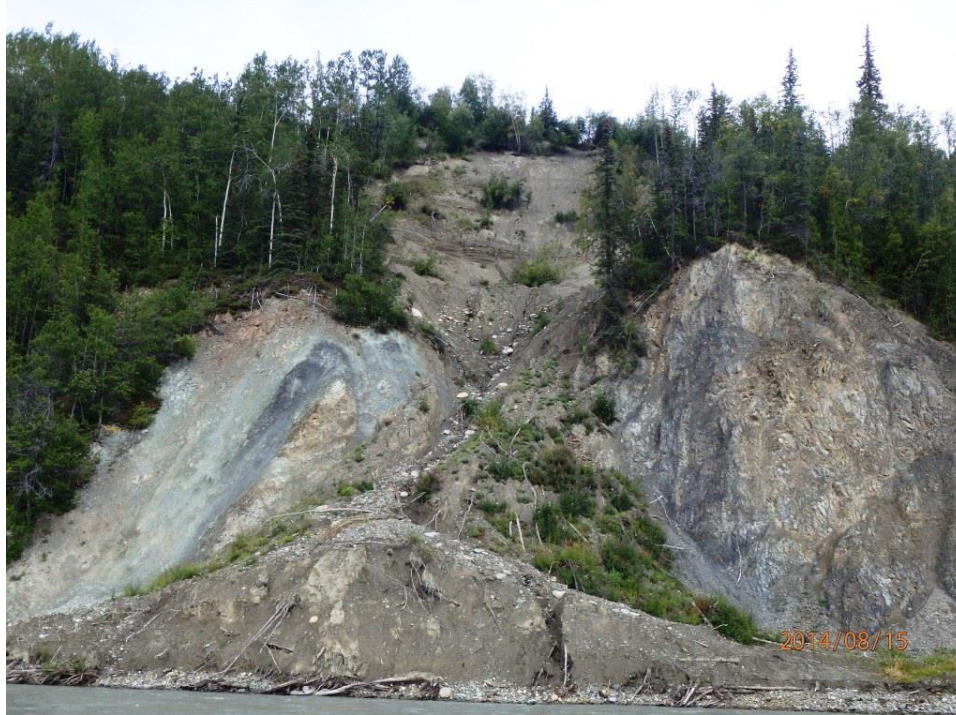
**Figure A.2-64 – Active landslide zone on bend near PRM 209 – till over bedrock (P371).**

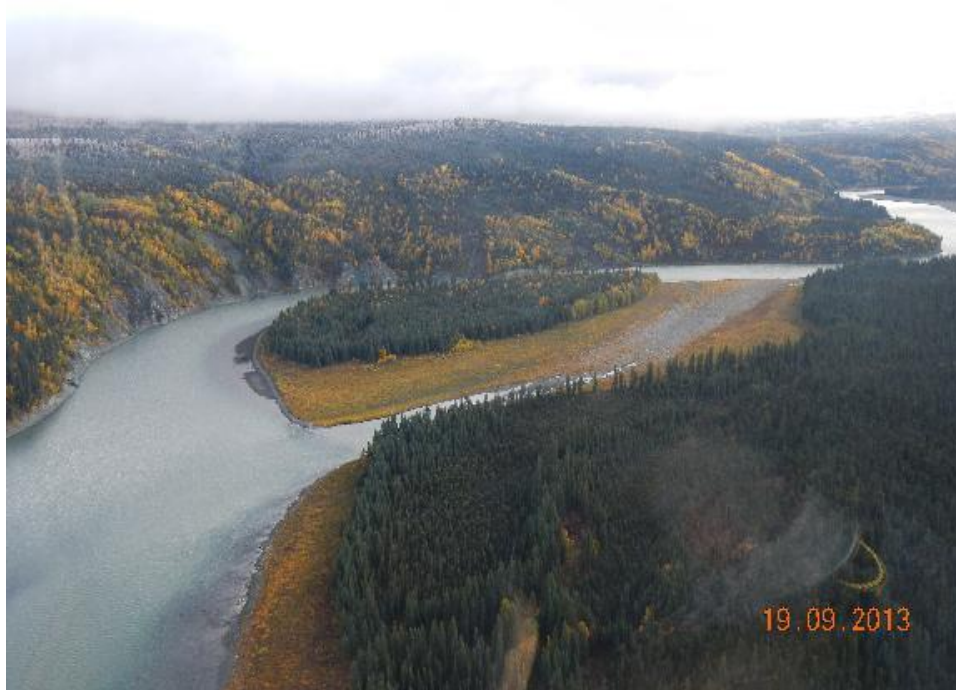
**Figure A.2-65 – View upstream near PRM 208.5 of terrace height island and side channel. Lateral weir at head of channel and vegetating side channel bed. Active landslide zone and local sediment supply on outside bend (river right) (P5473).**

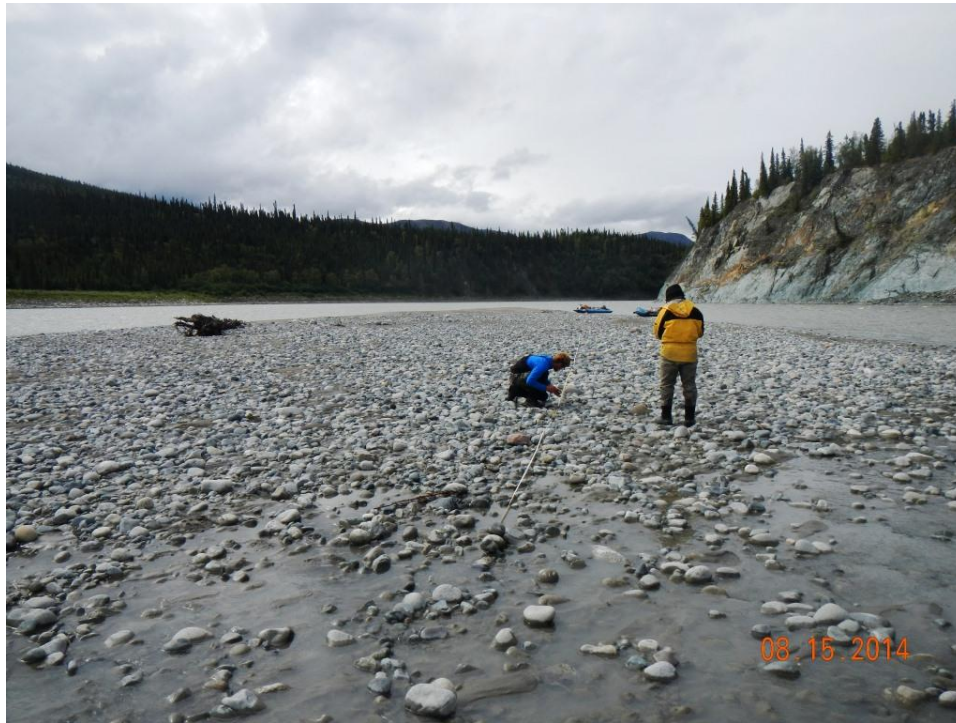
Figure A.2-66 – Surface material at head of bar at sediment sampling site at PRM 208.0. Bedrock outcrop on river right. Median particle diameter ( $D_{50}$ ) is 47.5 mm (P127).

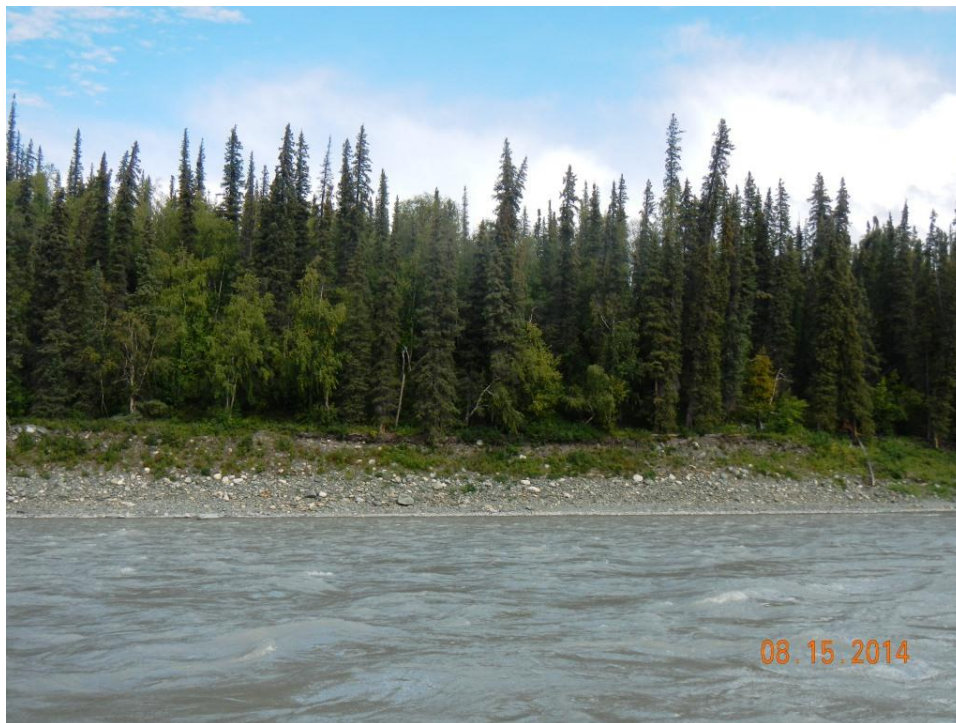
Figure A.2-67 – Ice shear line along vegetated bank typical throughout Geomorphic Reach UR-5 (photo near PRM 207.6) (P134).

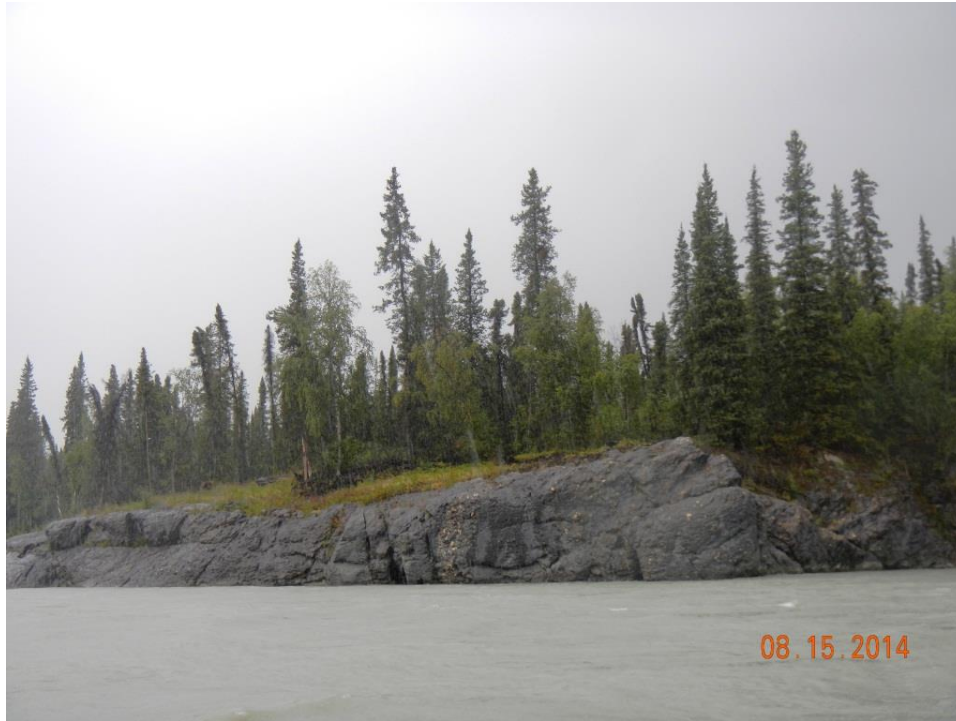
**Figure A.2-74 – Bedrock outcrop on right bank at PRM 204.1 (P210).**

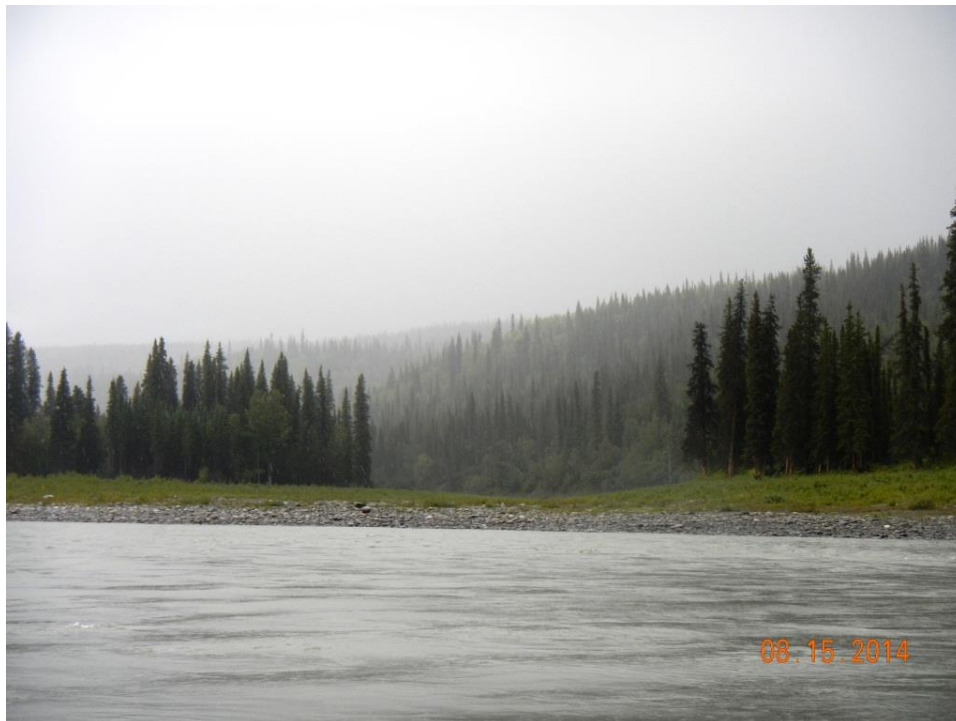
**Figure A.2-75 – High island surfaces (typical terrace height) with lateral weir and vegetating side channel near PRM 203.9. View looking downstream at inlet to side channel (P218).**

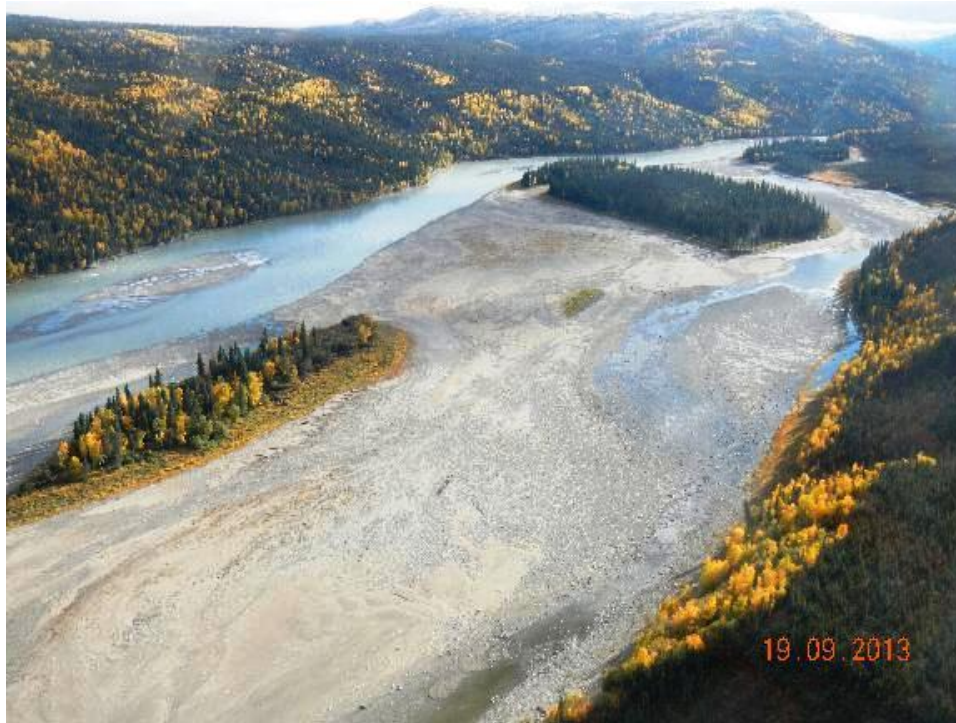
**Figure A.2-78– View upstream of expansion zone near PRM 202 (P5461).**

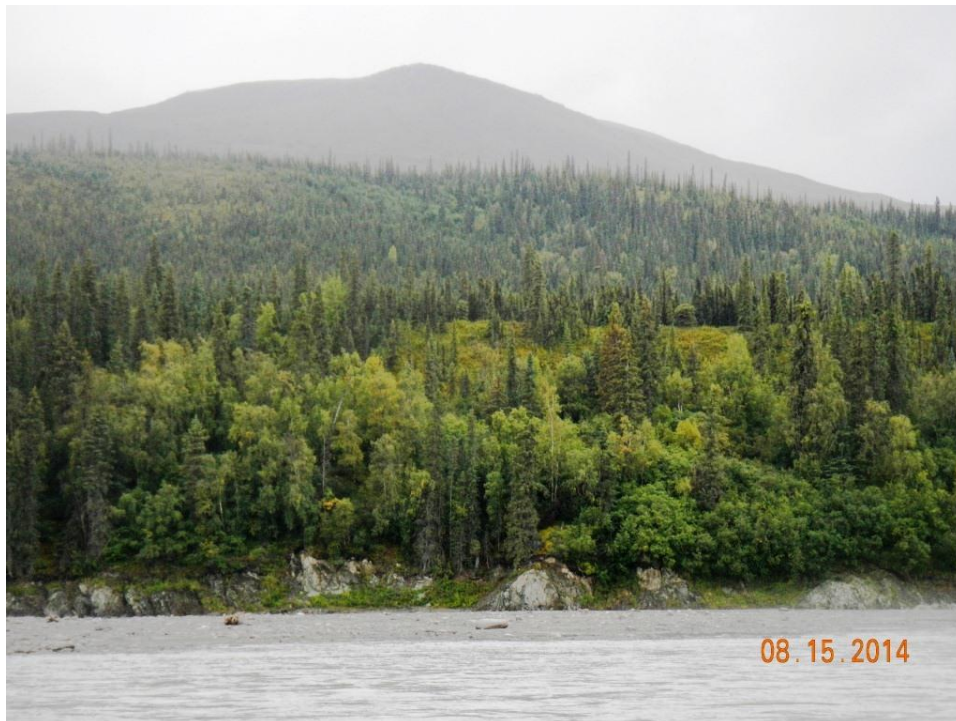
**Figure A.2-79 – View of Susitna River left bank near PRM 202. Wide bedrock bound valley floor with vegetated overlying outwash or till (P268).**

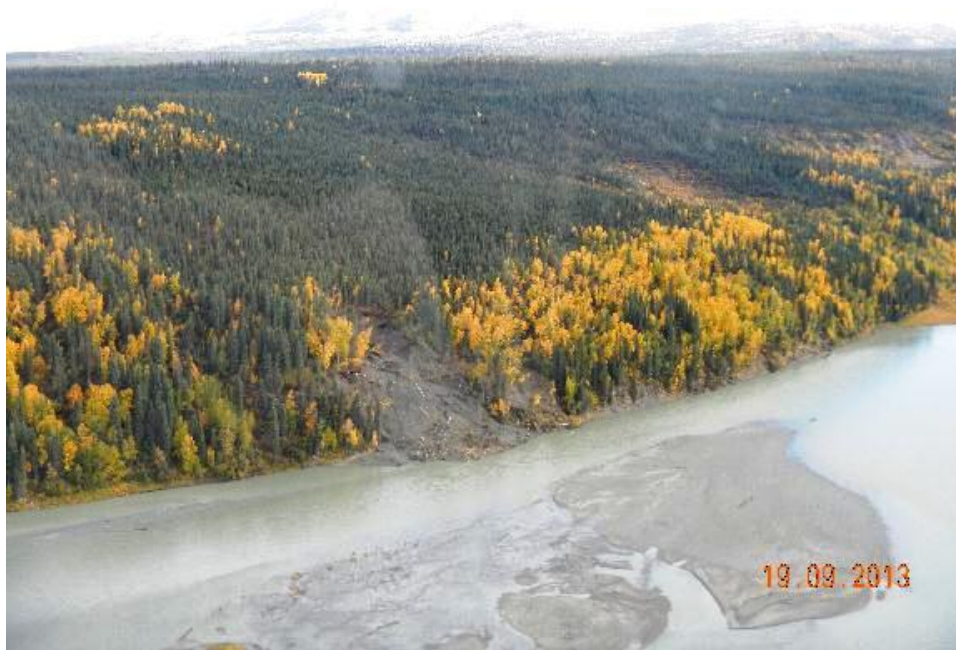
**Figure A.2-82 - Active landslide in till near PRM 199.5 – Susitna River right bank (P5454).**

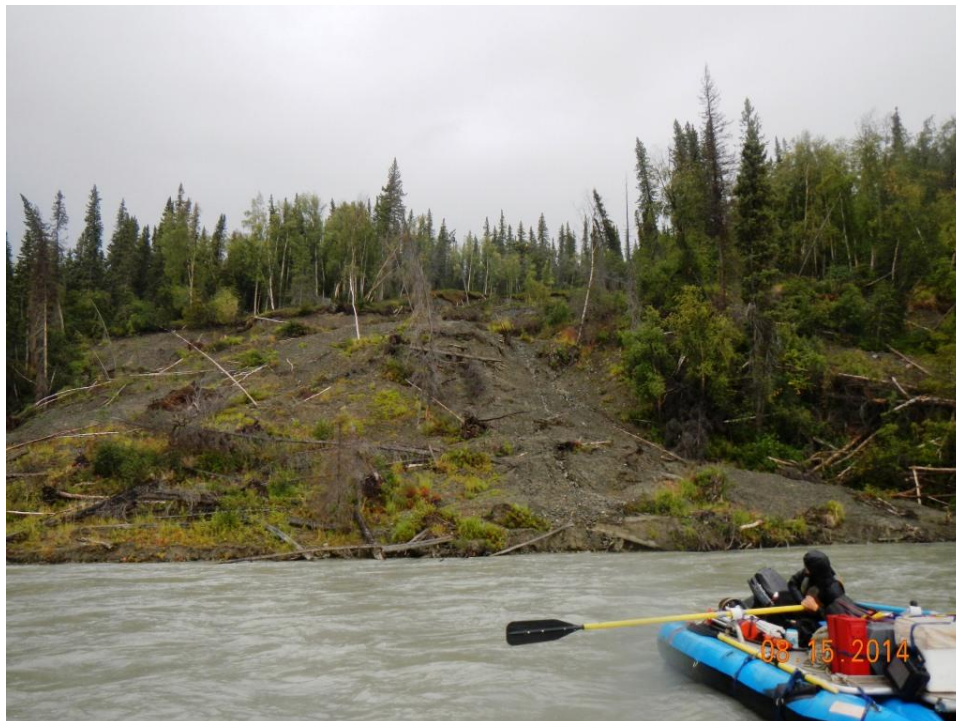
**Figure A.2-83 – View of active landslide in till near PRM 199.5 (P325)**
